Report on the Examination and Analysis of a Mortar Sample from a Stepped Footing in a Medieval Town Wall

Near the former Beverley Gate, Hull

Our Ref: M/1826/17
Your Ref: Town Wall, Hull
Doc. Ref: M182617R1

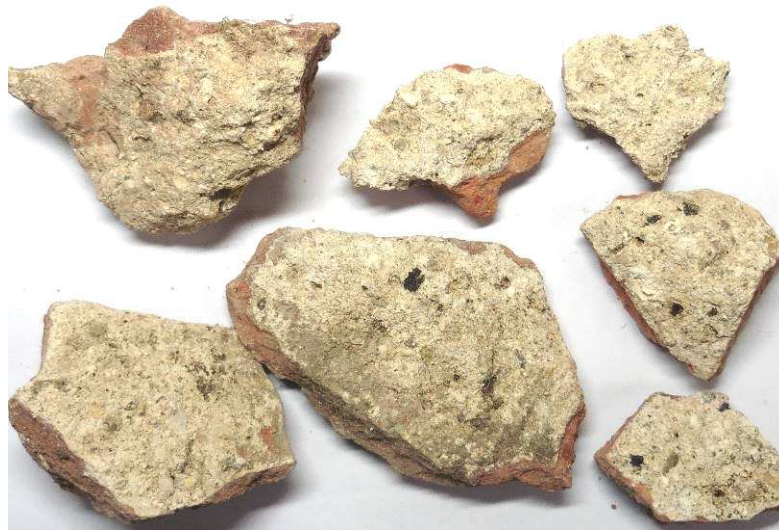
Plate No. 1: The above shows the sample as received with the mortar coated face of the brick fragments shown. The inner surfaces were of fractured soft brick and are shown below.

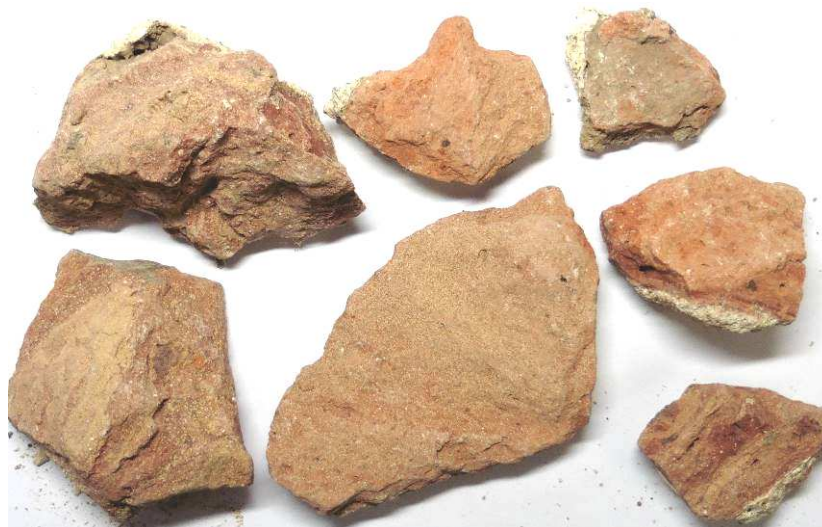
Plate No. 2: The fractured, mortar free surfaces, of the brick pieces are shown above.

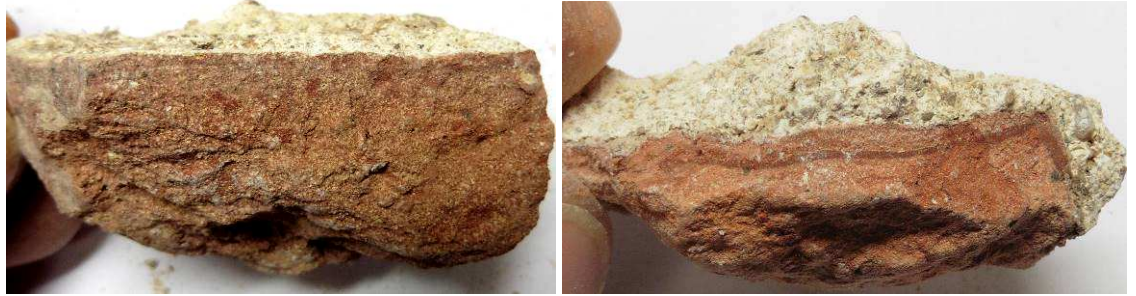
Plates No. 3 & 4: Both of the above show examples of the mortar adhering to pieces of the brick, which was typical of all of the pieces received.

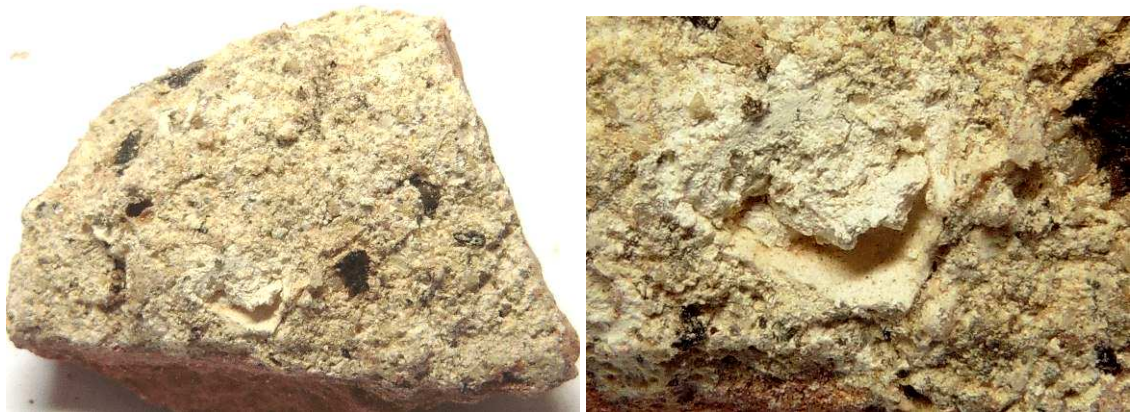
Plates No. 5 & 6: The left plate shows a view of the surface of the mortar adhering to the brick fragment in Plate No. 4 above. This being the thickest depth of mortar on any of the pieces received was used for thin section preparation. The right plate shows a close-up of one of the large lime inclusions observed in the mortar.

The mortar was noted to be strongly bonded to the brick to which it adhered, and it had the appearance and texture of a typical lime mortar, which contained a number of lime inclusions. These were sub-round to sub-angular in shape, with the largest observed being 9.3mm in size.

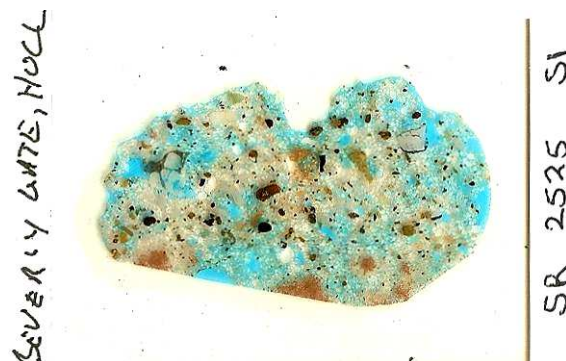
Plate No. 7:

Thin section prepared from a piece of mortar for microscopic examination and modal analysis.

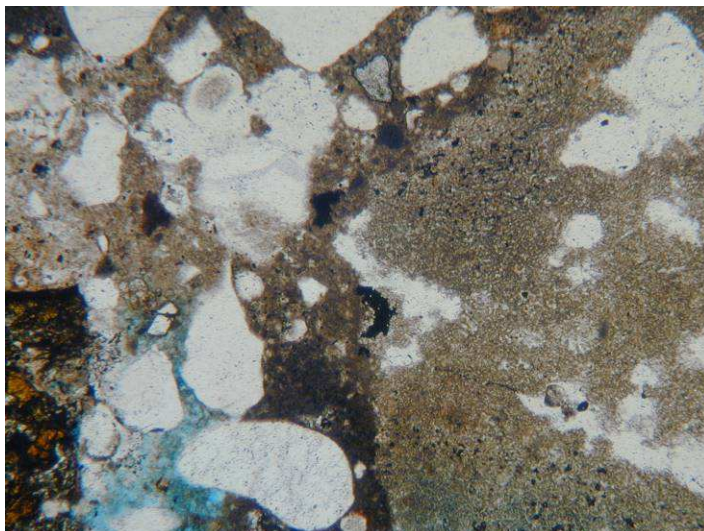
Plate No. 8:

A view in plane polarised light (ppl) showing an area paste within the mortar adjacent to a fully slaked angular lime inclusion.

The left side of the plate shows fine aggregate particles encapsulated in paste. Whereas the right side of the plate contains the inclusion, which is fully slaked and locally leached, but it does not diffuse into the mortar paste at its margins.

An ash clinker fragment can be seen in the lower left.

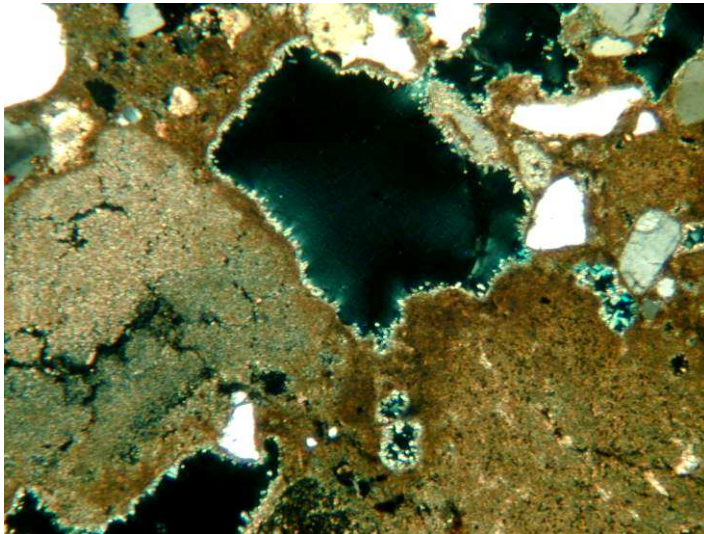
Plate No. 9:

A view in cross polarised light (xpl), of a paste rich area of the mortar, where an angular lime inclusion can be seen in the lower left with a putty inclusion in the lower right. The latter showing the typical globular structure with a fine shrinkage crack pattern throughout. The void in the centre of the plate (black) is rimmed with redeposited calcite crystals. The aggregates in the upper part of the plate are dominated by quartz grains.

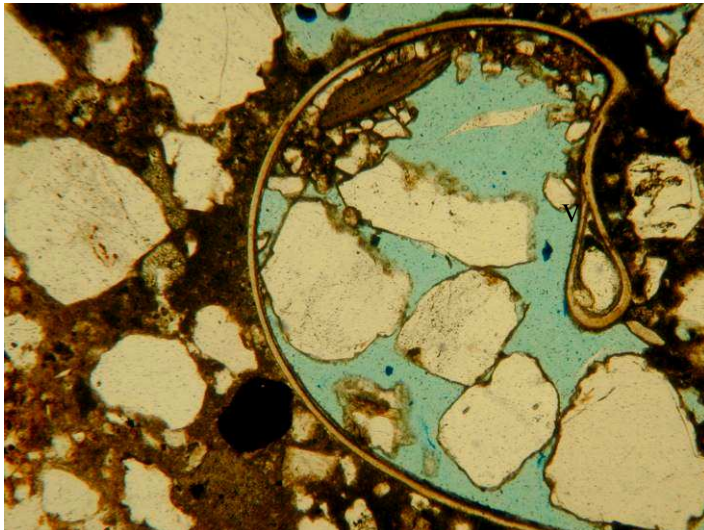
Plate No. 10:

Another view in ppl, of a voided area within a shell fragment surrounded by a dense area of mortar fabric. The sand grains within the void formed by the shell are quartz grains, as are most of the grains encapsulated within the paste to the left.

The paste is dense and fully carbonated, with the small black fragments being of coal and the small sub-rounded and vesicular particles being ash.

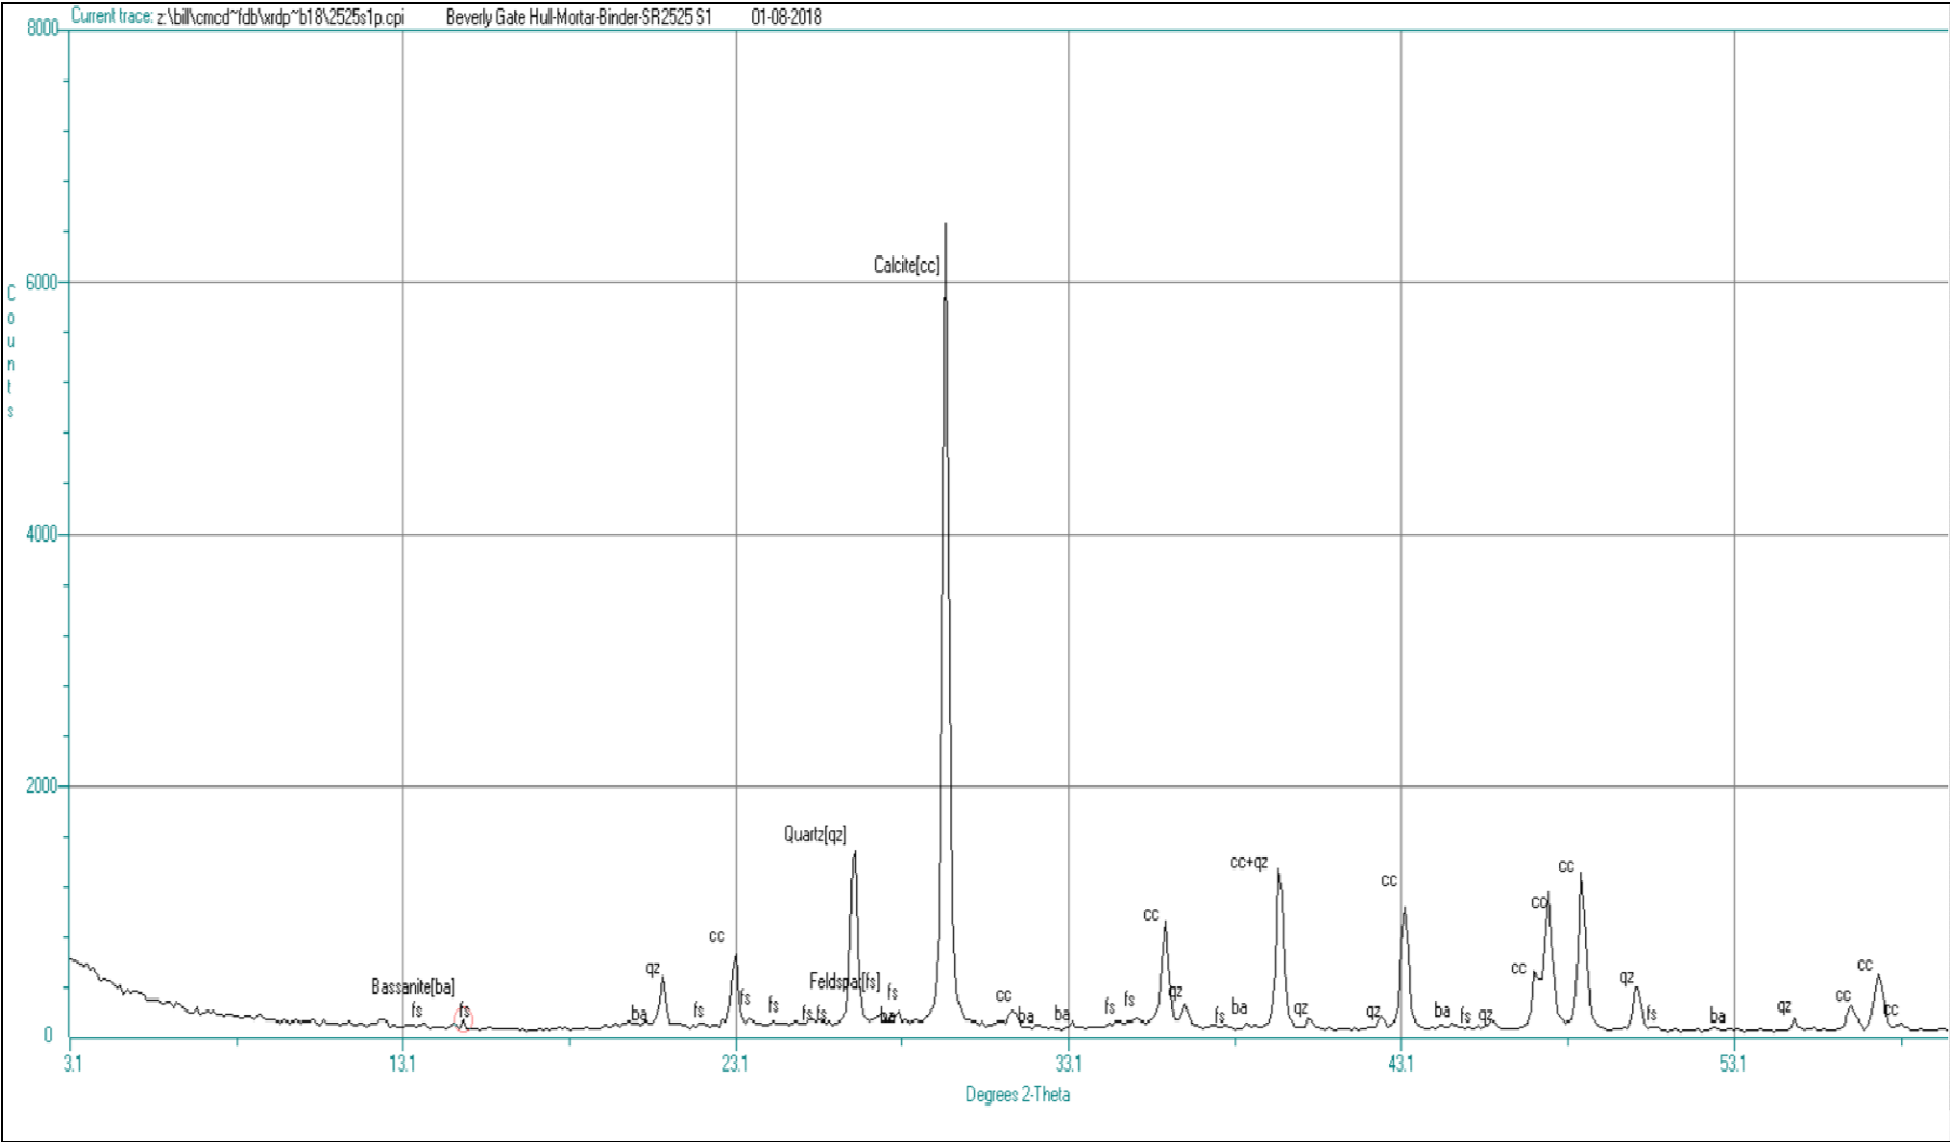
Figure No. 1 – SR2525-S1 – Binder from Bedding mortar in a stepped footing, in a brick Medieval Town Wall.

From the analysis it is confirmed that the binder used in the mortar was a non-hydraulic Calcium lime. There was no evidence from the analysis of any hydraulic components or pozzolanic materials in the sample analysed.

The low abundance of calcium sulphate detected would infer that the mortar has been affected by sulphates, perhaps from groundwater or leached from the brick itself. However, the quantity is such as not to have been detrimental to the mortar analysed. This is consistent with the condition of the mortar, as represented by the sample received.

The sulphate detected in the form of Bassanite, may infer limited reaction, or the possibility of loss of moisture from gypsum, the form commonly found, in response to drying and processing in the laboratory prior to analysis, with conversion of Gypsum (calcium sulphate hydrate) to Bassanite (calcium sulphate hemi-hydrate).
