Our Ref: M/2097/21/C1
Your Ref.: Old St. Margaret's

2nd February 2021

CERTIFICATE OF ANALYSIS ON A MORTAR SAMPLE FOR BINDER TYPE DETERMINATION & MIX COMPOSITION

Project Reference	:	Old St. Margaret's, Harwood Dale, North Yorkshire
Sample Source	:	Mid 17 th Century ruined church building
Sample Description	:	Masonry mortar
Date Received	:	21 st January 2021
CMC Sample Ref	:	SR 2823 - S1
Method of Test	:	Mix composition by acid digestion, with binder type by XRD analysis following in-house procedures. With the fabric condition assessed from a thin section examination.

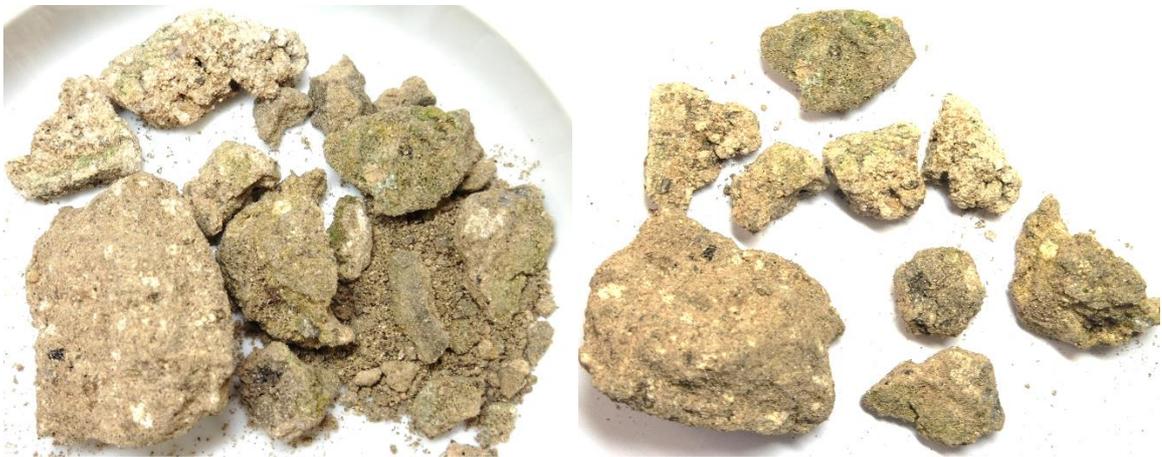
Plates No. 1 & 2: The left plate above shows the mortar sample as received, in which the abundance of lime inclusions can be clearly seen. The right plate shows the intact pieces selected for analysis, with the larger fragment used in the preparation of a thin section.

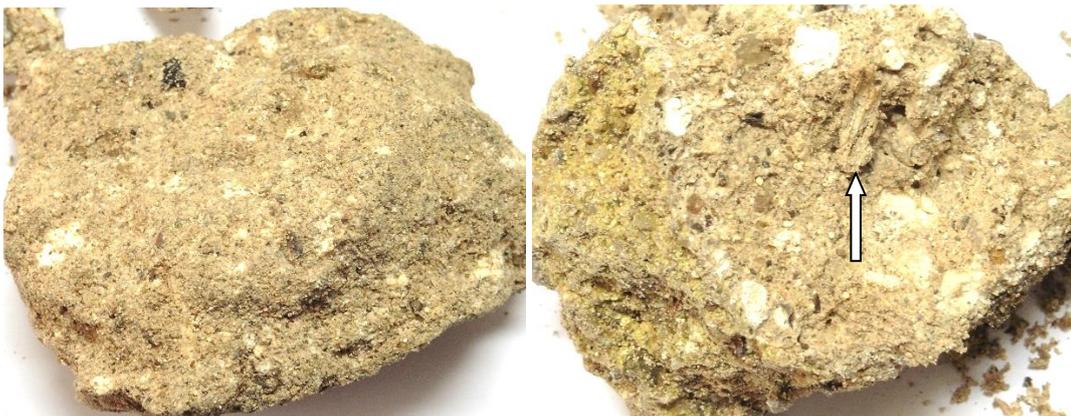
Plates No. 3 & 4: The left plate is a close-up of the largest fragment showing the abundance and distribution of the lime inclusions. The right plate shows a view of a freshly cut surface through the thickness of one of the fragments. Again, note the abundance and variation in size and shape of the lime inclusions, white, in the above images. Also note the presence of a wood fragment, arrowed in the right plate.

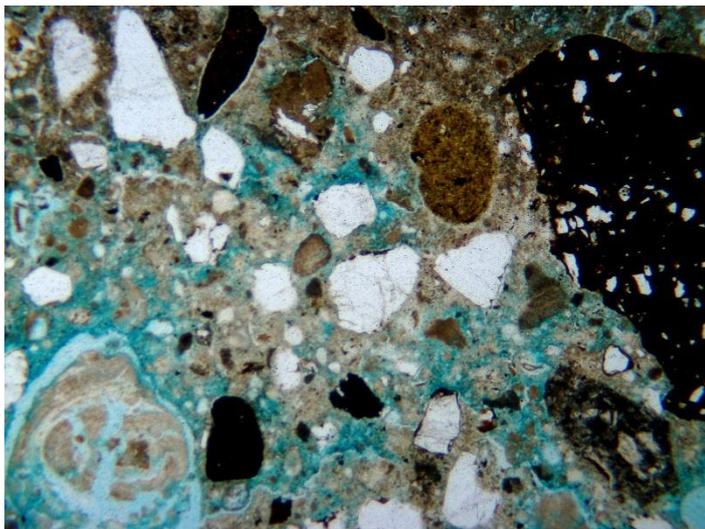
Plate No. 5:

A view in plane polarised light (ppl) of an area of the mortar, which depicts a typical area of the mortar fabric. An ironstone particle can be seen on the right side of the of the plate, with a partially disrupted Oolitic limestone particle in the lower left corner. The dense paste is fully carbonated and encapsulates a mixed suite of aggregates, dominated by quartz particles, along with siltstone, coal fragments, and altered igneous rock fragments

Porosity and voids are highlighted by the blue dyed resin.

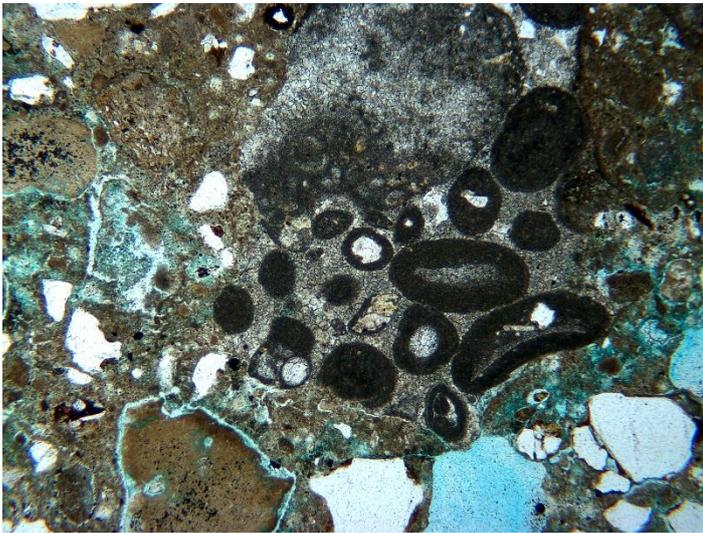
Plate No. 6:

Another view in plane polarised light (ppl) where a large limestone fragment can be seen filling centre to upper right part of the plate. The limestone is from a bioclastic rock containing Ooliths, shell fragments and foraminifera, etc. There is a calcined lime inclusion in the lower left, which has only been partially hydrated, and is surrounded by a shrinkage crack highlighting its perimeter showing that it did not form part of the paste. The aggregates in view are dominated by quartz grains, with minor opaque minerals and ash clinker. Porosity and voids are highlighted by the blue dyed resin. Field of view 2.4mm.

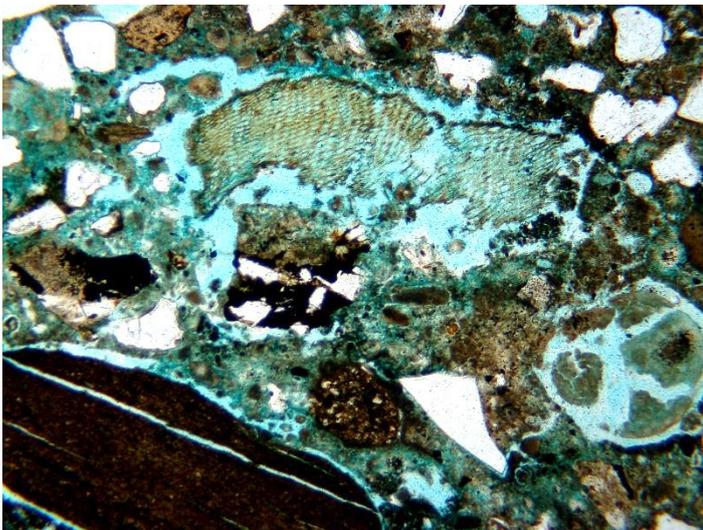
Plate No. 7:

Another view in plane polarised light, ppl, where a fire singed wood fragment can be seen in the centre of the plate. With a lime inclusion in the lower right and a large siltstone particle in the lower left. The paste within the lime mortar is fully carbonated and locally displays microporosity. The paste around the wood fragment has been depleted due to leaching. The aggregates in view are again dominated by quartz grains, mostly white in this image, with minor opaque minerals, black, feldspar and altered lithic grains. Porosity and voids are highlighted by the blue dyed resin. Field of view 1.2mm.

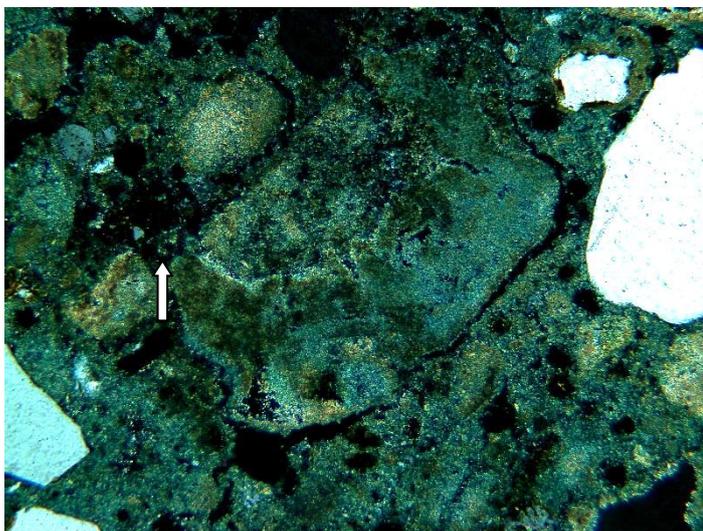
Plate No. 8:

A view in cross polarised light, xpl, showing a partially overburnt limestone particle in the centre of the plate, with the lime only partially diffusing into the paste, lower left and upper centre. The remainder of the inclusion is clearly defined by a sharp boundary. A small clinker grain can be seen in the left side of the particle (Belite), arrowed in plate. The aggregates in view are again dominated by quartz grains, white in this image, upper right. Porosity, voids, impregnating resin and opaque minerals all show dark in xpl. Field of view 1.2mm.

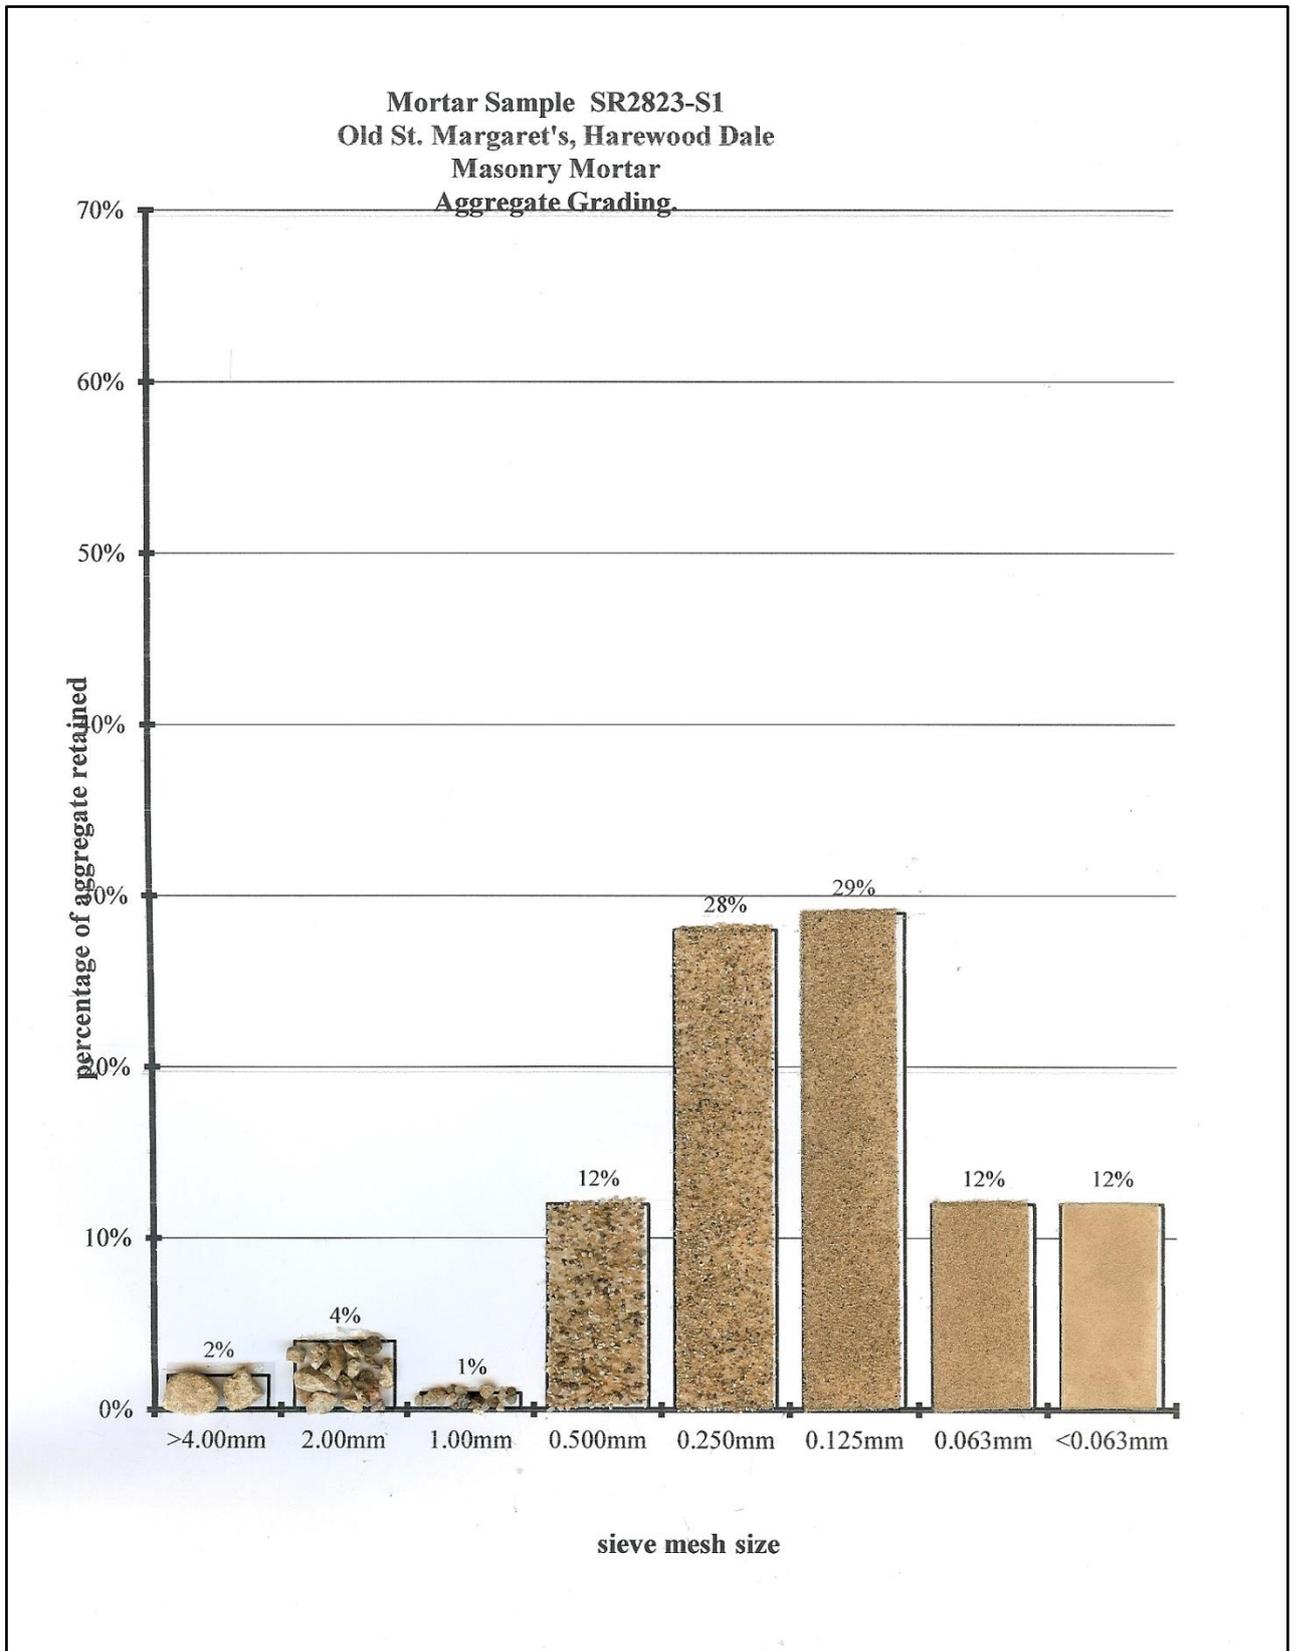
Figure No. 1: Sample SR2823-S1 – Grading of recovered aggregate following acid digestion.

The aggregate from the acid digestion was recovered, washed and dried then sieved through a nest of standard sieves. The particle size distribution was determined from the mass retained on each sieve, with the results of the aggregate grading presented in the form of an aggregate filled histogram, in the appended figure No. 1 and in tabular form below:

The aggregate particles are dominated by quartz grains, with Oolitic Limestone and sandstone/siltstone fragments, with altered lithic grains, quartzite, feldspar and clay minerals. The particles are sub-angular to sub-round in shape.
