Our Ref: M/2106/21/C1  
Your Ref.: Old Sun Inn

## CERTIFICATE OF ANALYSIS ON A MORTAR SAMPLE FOR BINDER TYPE DETERMINATION & MIX COMPOSITION

Project Reference	:	Old Sun Inn, Spout House Farm, Bilsdale North York Moors National Park.
Sample Source	:	16 <sup>th</sup> Century Thatched Cruck-framed House
Sample Description	:	Pointing mortar over Earth-lime mortar to Gable
Date Received	:	8 <sup>th</sup> April 2021
CMC Sample Ref	:	SR 2833 - S1
Method of Test	:	Mix composition fabric condition assessed from a Thin Section examination, with binder type by XRD analysis following in-house procedures.

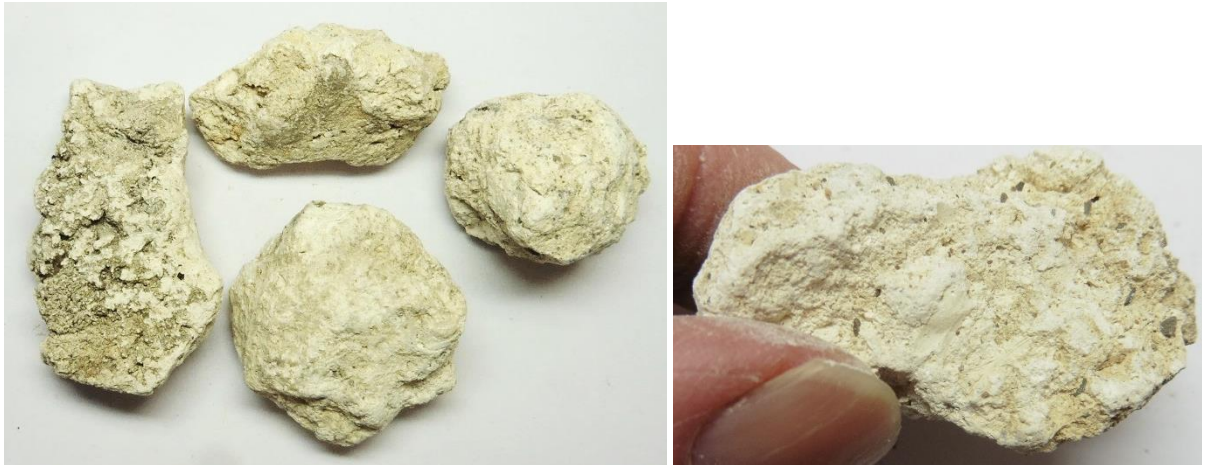
The sample received consisted of four intact pieces of mortar along with a small quantity of fines. The mortar pieces were soft to moderately hard and well compacted, only requiring firm finger pressure to break, though once disrupted the mortar could be powdered further under moderate to light finger pressure.

**Plates No. 1 & 2:** The left plate above shows the four intact pieces in the mortar sample as received. The right plate shows the intact piece selected for thin section preparation.

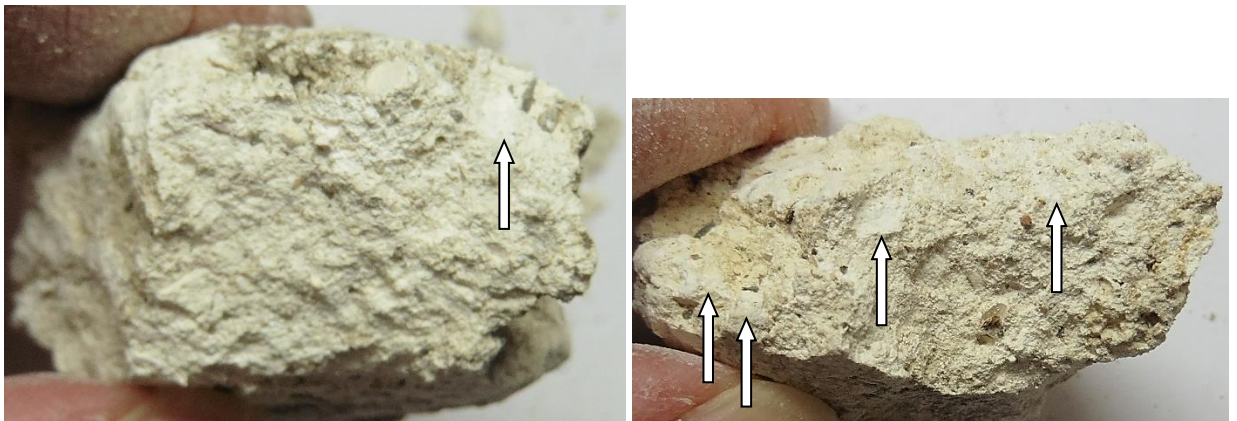
It was observed that all of the intact pieces contained an abundance of limestone fragments bound in a lime paste, in which several lime inclusions also appeared to be present. All four fragments were visually very similar. The inclusions were noted to range from sub-angular to sub-round and irregular in shape. The largest inclusion was measured at 4.2mm, but most were finer than 1.5mm in size.

**Plates No. 3 & 4:** The above plates show freshly fractured surfaces through two pieces of mortar. The left plate is a close-up of one fragment showing the abundance of fine limestone fragments bound in a lime paste with an angular lime inclusion, arrowed in plate. The right plate shows another view of a freshly broken surface through the thickness of another fragment. Again, note the presence of white soft lime inclusions, arrowed in the right plate.

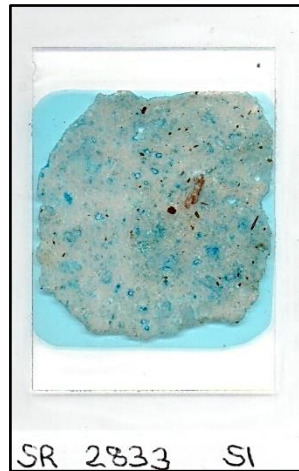
**Plate No. 5:**

Thin section prepared from a representative piece of the pointing mortar to allow for its examination in the petrographic microscope.

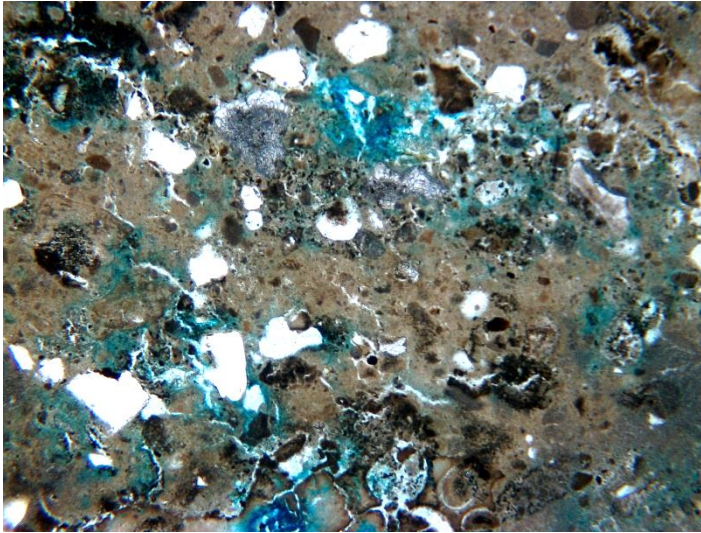
**Plate No. 6:**

A view in plane polarised light (ppl) of a quartz aggregate rich area of the mortar fabric. The paste containing an abundance of shrinkage cracks typical of an air lime mortar placed in a putty consistency. The paste is fully carbonated and encapsulates a mixed suite of aggregates, dominated by quartz particles, white in plate, along with siltstone, coal/ironstone and ash fragments

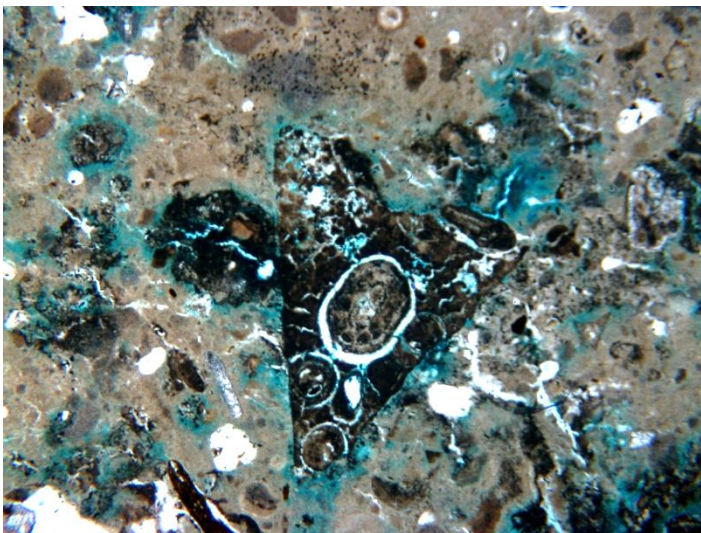
**Plate No. 7:**

Another view in plane polarised light (ppl) where an angular limestone fragment can be seen in the centre part of the plate. The limestone is from a bioclastic rock containing Ooliths, shell fragments and foraminifera, etc. The aggregates in view on are dominated by quartz grains, with opaque minerals and ash clinker.

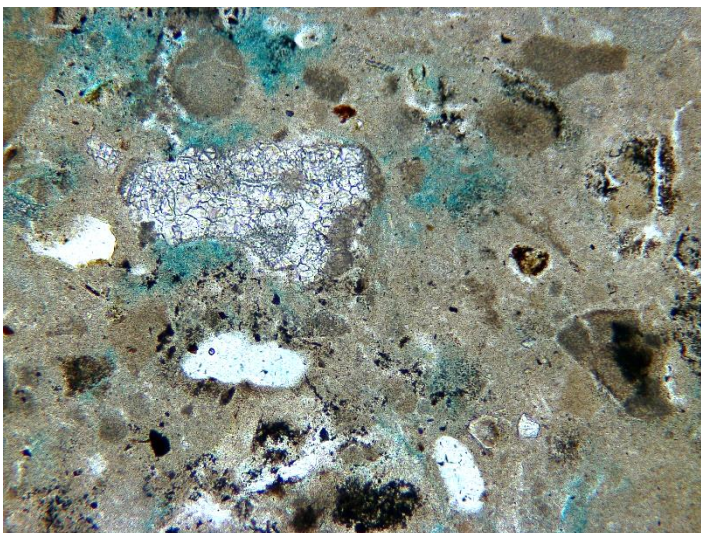
**Plate No. 8:**

Another view in plane polarised light, ppl, where a small dolomitic limestone fragment can be seen in the centre left of the plate. The surrounding paste is relatively compact and is fully carbonated with a moderately high microporosity. The aggregates in view are again dominated by quartz grains, mostly white in this image, with minor opaque minerals. Small limestone dust concentrations can be seen distributed throughout.

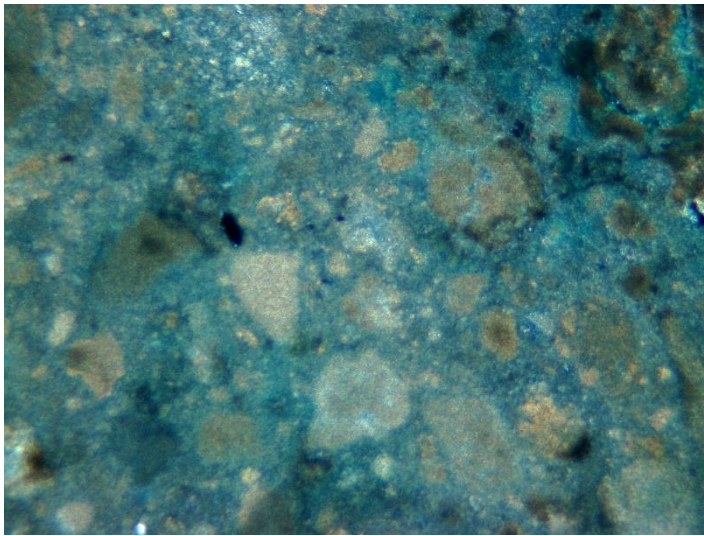
**Plate No. 9:**

A view in cross polarised light, xpl, showing an area of the fabric containing an abundance of fine limestone fragments distributed throughout the lime paste. The paste displays a high microporosity. Ash fragments can be seen in the upper right corner. No natural aggregates are present in this view

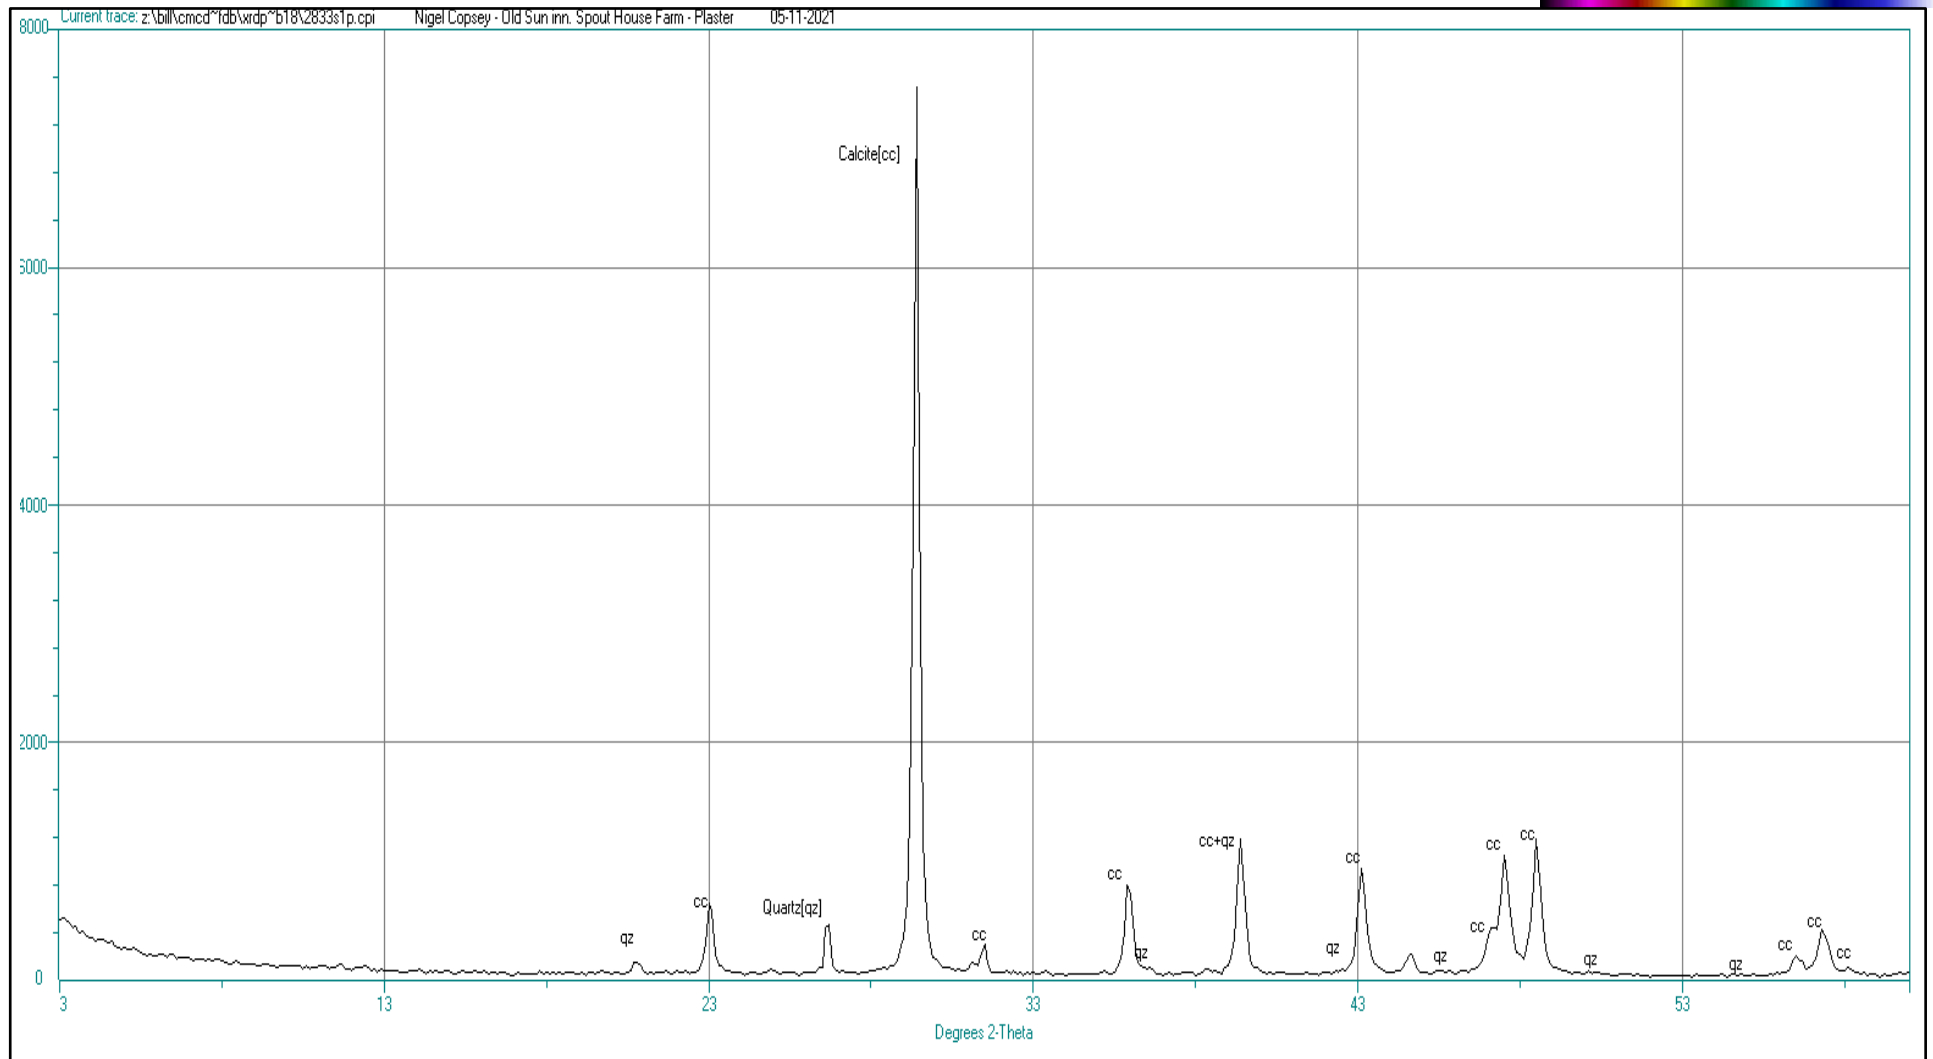
**Figure No. 1:** Sample SR2833-S1 – Binder rich sub-sample from Pointing mortar, ex the Old Sun Inn.

On the basis of the XRD analysis, it is indicated that mortar sample was made from an air lime binder, with no evidence of any hydraulic components present. Trace proportions of feldspars of the Plagioclase Group of minerals were detected, along with Dickite, a clay mineral of the Kaolinite group, but these were of insufficient quantity to infer that they were present as components of the mix and were most likely present as residue from surface, or substrate, contaminants.

The mortar is fully carbonated and there was no evidence of the mortar having been affected by reactions with any form of environmental sulphate, or other deleterious contaminants.
