## CERTIFICATE OF ANALYSIS OF MORTAR SAMPLES FOR DETERMINATION OF MIX COMPOSITION & BINDER TYPE

Project Reference	:	North Yorkshire Moors – This Exploited Land of Iron
Sample Location	:	Rosedale East Iron Kilns
Sample Description	:	REIK1 – Mortar from Fire Brick Lining REIK2 – Mortar from Pier 1 Stonework
Date Received	:	12 <sup>th</sup> March 2019
CMC Sample Ref	:	SR 2707-S1 = REIK1 – Mortar from Fire Brick Lining SR 2707-S2 = REIK2 – Mortar from Pier 1 Stonework
Date Analysed	:	10 <sup>th</sup> April to 30 <sup>th</sup> May 2019
Method of Test	:	Determination of binder type by X-Ray Diffraction analysis. Mix composition by acid digestion with grading analysis of recovered aggregate, and thin section examination.

**Rosedale East Iron Kilns**

Examination and Analysis of Mortar samples.

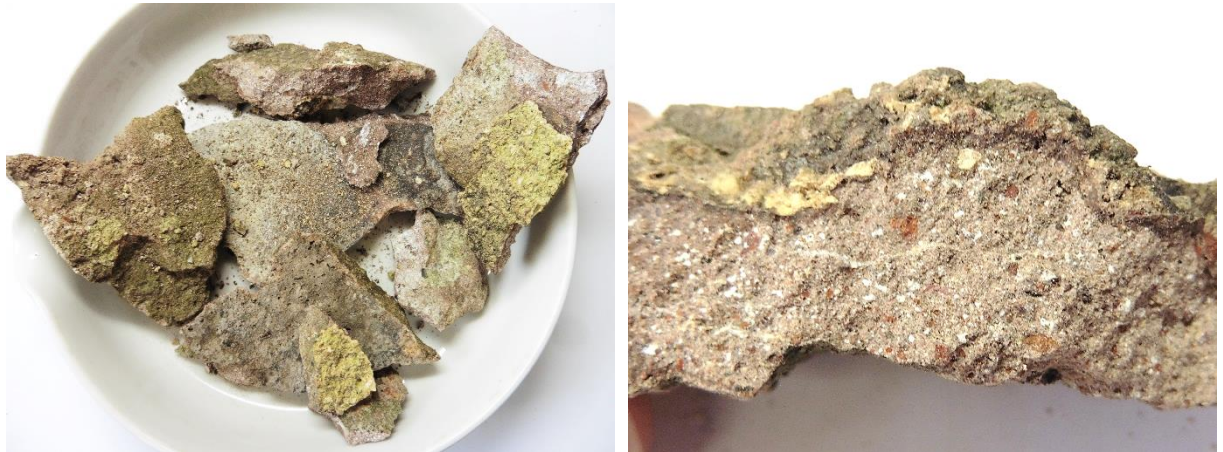
**Plates No. 1 & 2:** The left plate shows the intact pieces in the mortar sample, as-received. With the right plate showing a close-up image of a freshly fractured surface through the thickness of the sample. Note compact nature of the mortar and the brick fragments adhering to the upper surface of the mortar, to which it was very well bonded.

The aggregates appear to be dominated by dark minerals with coal and brick fragments also apparent. With the largest aggregate particle observed being in the region of 5.5mm in size, however most of the aggregate particles are less than 1.0mm.

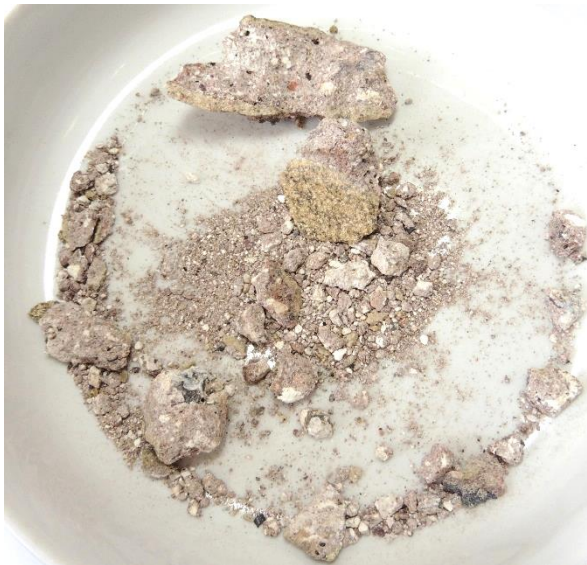
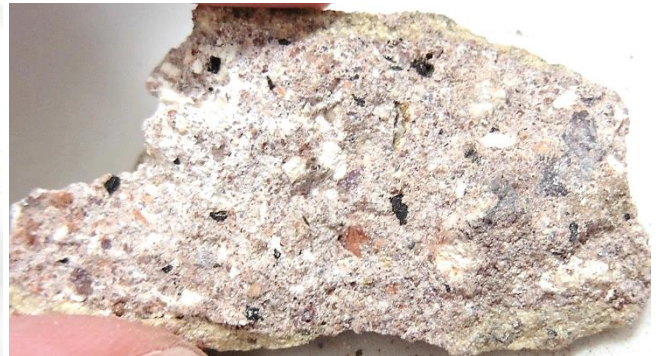
**Plates No. 3 & 4:** The left plate shows the sample as-received, which was mostly of small mortar fragments along with a quantity of fines. The right plate shows a freshly fractured surface through the thickness of the largest fragment, in which an abundance of lime inclusions, and possibly limestone fragments were apparent. Small dark coal and brick fragments were observed randomly distributed throughout.

A fragment of sandstone adhered to one of the outer surfaces, on some fragments, indicating that a good bond had formed between the mortar and the masonry of the Pier to which it was applied.

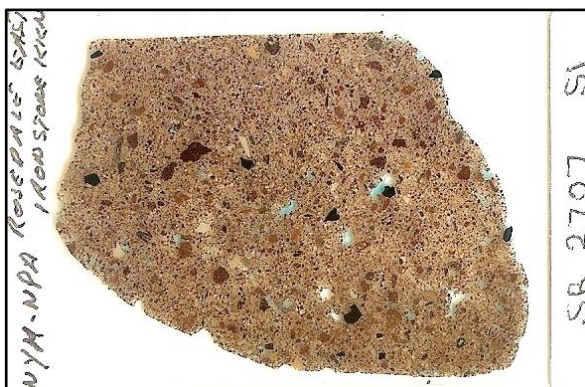
**Plate No. 5:**

Thin section prepared from mortar sample SR2707-S1 (REIK1).

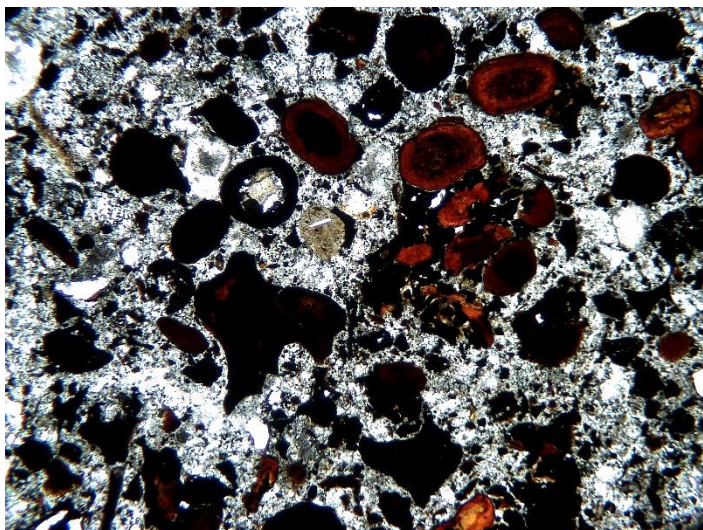
**Plate No. 6:**

A view in plane polarised light (ppl) of a typical area of the mortar, which shows the aggregates bound in a dense and fully carbonated paste. There are no lime inclusions observed in this area. The aggregates are dominated by opaque particles (black in image), with fine ash grains distributed throughout the paste. The coarser grains are dominated by coal fragments, coal clinker and ironstone (the latter brownish orange/black). Localised patches of microporosity are apparent, along with very fine angular quartz grains (white in image). Porosity is highlighted by the blue dyed resin. Field of view 2.4mm.

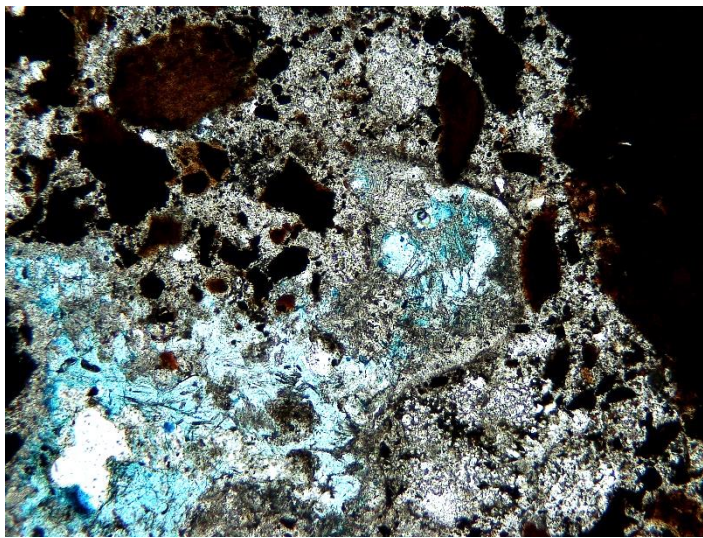
**Plate No. 7:**

A magnified view in ppl, of an area of paste where the paste is partially depleted and both the small voids and the affected paste contain an abundance of secondary sulphate minerals. Some of the fine opaque grains show reaction rims and a pseudo-morph Belite grain is apparent in the upper centre of the plate, both inferring that the mortar has hydraulic and pozzolanic hydrates present. The right side of the plate is filled with a large ironstone fragment, with small particles also seen in the left side. Porosity and voids are highlighted by the blue dyed resin. Field of view 1.2mm.

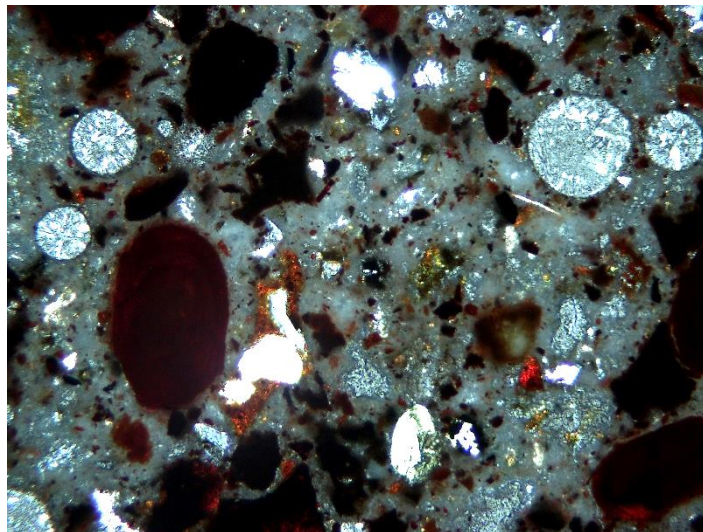
**Plate No. 8:**

A view in cross polarised light (xpl), of an area of dense fully carbonated paste in which a number of entrained air voids (spherical) can be seen. These are all filled with sulphate minerals. Small ironstone fragments can be seen along with fine Belite grains, mostly upper right and right of centre. The alteration of fine coal clinker fragments, and slag particles, is highlighted by the loss of detail in the altered particles, with discolouration/alteration of the surrounding paste. The impregnating resin, porosity and voids all show dark in xpl. Field of view 1.2mm.

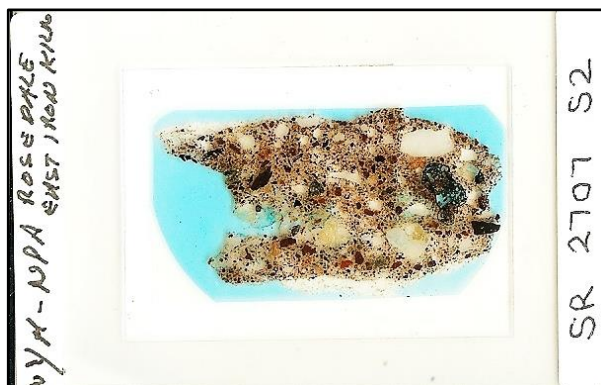
**Plate No. 9:**

This section was prepared from an intact piece of mortar from sample SR2707-S2 (REIK2).

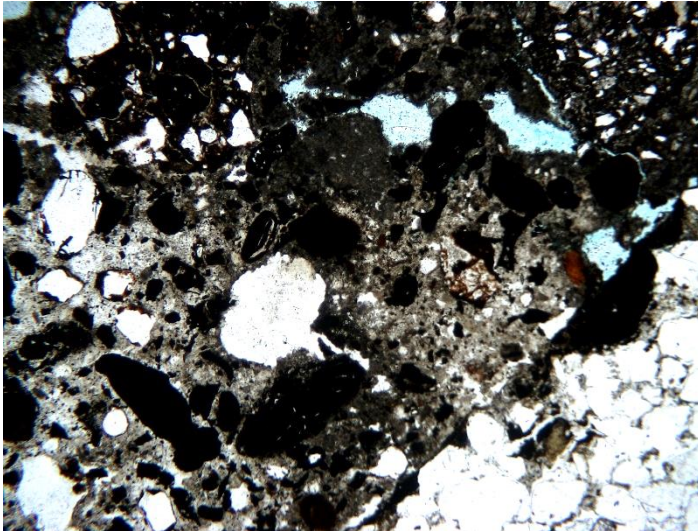
**Plate No. 10:**

A view in plane polarised light (ppl) of an area of the mortar adjacent to the sandstone masonry. A fragment of masonry is shown in the lower right corner. The mortar shows a relatively dense fabric but with a line of small elongated voids (upper part of plate) extending along a fine shrinkage crack extending out from the stone interface. A sulphate filled void can be seen in the lower centre (white). A number of the fine clinker particles display reaction rims and indicate a pozzolanic reaction has occurred. Aggregates are mostly coal and ironstone, with minor quartz. Porosity is highlighted by the blue dyed resin. Field of view 2.4mm.

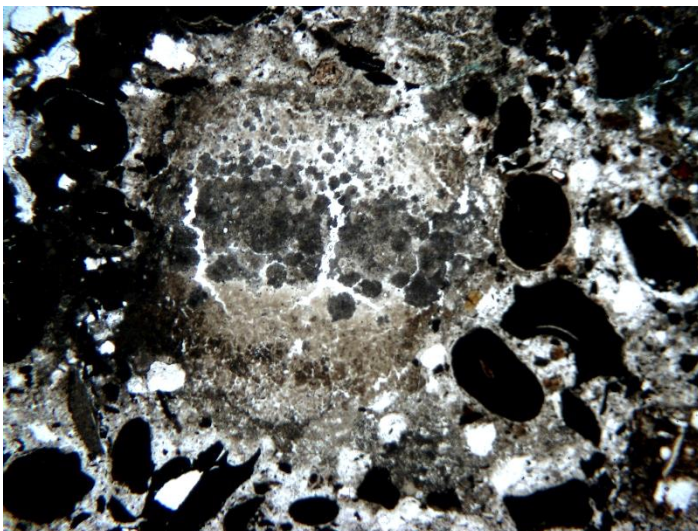
**Plate No. 11:**

A magnified view in ppl of a large lime inclusion, is shown in the centre of the plate. The inclusion is only partially burnt and partially slaked. The inclusion shows a clear compact margin and it is indicated that it had continued to slake after the mortar was placed. Partial diffusion into the surrounding paste can be seen at the upper part of the plate. Aggregates are dominated by coal fragments, with minor ironstone and clinker. Ash and rare Belite particles can be seen within the paste in the upper right and lower centre and right. Porosity and voids are highlighted by the blue dyed resin. Field of view 2.4mm.

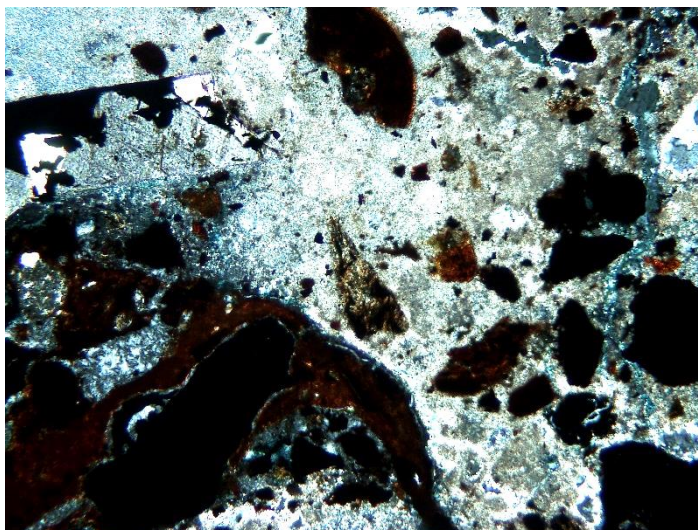
**Plate No. 12:**

A view in Cross Polarised Light (xpl), of an area of paste where depletion of the lime has resulted in an increased microporosity, however, the paste has been heavily altered and is now dominated by gypsum. With the gypsum infilling crack paths, filling voids and diffused through the paste. The aggregates in view are dominated by coal fragments, ironstone with ash and rare clinker particles. The upper left corner shows part of a lime inclusion where the lime has been fully converted. Porosity, the blue impregnating resin and opaque minerals all appear black in xpl. Field of view 1.2mm.

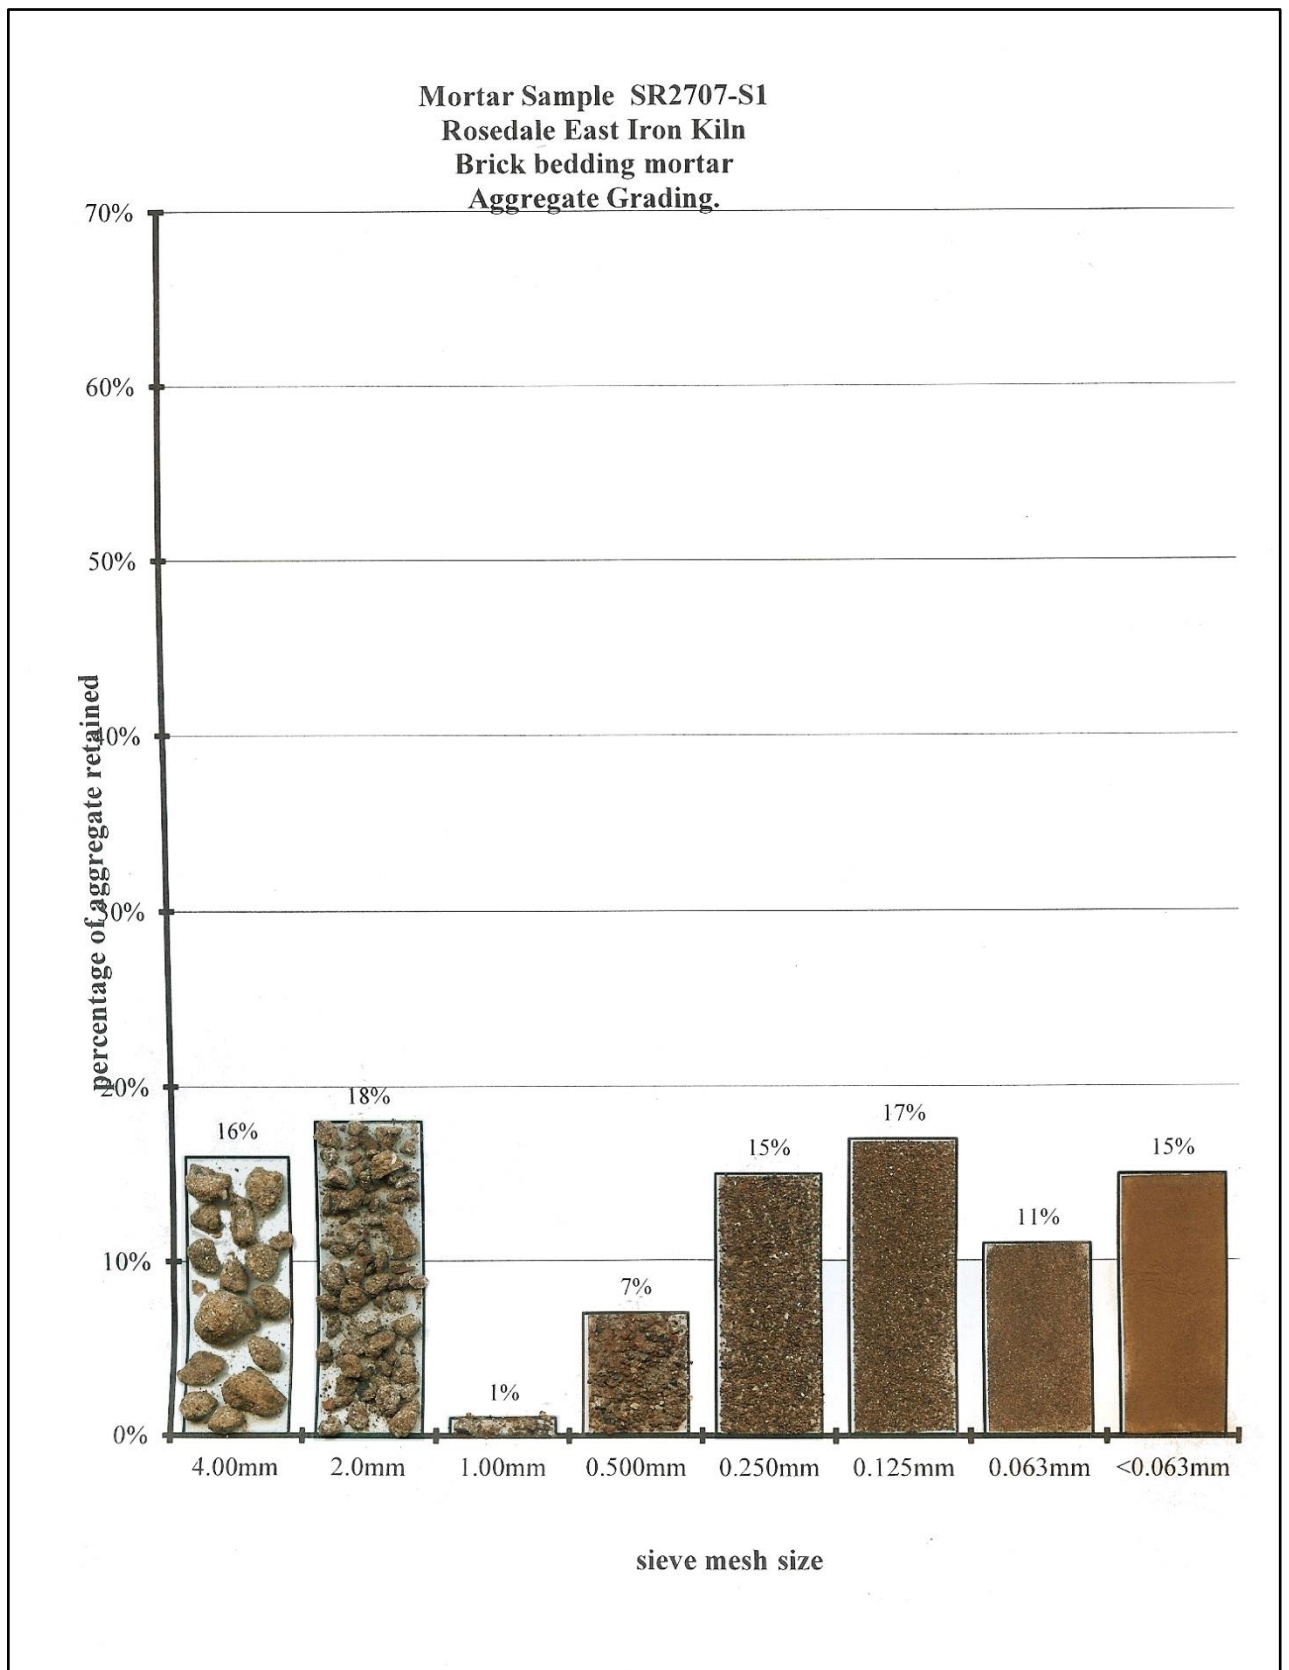
**Figure No. 1:** Aggregate Grading on Aggregate recovered from sample REIK1.

The residue from the acid digestions were recovered its particle size distribution determined, with the result of the grading analysis presented in table No. 1 above. With the grading also presented in the form of an aggregate filled histogram in the appended Figure No. 1.

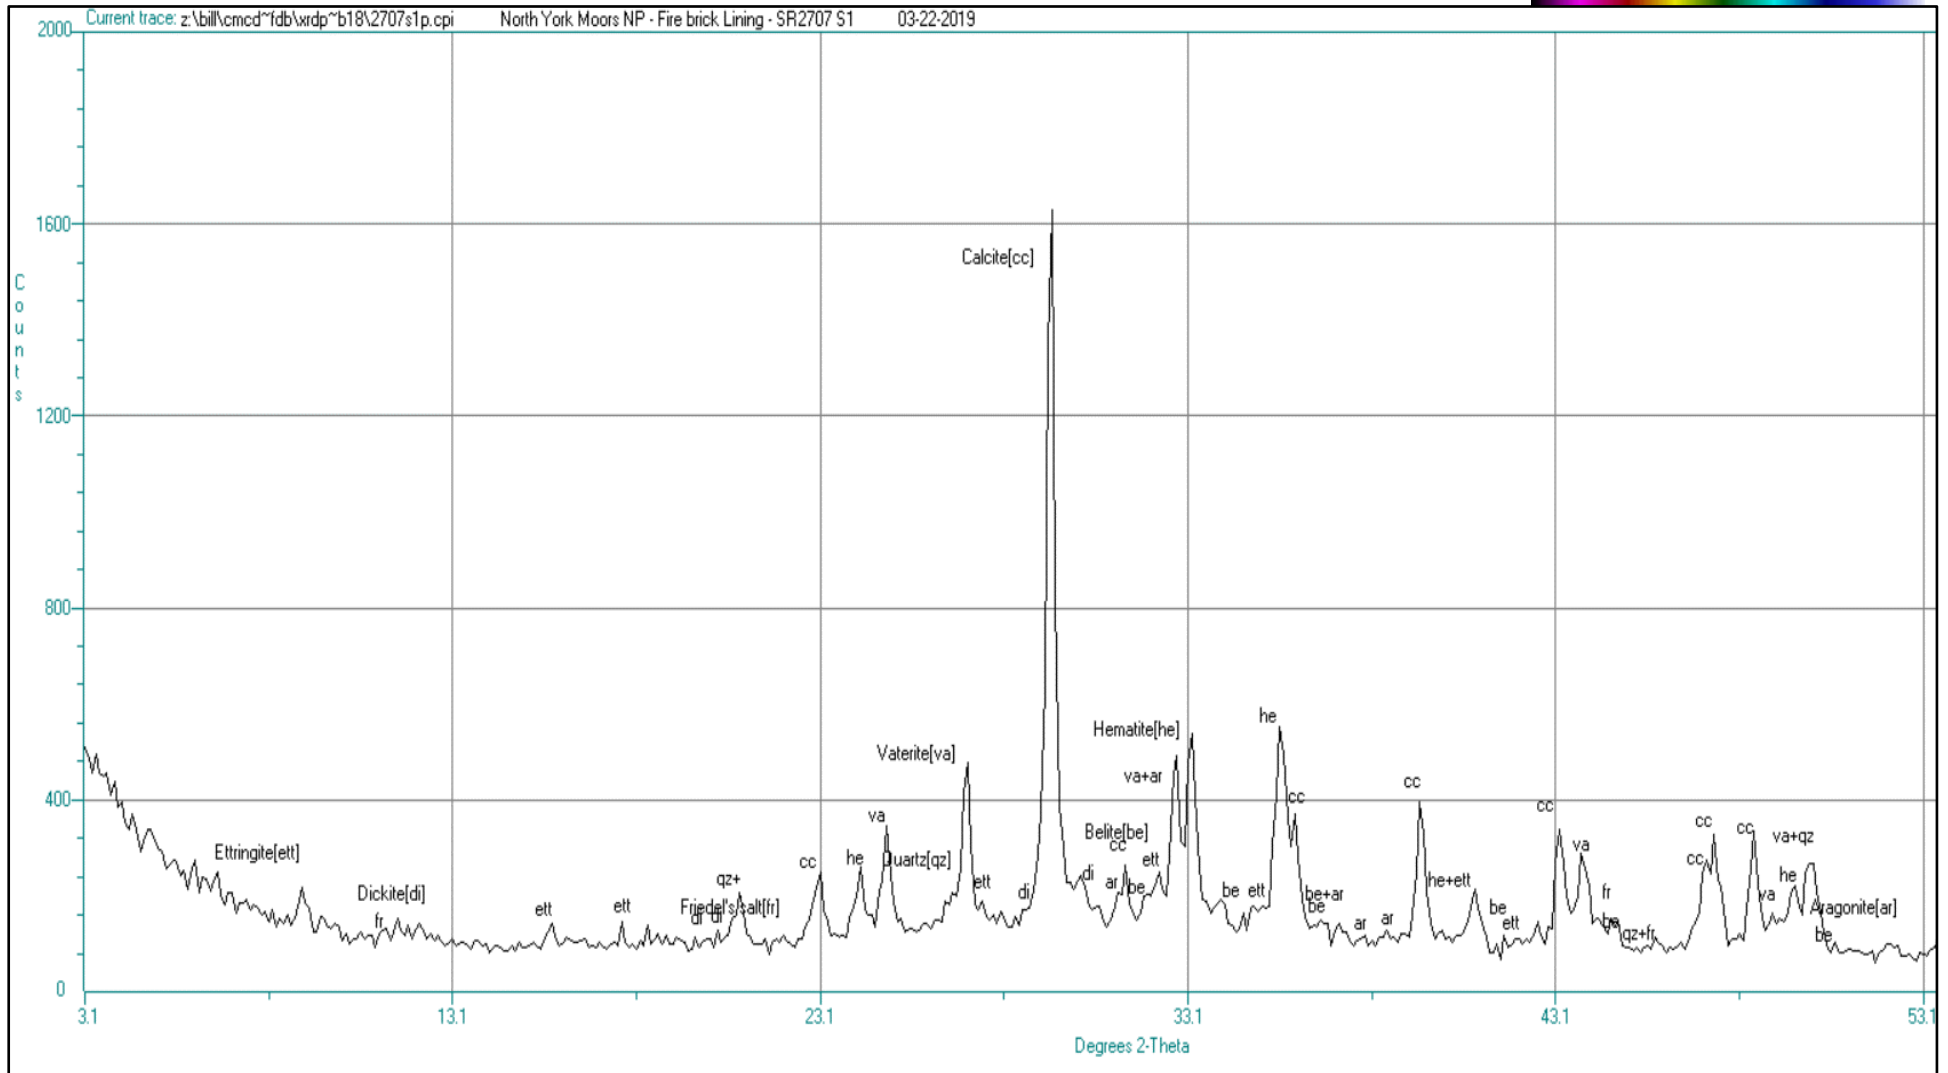
**Figure No. 2:** SR2707-S1 (REIK1) Mortar from Fire brick Lining – Iron Kiln,

From the XRD analysis, it is indicated that the mortar in the two samples differ with respect to their aggregate composition, albeit both are indicated to be lime mortars, made with an air lime. The strength in sample SR2707-S1 (REIK1) is considered to be due to the presence of an abundance of pozzolanic components in the aggregate, with their reaction indicated by the abundance of hydration products present.

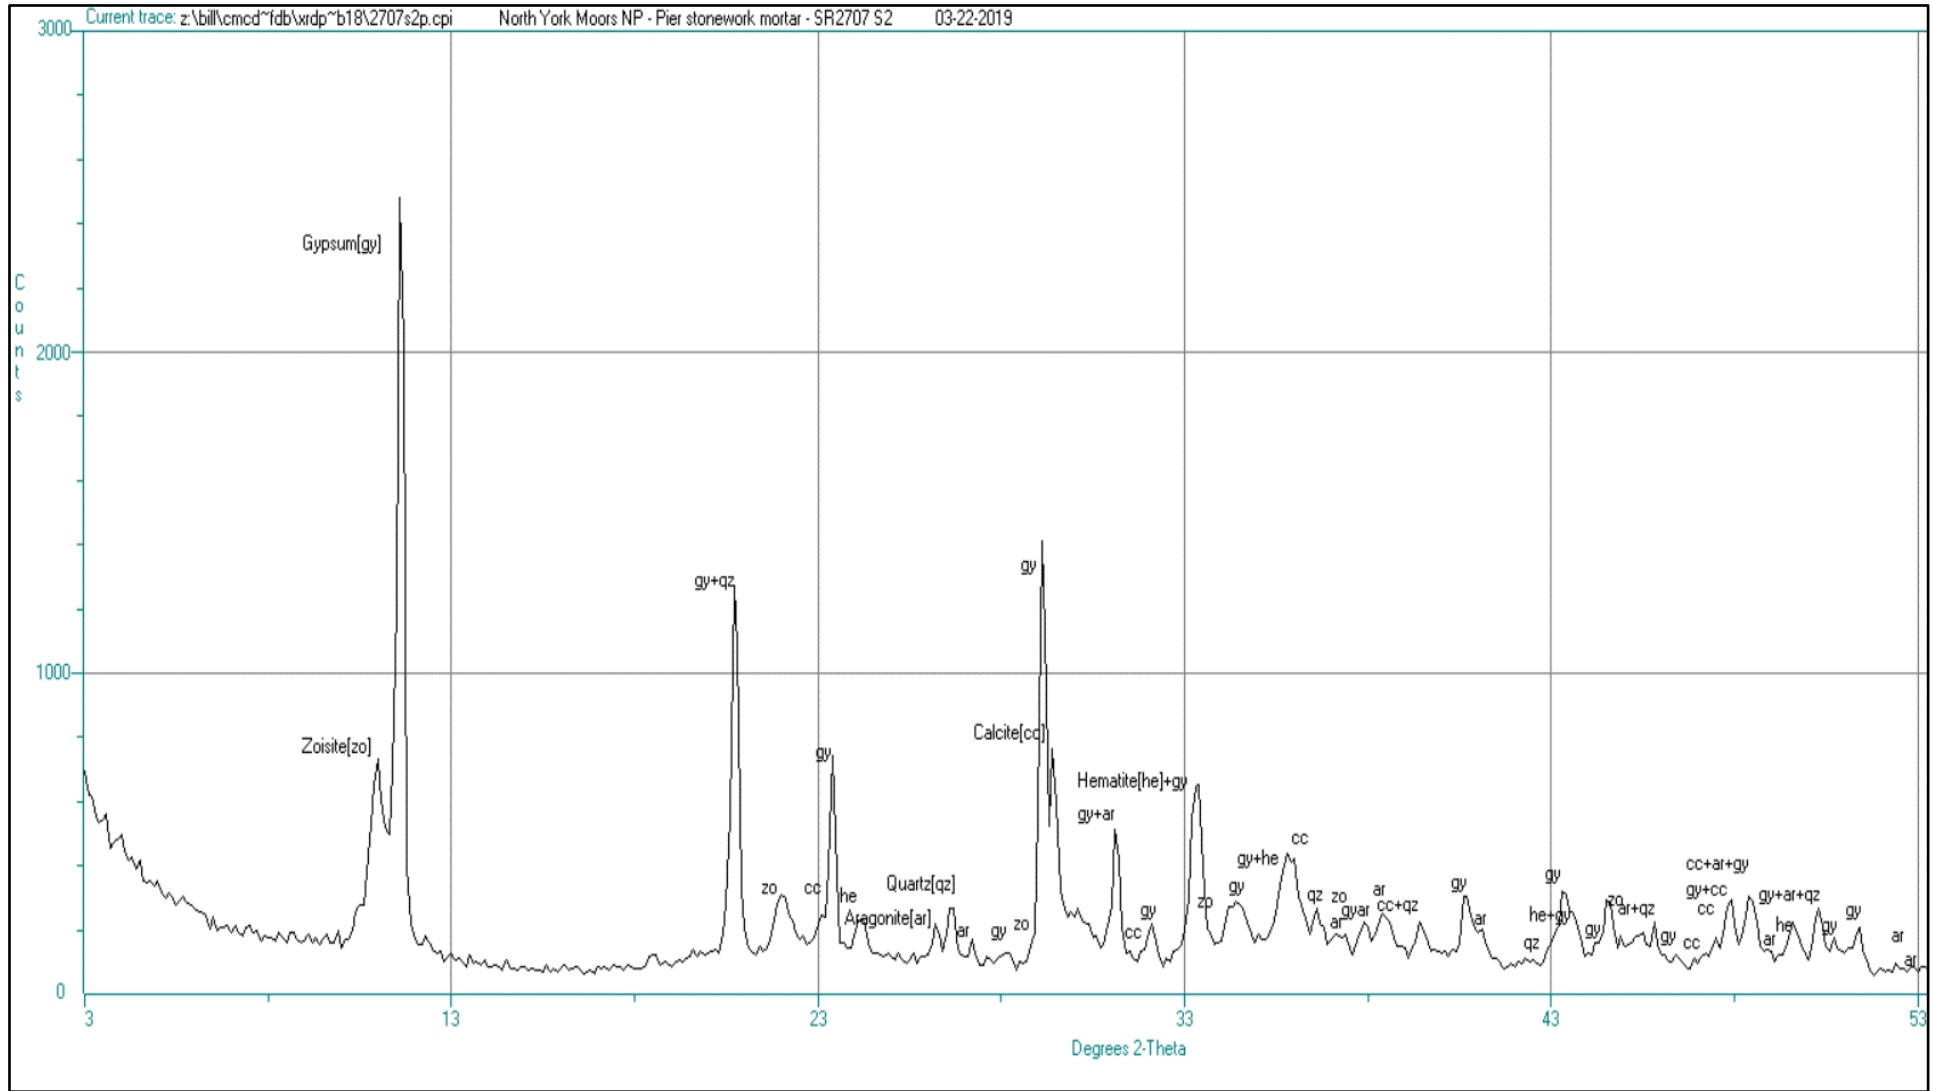
**Figure No. 3:** SR2707-S2 (REIK2) Mortar from Pier Stonework – Iron Kiln.

Sample SR2707-S2 (REIK2) although again made with a high Calcium lime, the binder in this sample appears to have undergone severe sulphate attack, with most of the lime now converted to gypsum, in the sample analysed. The source of the sulphate required for this reaction may have been from within the aggregate, but also in percolating waters or from flue gasses arising from the burning process.
