## CERTIFICATE OF ANALYSIS OF A PLASTER SAMPLE FOR DETERMINATION OF MIX COMPOSITION & BINDER TYPE

Project Reference	:	Iron Workers Cottages, Rosedale
Sample Location	:	Rosedale, North Yorkshire Moors
Sample Description	:	Two coat Plaster from Workers Cottages
Date Received	:	23 <sup>rd</sup> September 2019
CMC Sample Ref	:	SR 2762-S1 Two Coat Plaster
Date Analysed	:	1 <sup>st</sup> to 7 <sup>th</sup> September 2019
Method of Test	:	Determination of binder type by X-Ray Diffraction analysis. Mix composition by acid digestion with grading analysis of recovered aggregate, and thin section examination.

Iron Workers Cottages, Rosedale, North York Moors  
 Examination and Analysis of a two Coat  
 Plaster sample.

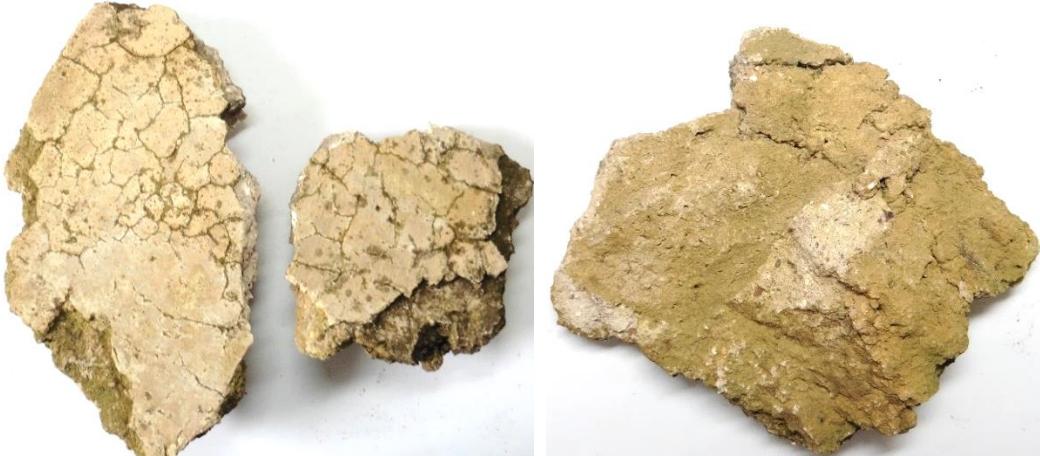
The surface of the outer finish coat displayed a mapwork pattern of fine cracks, with the cracks highlighted by soiling and algae growths which have become established within them. This would suggest that the sample had been obtained from an area of wall exposed to the environment.

**Plates No. 1 & 2:** The left plate shows the intact pieces in the plaster sample, as-received, with the outer finish coat in view. It was noted that cracks in the finish coat are highlighted by entrapped soiling and algal growths. The right plate shows an internal, masonry contact surface of the inner base coat plaster, with adhered soiling. The soiling is clayey to touch and may infer that the masonry was either bedded in a clay or clay lime mortar, or the interface was exposed to weathering with decay of the plaster at the masonry interface.

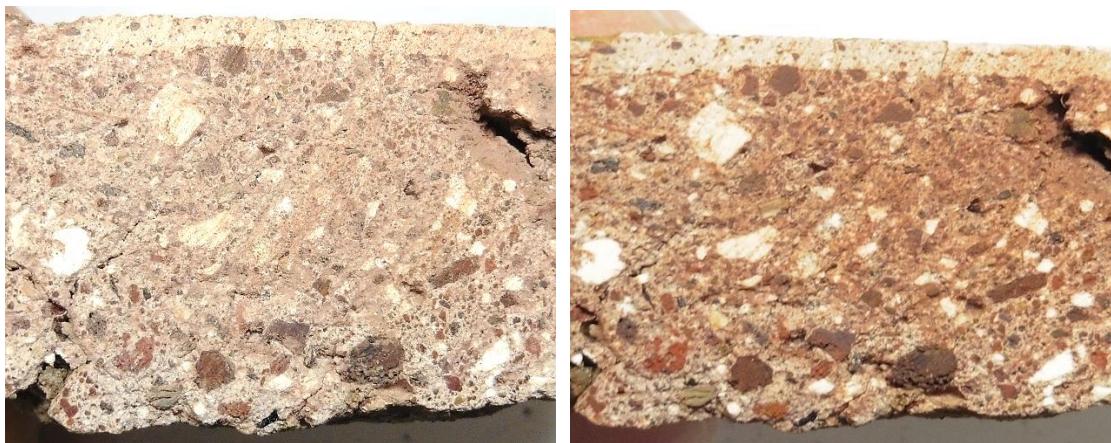
**Plates No. 3 & 4:** The left plate shows a freshly sawn surface through the two coat plaster, where the finish coat, top of plate, is relatively thin and very fine grained. The underlying base coat is coarser grained, with an abundance of lime inclusions apparent, along with ironstone aggregates. The right plate shows the sample after wetting to highlight the two coats, during which it was noted that the base coat appeared more red in the moist condition, as did the ironstone aggregates.

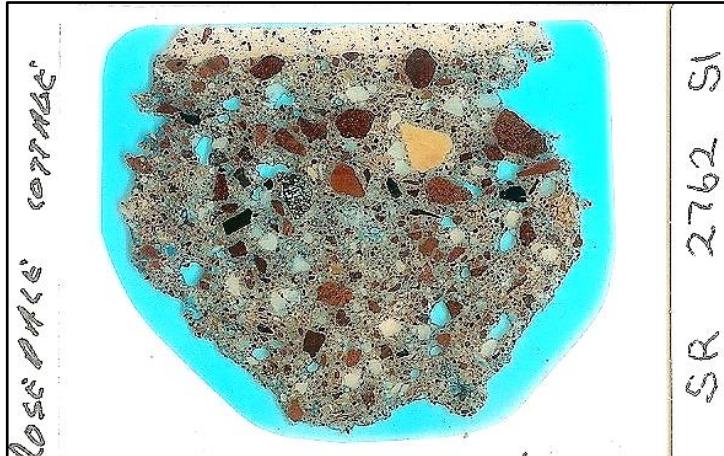
### Plate No. 5:

Thin section prepared from Plaster sample SR2762-S1.

The outer finish coat is seen at the top of the plate.

Note the high ironstone content in the base coat plaster.

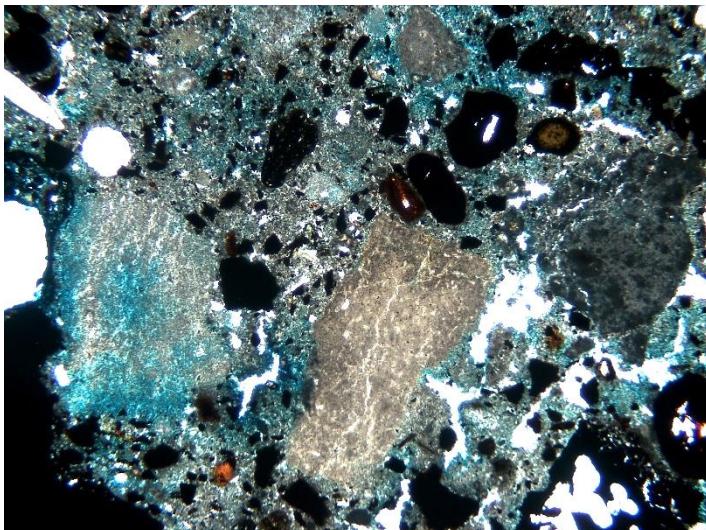
**Plate No. 6 - Base Coat Plaster:**

A view in plane polarised light (ppl) of a typical area of the mortar, which shows the aggregates encapsulated in the paste. There are three lime inclusions apparent in this view, with that on the lower left being well calcined but poorly hydrated, with the lower centre inclusion being incompletely calcined and retains part of the original limestone fabric, whereas that in the centre right is overburnt and had not slaked. The aggregates in view are dominated by ironstone fragments. The paste in the lower right is partially depleted, whereas that in upper left is compact. Porosity is highlighted by the blue dyed resin. Field of view 2.4mm.

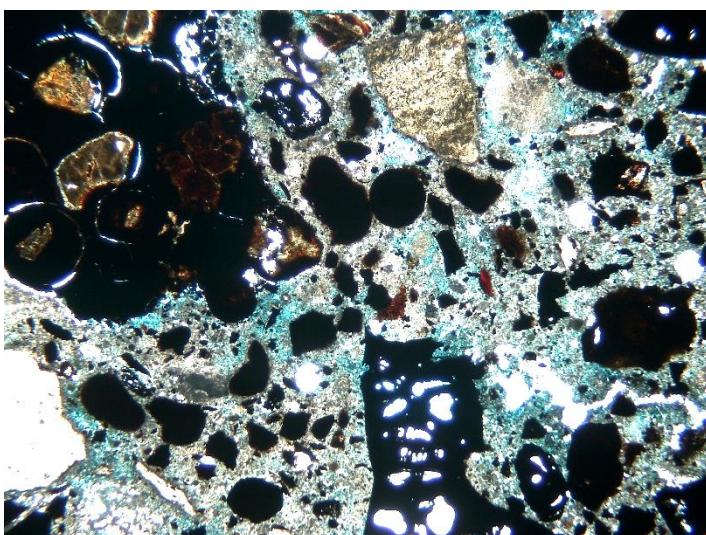
**Plate No. 7 – Base Coat Plaster:**

A magnified view in Cross polarised light, xpl, of an area of paste where the paste is locally depleted, upper right, with a patchy high microporosity also noted. The aggregates in view are dominated by ironstone fragments, see upper left, along with coal and partially burnt coal clinker, bottom centre. Narrow reaction rims can be seen around small fragments of clinker and some fine ironstone fragments. The cracks in view are free from secondary mineral deposition. The paste is fully carbonated and free of any evidence of deleterious reactions. The blue dyed resin, porosity and voids all appear dark in xpl. Field of view 2.4mm.

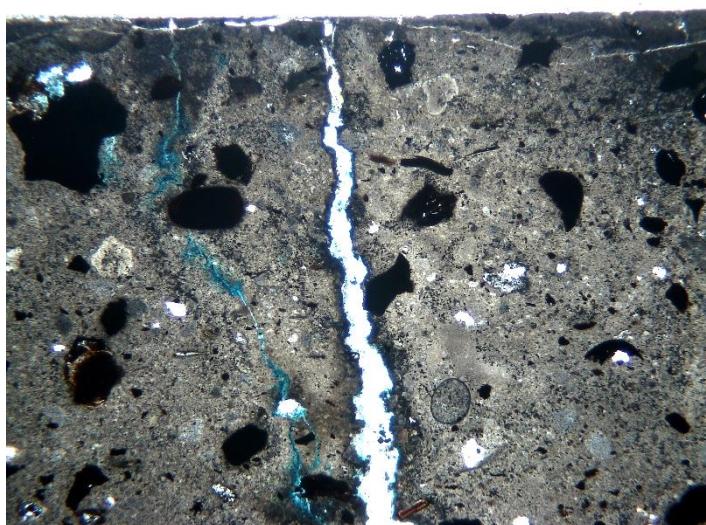
**Plate No. 8 – Finish Coat Plaster:**

The binder although dense is fully carbonated and is locally transected by shrinkage cracks extending from the outer surface to the interface with the base coat, however the cracks do not penetrate the base coat plaster and the bond between the finish and base coats is well formed and intact.

A view in plane polarised light (ppl), of the near surface of the finish coat plaster, with the outer surface at the top of the plate. A shrinkage crack widens towards the inner contact surface, and is a common feature, indication water loss into the base coat when placed. Aggregates are dominated by ironstone, with minor coal fragments and fine quartz grains. Small patches of lime putty can be discerned within the paste. The crack margins are coated in redeposited calcite. The paste is dense and fully carbonated. Porosity is highlighted by the blue dyed resin. Field of view 2.4mm.

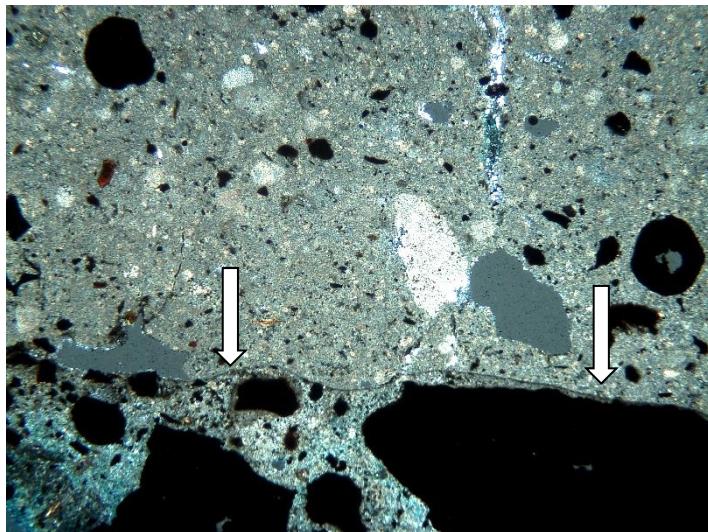
**Plate No. 9:**

A view in cross polarised light (xpl), of an area of the finish coat at its interface with the base coat plaster. Base coat is at the bottom of the plate, with the interface arrowed in plate. The paste of the finish coat is dense and fully carbonated and displays a low aggregate content, with the aggregate in view dominated by ironstone fragments and coal, along with fine quartz grains and ash. Two elongated air voids (grey) can be seen towards the base coat interface, formed from entrapped air during placing. The impregnating resin, porosity and voids all show dark in xpl. Field of view 2.4mm.
