CERTIFICATE OF ANALYSIS OF A COATING SAMPLE FOR DETERMINATION OF BINDER TYPE

Project Reference	:	Sandsend Kiln and Milhouse, Whitby, North East Yorkshire
Sample Location	:	Cement Grinding Mill Building
Sample Description	:	Slurry Wash/Lime Wash on exterior of Mill Building
Date Received	:	13 th December 2019
CMC Sample Ref	:	SR 2777-S1
Date Analysed	:	13 th & 27 th December 2019 & 13 th & 14 th January 2020
Method of Test	:	Determination of Composition by X-Ray Diffraction analysis. With comment on fabric from a thin section examination.

Atkinson's (Yorkshire) Cement Mill & Kiln, Near Whitby
Examination and Analysis of a Multi-Coat
Slurry Coat/Lime Wash from exterior of Mill Building.

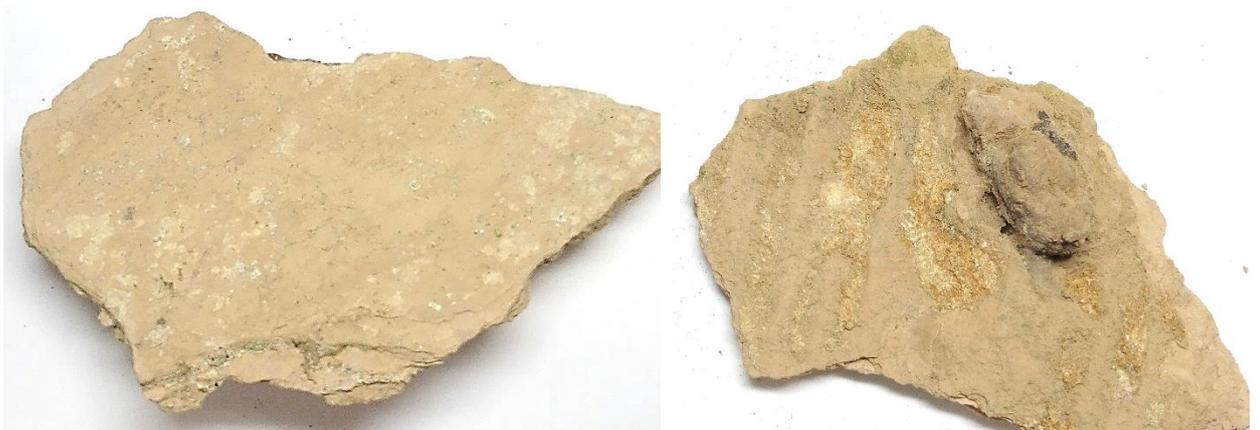
Plates No. 1 & 2: The left plate shows the outer surface of the intact piece of the Coating sample, with the right plate showing the inner masonry wall contact surface, which retained fines from the underlying sandstone masonry along with a fragment of sandstone.

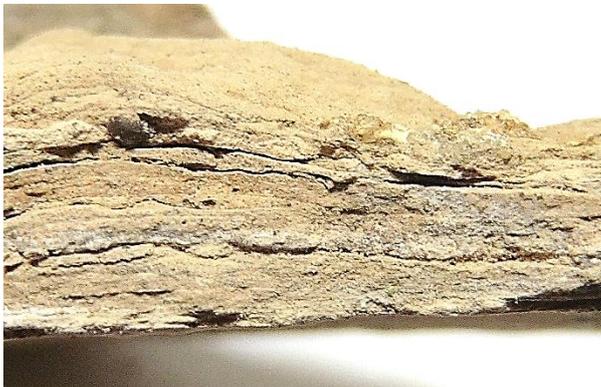
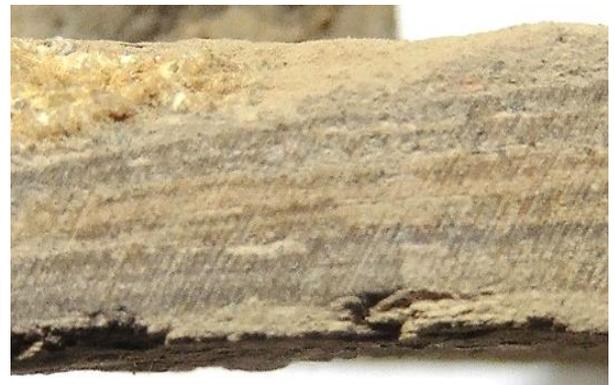
Plates No. 3 & 4: The left plate shows weathered fracture surface through the thickness of the coatings as received, which shows the presence of several delaminations within the coating thickness. The outer surface is shown at the bottom of the plate, with fragments from the sandstone substrate adhering to the inner coat, upper part of plate. The right plate shows a magnified view of a freshly sawn surface through the coating, where, again, the outer coat is shown at the bottom of the plate.

The outer coats appear to be comprised of three thin lighter coloured coats that appear to differ from the inner coats and appear more akin to a paint or modern cement slurry coat, whereas, that within the thickness of the coating have a coarser texture, are harder to the touch, and are more dense, and appear more uniform in both texture but not colour. The colour of the coats alternating from light grey through pinkish grey to reddish brown and dark brown. This inferring a variation in the coating composition.

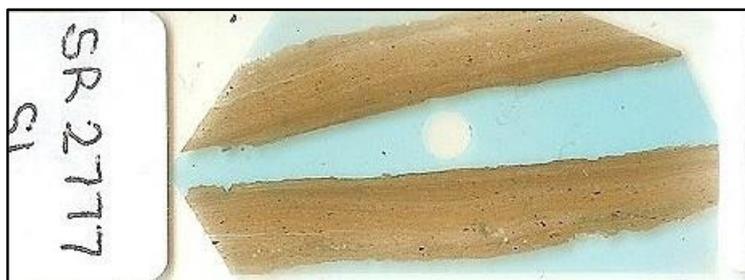
Plate No. 5:

Thin section prepared from Coating sample SR2777-S1.

Two slices taken through the thickness of the coating were mounted on a single slide, with the slices orientated so that their outer surfaces were opposite each other, in the centre of the slide.

The coating was noted from the thin section to consist of 19 to 20 coats, with part of the outer coats lost by erosion. In addition, grains from the underlying masonry adhere to the surface of the inner coating, aligned towards the outer edges of the slide.

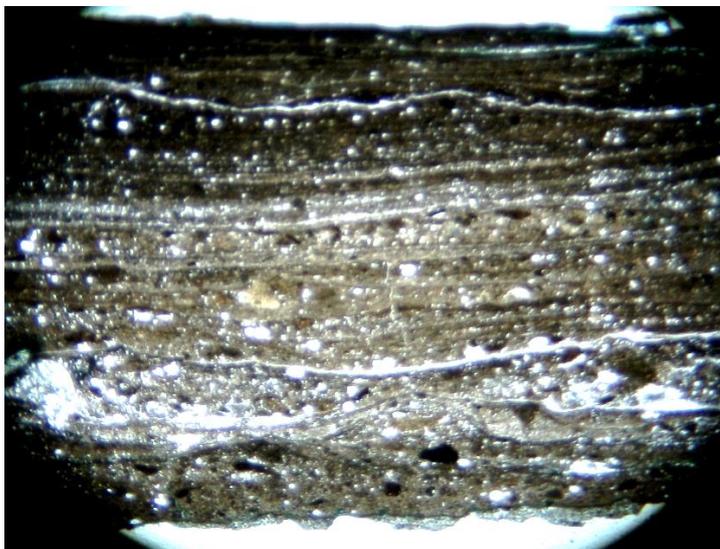
Plate No. 6:

The opposite plate shows a view of the full thickness of the coating, with the inner surface, retaining fines plucked from the surface of the sandstone substrate, shown at the bottom of the plate. Although there appears to be a greater number of layers (32) within the image, than the actual number of coats, this is due to a number of the coats having been applied in several applications, with each application applied prior to the previous application fully drying. The presence of soiling between coats is taken as the delineation between complete individual coatings.

Porosity is highlighted by the blue dyed resin. Field of view 12.0mm.

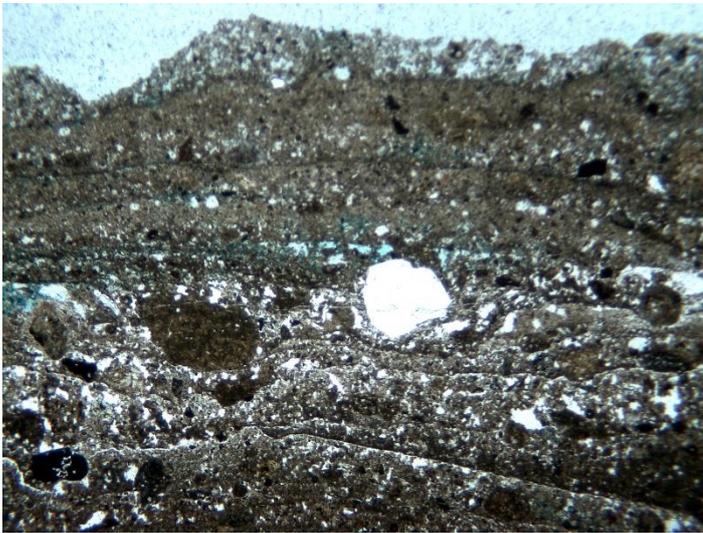
Plate No. 7:

A magnified view in plane polarised light, ppl, of the inner part of the coating, with the stone contact surface shown at the top of the plate. Note the coarse quartz grain (white) embedded in the soiling at the interface between the 2nd and 3rd coats, with coarse incompletely ground fragments of natural cement concentrated in the 3rd, 4th and 5th coats (bottom of plate). Note the presence of soiling in the interfaces between the 2nd and 3rd, 3rd and 4th and 4th and 5th coats. A partial delamination has formed within the interface between the 4th and 5th coats. Porosity is highlighted by the blue dyed resin. Field of view 2.4mm.

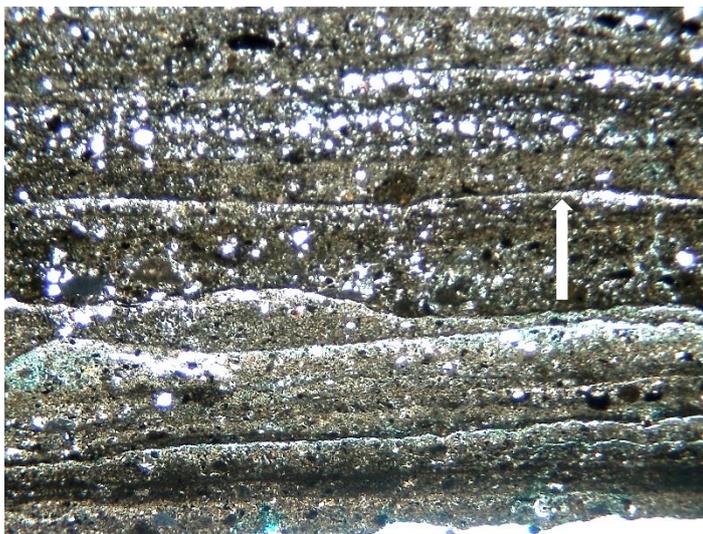
Plate No. 8:

A view in plane polarised light (ppl), of the coats towards the outer surface, which is shown at the bottom of the plate. Note the increased density and the reduced occurrence of fine quartz grains (white in image) in the coats closer to the outside surface, perhaps suggesting that the product produced at the kiln was being better burned and more refined over time. A fine delamination is forming along a soiled interface between the 6th and 7th coats from the outer surface 13th & 14th from the inner surface), arrowed in plate. The paste is dense and fully carbonated. Porosity is highlighted by the blue dyed resin. Field of view 2.4mm.

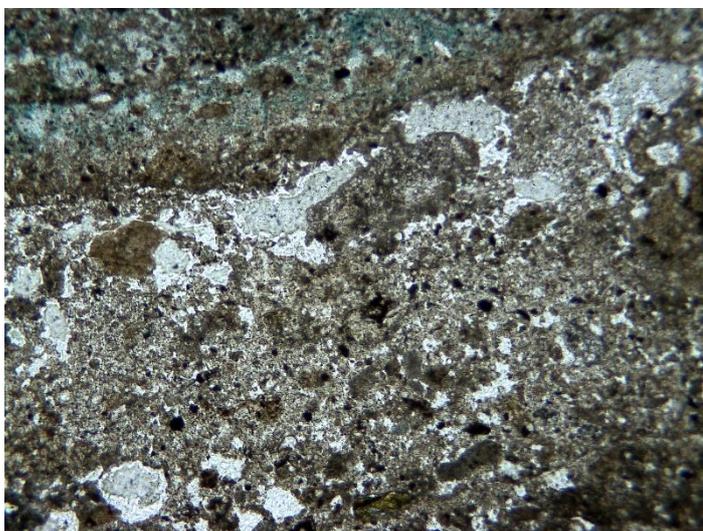
Plate No. 9:

Another view in plane polarised light (ppl), of an area adjacent to a delamination through which water has percolated, with partial leaching of the paste along with the redeposition of calcite as void linings, seen as white crystal deposits in the hand specimen. The paste within the adjacent coats are well compacted and contain fine quartz grains, with amorphous (black) particles and clinker grains, containing both Belite and Gehlenite present. The paste near the lower interface, at the base of the plate also contains fine entrained air bubbles, from the application procedure (brushing). Porosity is highlighted by the blue dyed resin. Field of view 1.2mm.

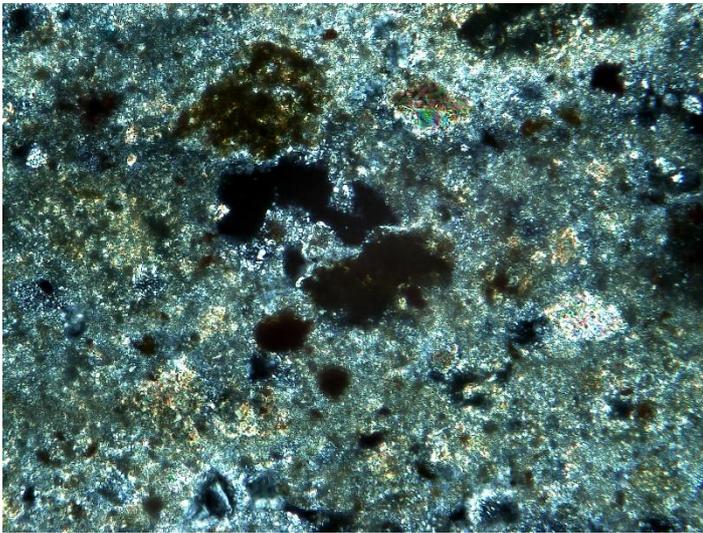
Plate No. 10:

A view in cross polarised light (xpl), of a dense area of the paste within the centre of the Slurry coat, at an interface between two well bonded coats. The interface is highlighted by the paste in the earlier coat, top of plate, displaying a well carbonated paste with intergranular redeposited binder in the form of calcite and Vaterite present. Note several coarse clinker grains apparent within this coat (brown in colour). There is an abundance of clinker grains, amorphous fragments and partially hydrated clinker throughout the thickness of the coating filling the remainder of the field of view. Porosity, amorphous particles and impregnating resin all appear dark in xpl. Field of view 0.6mm.

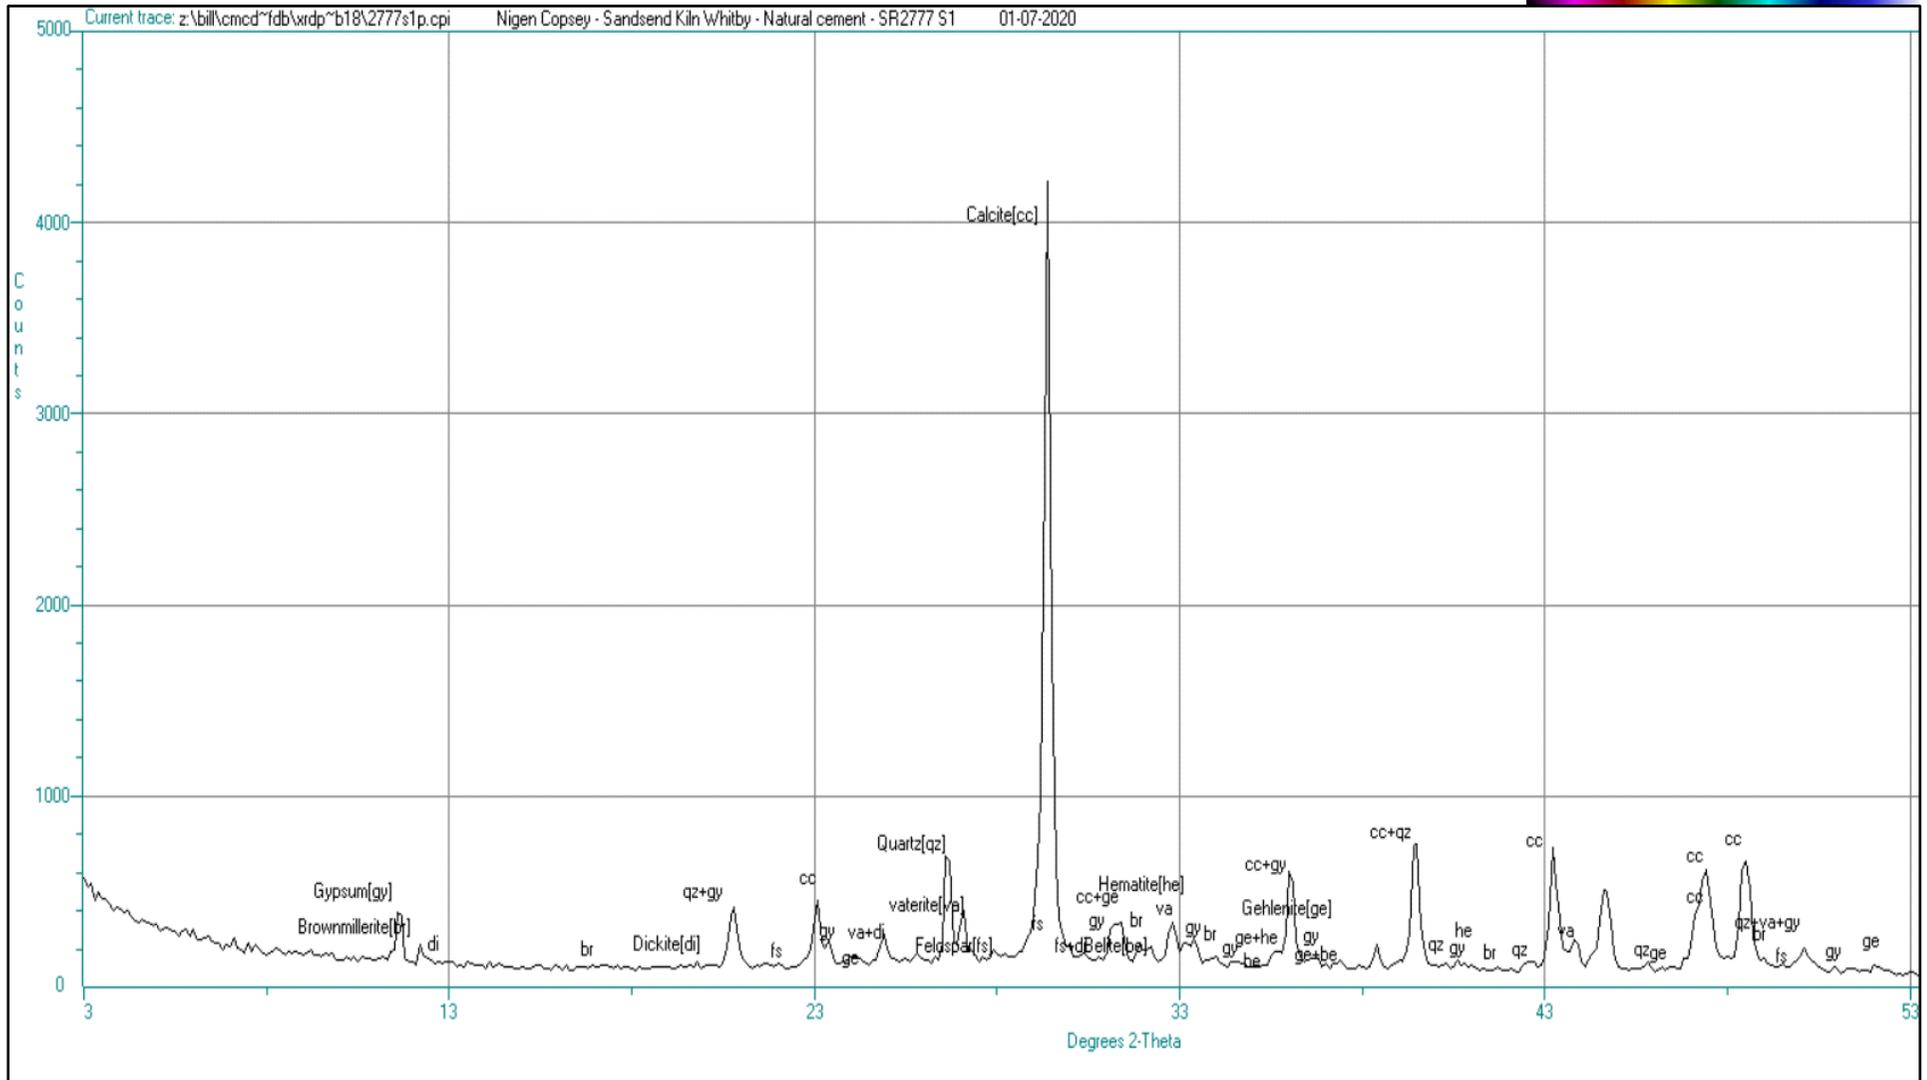
Figure No. 1: SR2777-S1 – Composite of the coatings from Wall Coating on the Mill Building.

Sample:	SR2777-S1
Coat	Combined Coats
Component	Proportion (% by Mass)
Calcite	67.2
Vaterite	7.5
Belite (B ₂ S)	0.6
Brownmillerite	1.1
Gehlenite	1.9
Hematite	0.9
Gypsum	9.4
Quartz	7.8
Feldspar (Anorthite)	2.8
Dickite	<u>0.8</u>
Total	100.0

From the XRD analysis, it is indicated that the binder in the coating is a Natural cement, with it likely that, given the variation in the colour and hardness of the individual coats, that the difference was due to the degree of hydration of the binder in each coat being variable, along with varying degrees of calcining at the time of production. The quartz, feldspar and Dickite all appear to be associated with soiling trapped on the individual coat surfaces.
