Report on the Examination and Analysis of Mortar Samples from Stone and Brick Masonry

The Guild Hall, York

19th March 2018

Our Ref: M/1844/18 Your Ref: Guild Hall, York Doc. Ref: M184418R1

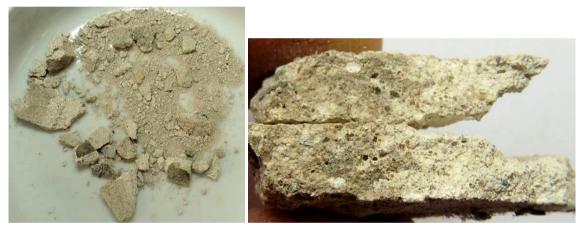
This sample is of a hard well compacted and well bonded mortar. Although it was possible to break pieces under persistent finger pressure the mortar broke with an audible "snap", confirming that it was a hard but brittle mortar. The mortar contained a few small lime inclusions, which were rounded and had the appearance of balled hydrate.

Plates No. 1 & 2: The above left plate shows the sample as received, with a few intact pieces along with a quantity of fines. The right plate shows a freshly fractured surface through the thickness of the mortar. The piece in the image had been treated with a phenolphthalein indicator solution to check for carbonation. The mortar was found to be fully carbonated.

Water droplet tests indicated that the mortar had a moderately well-connected pore structure with droplets supported for a short period prior to being absorbed and diffused throughout the matrix.

The colour¹ of the mortar, was found to be 7.5 YR 8/1 "White".

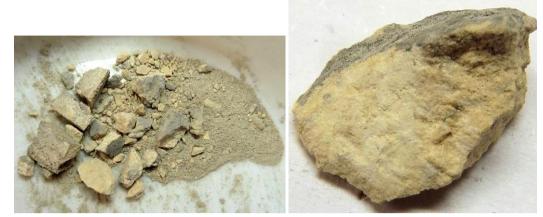
Plate No. 3 & 4: The left plate shows the sample as received, with the right plate showing a freshly fractured surface through the thickness of an intact piece.

The mortar was found on testing to be fully carbonated and did not absorb water droplets placed onto its outer or a freshly fractured surface.

The mortar colour was found to be 2.5Y 8/3 "Pale Yellow".

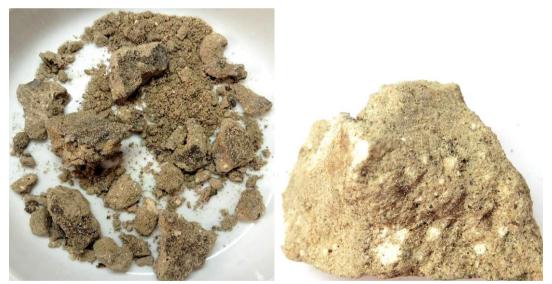
Plates No. 5 & 6: The plates above show the condition of the mortar in sample "D". The left plate is the sample, as received, with the right plate showing a fractured surface through one of the larger pieces. Note the abundance of sub-angular to rounded lime inclusions.

The mortar was found on breaking to be hard and was difficult to break under persistent finger pressure, requiring a hammer tap to disrupt. The mortar was compact and on testing was found to be fully carbonated. On placing water droplets on the surface, they were supported for a short period prior to the droplets being slowly absorbed.

The mortar was found to be 10YR 6/2 "Light Brownish Grey" in colour, on a fractured surface.

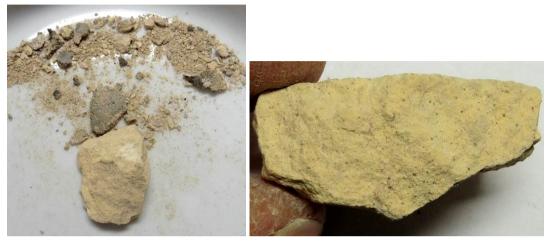
Plates No. 7 & 8: The left plate shows a view of the sample as received. The right plate shows a close-up of a freshly fractured surface through the stone fragment.

Spot tests indicated that the stone was a limestone, and possibly Dolomitic, with a very fine texture and a well-connected pore structure.

The colour of the stone was found to be 10YR 8/2 "Very Pale Orange".

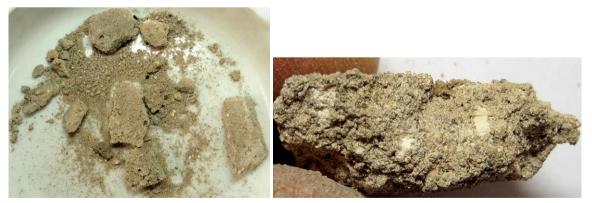
This mortar was variable in hardness, with some pieces soft and others moderately hard. They were all well compacted and all contained large sub-angular to sub-round lime inclusions, which were up to 4.5mm in size.

Plates No. 9 & 10: The left plate shows the sample as received with the right showing a fractured surface trough an intact piece of the mortar, where lime inclusions can be seen.

The mortar is fully carbonated and was indicated to have a well-connected porosity from the water test, with water droplets being rapidly absorbed and diffused throughout.

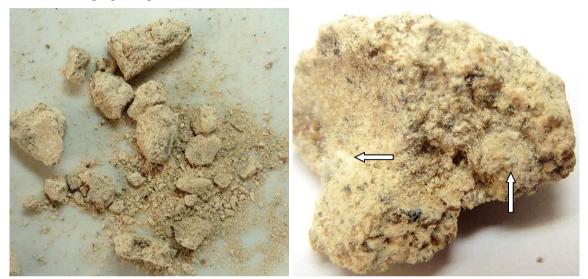
The mortar in sample "G" was an Ashlar mortar, but unlike the other ashlar samples it contained a proportion of natural sand, which was slightly coarser than the normal 'silver sand' (Fine processed Quartz sand) normally associated with this form of putty mortar. There were also lime putty inclusion apparent, which would indicate that the mortar had not been well prepared prior to use.

Plates No. 11 & 12: The left plate shows the sample as received, with the right plate showing a magnified view of one intact piece, where the dense fabric can be seen along with line inclusions, these are arrowed in plate.

The mortar was fully carbonated and displayed a degree of water repellence. On heating a faint odour of linseed oil was apparent.

The colour of the mortar was found to be 10YR 8/2 "Very Pale Brown".

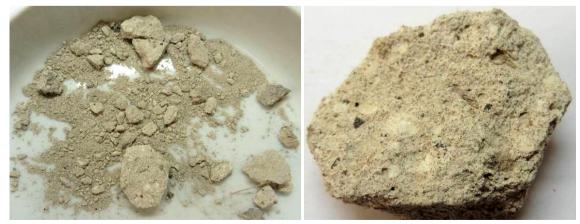
Plates No. 13 & 14: The left plate shows the sample as received, with the right plate showing a close-up of the largest fragment, which contains an abundance of lime inclusions.

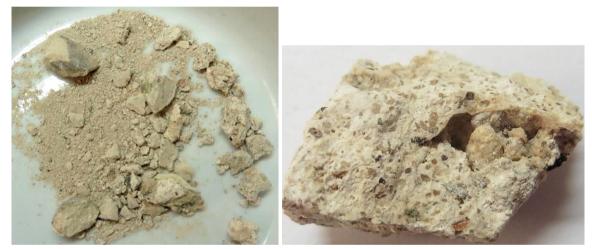
This sample was from another Ashlar mortar, similar to sample "G", with it being a putty mortar containing a low proportion of quartz aggregate, which were coarser than commonly found, along with putty lime inclusions, up to 3.5mm in size. A low content of linseed oil was also indicated to be present.

Plates No. 15 & 16: View of the sample as received, left plate, and a magnified view of a fractured surface through the thickness of the pointing mortar.

The sample contained some small stone samples, along with the mortar, the stone being similar in appearance to sample "E" and the mortar being an ashlar mortar.

On testing the mortar, it was found to be fully carbonated and water droplets were supported with only minimal absorption observed.

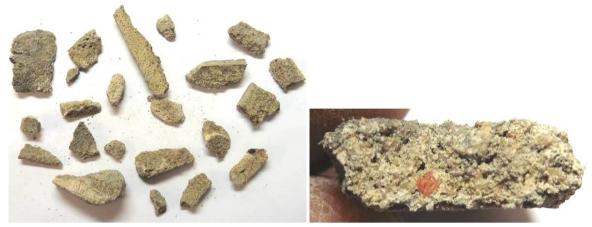
This sample consisted of several pieces of a hard pointing mortar. The longer pieces could only be broken under persistent firm finger pressure whilst the short lengths required a hammer impact to break.

The mortar was hard and well bound and had the appearance of a cementitious mortar.

Plates No. 17 & 18: The left plate shows the intact ribbons of pointing mortar from which the sample was composed. The right plate shows a fresh fracture through the thickness of one of the intact pieces, displaying a well compacted mortar.

The mortar was fully compacted and appeared to contain a patchy air entrainment, and on testing with water droplets it was noted to be porous, with the water droplets slowly absorbed and diffused throughout the thickness of the sample.

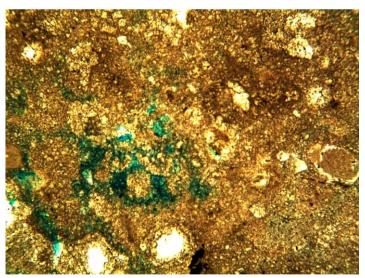
Plate No. 20:

A view in plane polarised light (ppl), of a typical area of the mortar where the chalk components are moderately well distributed throughout the paste, over most of the area in view. Rock flour inclusion (balled and unmixed flour) can be seen in the lower left and upper right side of the paste. The patchy colour change in the paste around the lower left lime inclusion is considered to be due to the oil in the mortar. There is little microporosity observed in this area of the plate.

Porosity is highlighted by the blue dyed resin. Field of view 1.2mm. The Earth Stone & Lime Company The Guild Hall, York, Mortar from Stone & Brick Masonry Examination and Analysis of a Mortar Sample

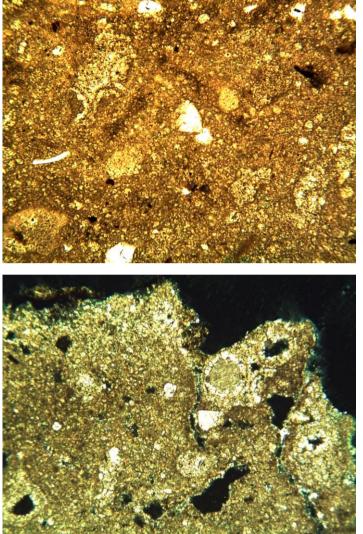
Plate No. 21:

Another view in ppl, of an area of paste containing an abundance of unmixed limestone four and fine quartz aggregates (white in the image) distributed throughout.

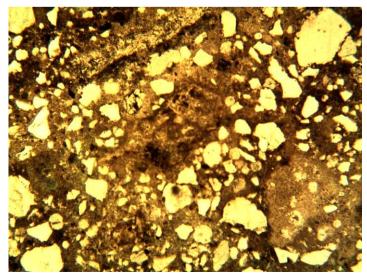
Plate No. 24:

A view in plane polarised light (ppl) showing a typical area of paste within the mortar, with a fully slaked angular lime inclusion, in the centre of the plate, which contains Belite clusters, indicating a hydraulic component in the binder. The aggregates are dominated by quartz in this view However, on the lower right, there is a sub-angular lime inclusion which appears to contain fine quartz grains, but these have not been altered during calcining. The paste within the inclusion has slaked to putty but this has not diffused into the surrounding matrix.

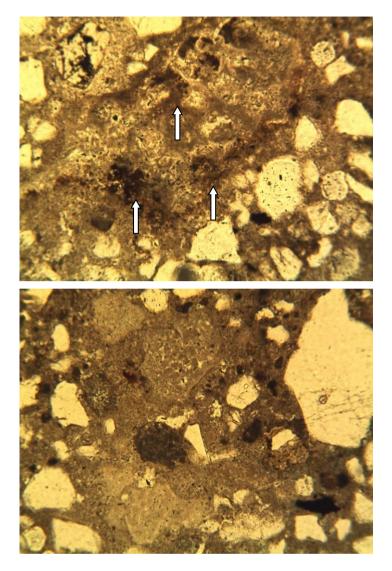
Plate No. 25:

A magnified view of the angular inclusion in the centre of the area in Plate No. 24 above. This view is again in ppl.

Belite clusters can be seen clearly within the inclusion, arrowed in plate, and also within the surrounding paste, confirming that the mortar was made from a hydraulic binder. In addition to this there was both fine brick and ash material observed within the paste, some of which appears to have altered and may have acted as a pozzolan in the mortar.

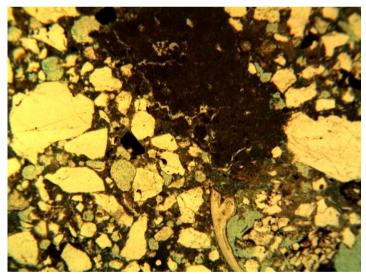
Plate No. 28:

A view in plane polarised light (ppl) showing a typical area of the mortar.

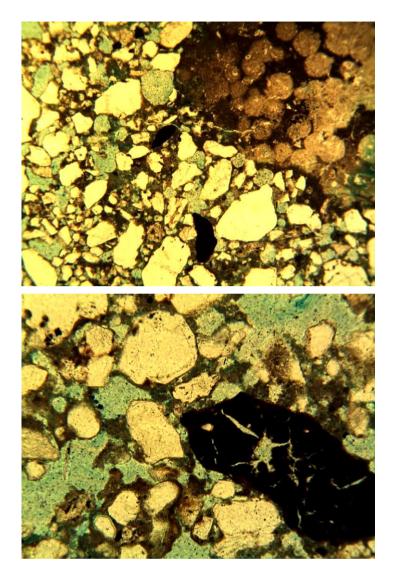
Plate No. 29:

Another view of the mortar again in ppl.

The image shows a partially burnt Oolitic limestone fragment in the upper right abutting a highly porous area of mortar. Although the mortar is dominated by subangular quartz grains, encapsulated in a non-hydraulic lime binder, there are patches of the paste that appear to contain ash fragments, which show reaction rims, and this may therefore impart a measure of Hydraulicity (pozzolanic) property to the mortar.

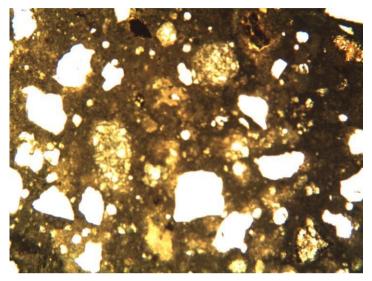
Plate No. 32:

A view in plane polarised light (ppl), of a typical area of the mortar. The sand grains in this view are dominated by angular quartz grains (white in image). The patchy appearance of the paste is due to the presence of crushed limestone fragments and fines are dolomitic in form. The paste is dense and there is little microporosity observed in this area of the plate. The darker zone down the right side of the plate is considered to be an oil rich area of paste. Porosity is highlighted by the blue dyed resin. Field of view 2.4mm.

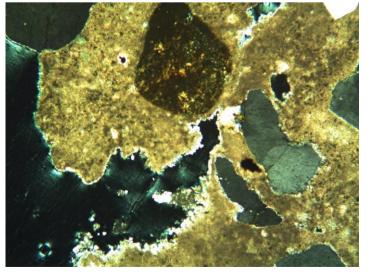
Plate No. 33:

Another view in ppl, of an area of paste surrounding a coarse limestone fragment, left of centre, with smaller fragments and fines (dust) also present distributed throughout the paste.

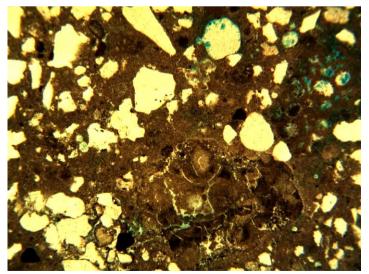
Plate No. 36:

A view in plane polarised light (ppl) showing a typical area of the mortar.

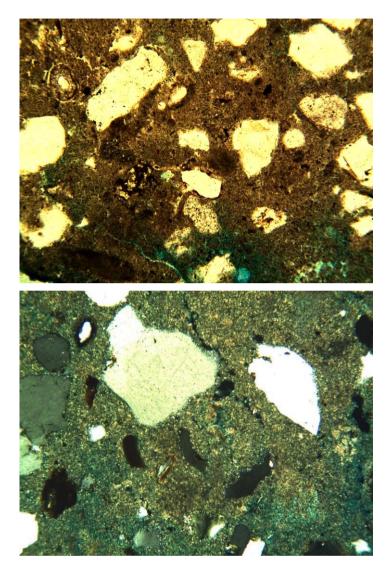
Plate No. 37:

Another view of the mortar ppl.

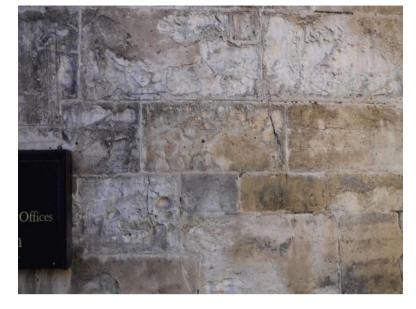
G) probably earliest masonry – Ashlar Pointing

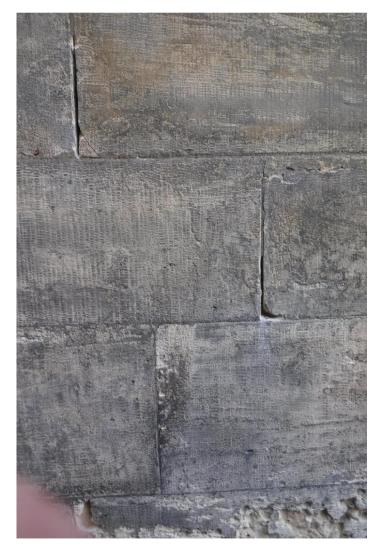
C) Ashlar Pointing

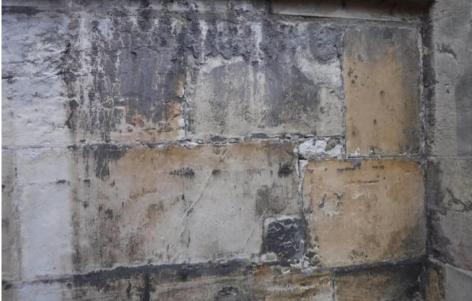
I) – Ashlar pointing

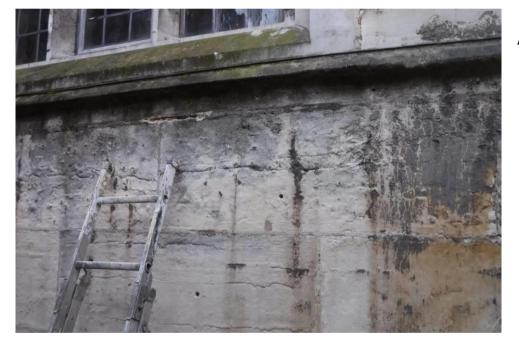
Also, I)

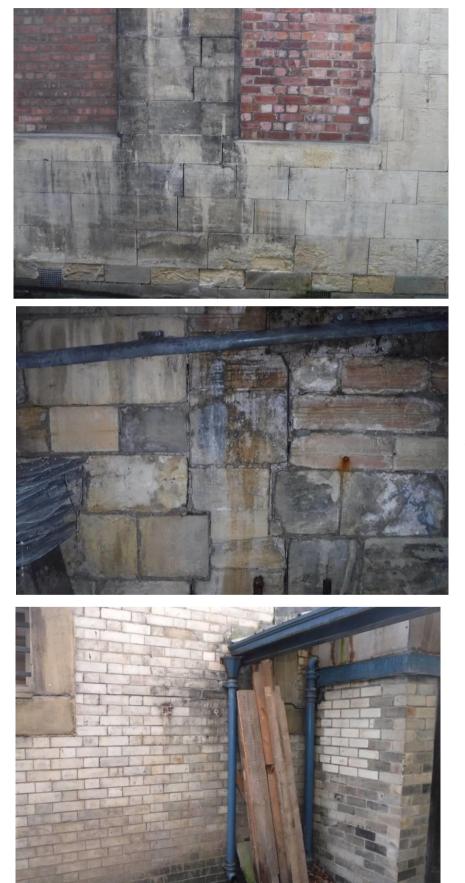
D) wall of original guild Hall within stone lean-to shed

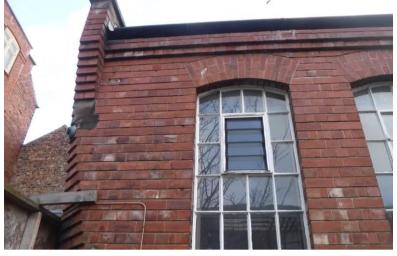
B) probably same as H)
