# OLD TRENT BRIDGE, NOTTINGHAM

## CONDITION SURVEY AND RECOMMENDED REPAIR AND CONSERVATION.

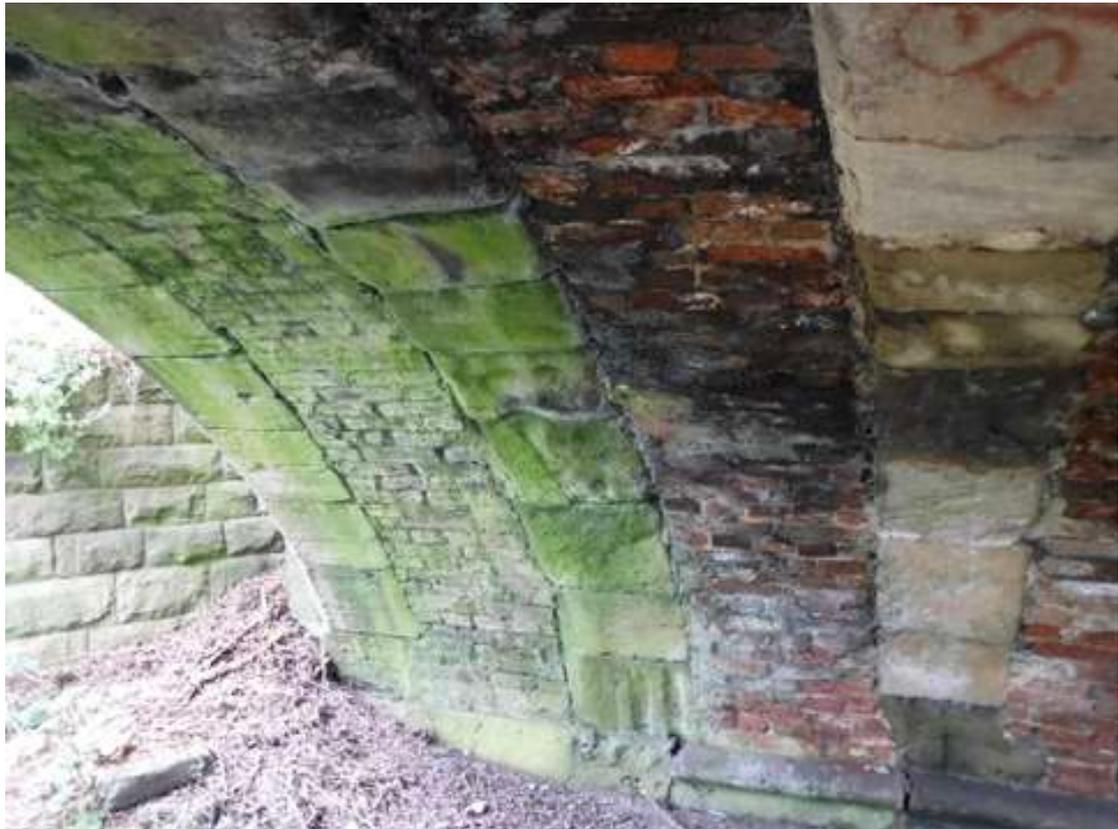
The bridge roadway is paved with York stone flags between remodelled wall-tops. The latter would seem to be a Ministry of Works-era rebuild at upper levels, using cementitious mortars with coarse, sharp sand aggregates. These are probably 1:1:6, Portland cement: hydrated lime: sand. This has been durable and has not caused decay to the uppermost stones of the remnant parapet. However, to the east elevation, lower courses of the same have suffered significant frost damage contributed to by such mortar and the associated run-off from the upper parapet. Much of the pointing to the stone flags has been lost, or is fractured, adding to the potential burden of water within the lower former parapet wall, as well as within the arch vaults, which latter exhibit extensive salt crystallisation, as well as salt-induced decay to brick and stone surfaces, as well as to original construction mortars. The cementitious mortars remain substantially intact and well-attached and should be left. In the absence of their promoting decay, they are fit for purpose (in the absence of weathering detail) and were well-executed. The paving should be repointed with similarly robust and frost-resistant mortar to reduce the water (and salt) burden within the arch vaults beneath. (1).

- Repoint with 1:2:7 mortar: 1 part white Portland cement: 2 parts hydrated lime, run to a lime putty the day before mixing: coarse, well-graded sharp sand. (1) £900

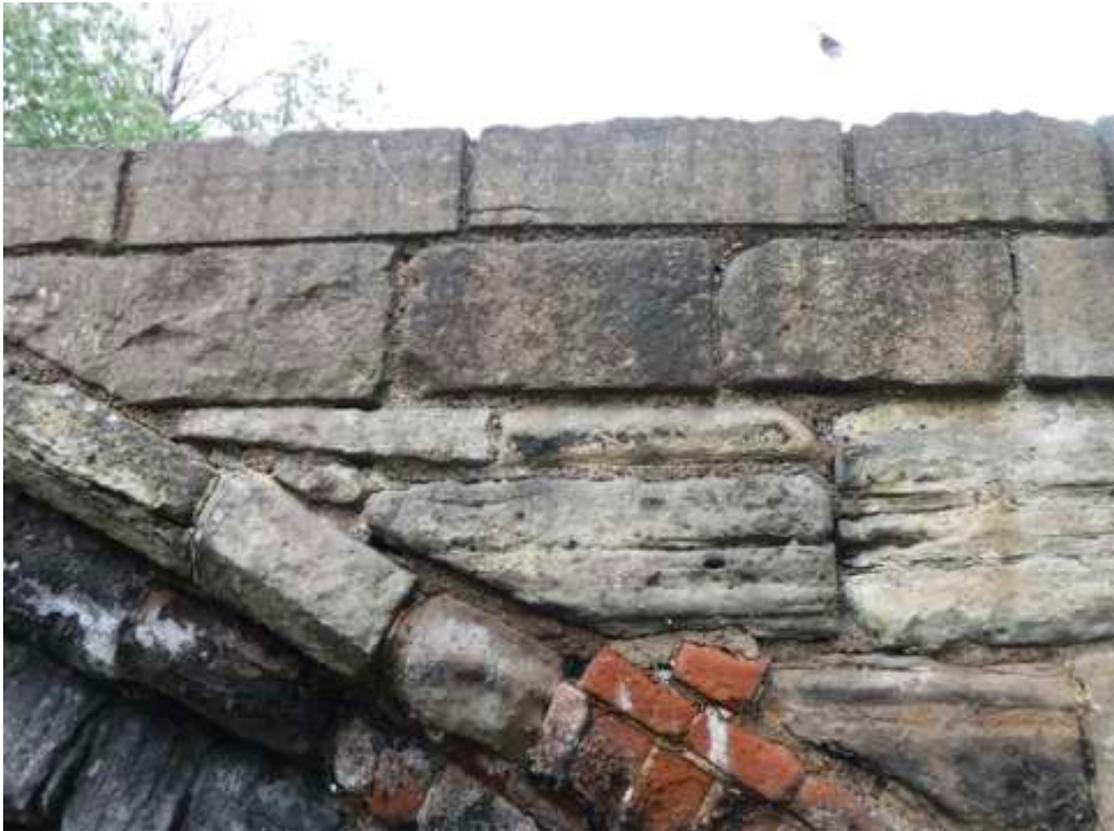
*A) & B) the upper two courses wholly rebuilt using probable 1:1:6 mortar. Water run-off has led to somewhat accelerated weathering of the ashlar beneath.*

- Remove all weed growth from rough-racked cutwaters and over disrupted arch; assess stability of rough-racking and reconsolidate as necessary using a hot mixed mortar as above but with 25% meta-kaolin addition as a proportion of the quicklime by volume. Provide weatherings throughout to shed, rather than to trap, received water. (2) £600
- Provide mortar weatherings to exposed arch voussoir tops. (1) £200
- Repoint approximately 40%, leaving all intact original or earlier hot mixed lime mortars.(1) £800

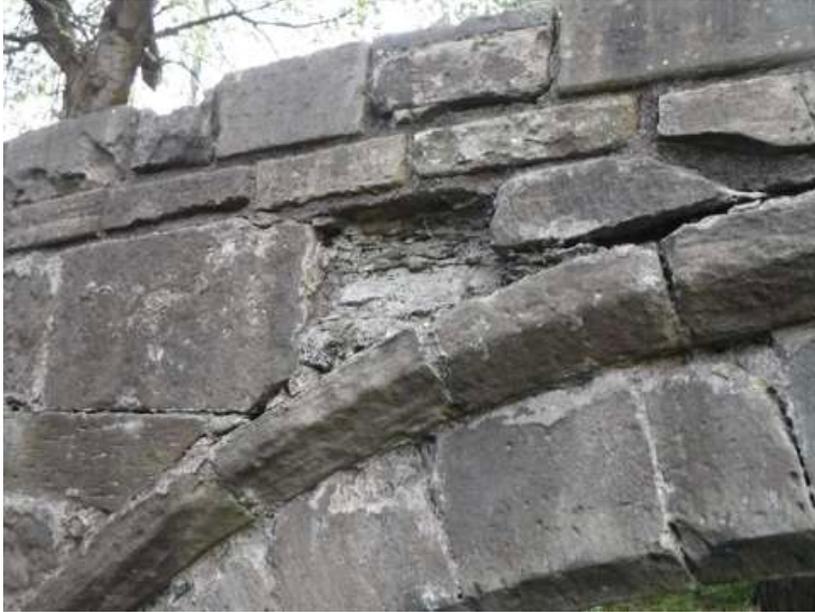
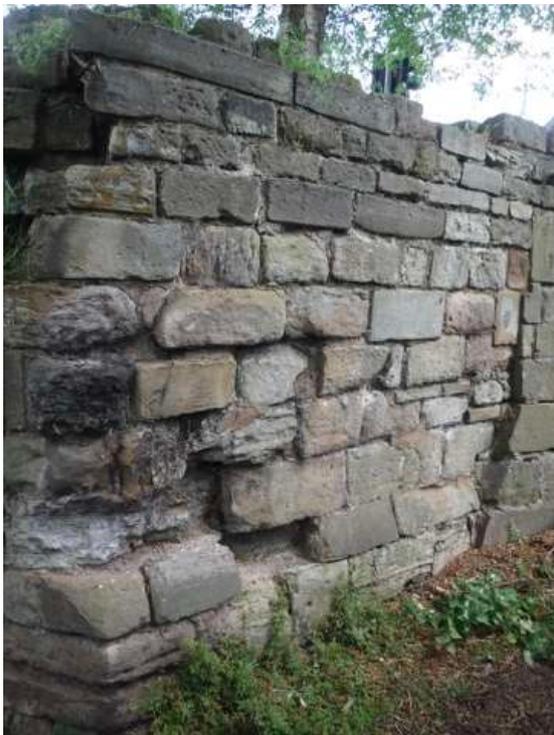
*C) Water run-off has exposed the weaker ashlar stones to significant frost damage at higher levels; rising moisture being trapped by cementitious repointing at lower level has contributed to similar damage at this level, D). This would ideally be rectified by the introduction of projecting stone copings. Providing a proper drip function (1).*

- Remove all gypsum soiling to arch stones using fine stainless steel brushes and water. (1) £600
- Repoint 90% using a mildly pozzolanic hot mixed lime mortar. This might be 1 part powdered quicklime: 2 parts coarser sharp sand: 1 part fine sharp sand plus 5% pozzolanic brick dust as a proportion of the slaked lime (10% of the quicklime), or wood ash (fines and charcoal) added at similar proportion. More exposed areas might receive 20% wood ash as a proportion of the quicklime. (1) £1500

- Replace 2 # outer arch voussoirs with matching sandstone and dressing, southerly arch. (1) £900
- Replace 4 # ashlar stones like-for-like, new stones to be at least 6" deep. If the same stone cannot be sourced, these repairs may be effected using low-fired, handmade clay plain tiles, consistent with the historic significance of the original fabric. (1) £800

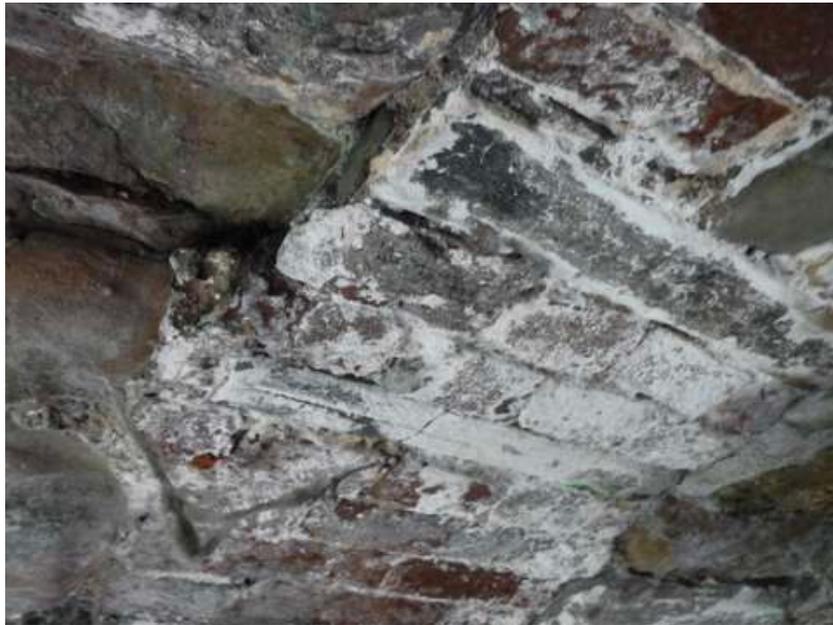
*Salt incrustations to the arch vaults, indicating significant passage of water and periodic wetting and drying. Salts within the brick or stone will promote their progressive disintegration*

- Brush away all salt efflorescence, gathering removed salts and carrying away from site (1) £500
- Repoint brick and stonework 100%. Intact original pointing mortars will be salt-infused and friable. Joints should be cut back approximately 25mm, removing zones of heaviest salt contamination. Mortar should be as above but with 15% graded brick aggregate addition, approximately 5% of which should be in fine powder form to offer pozzolanic reaction. Brick aggregate enhances the management of salts. (1) £1800

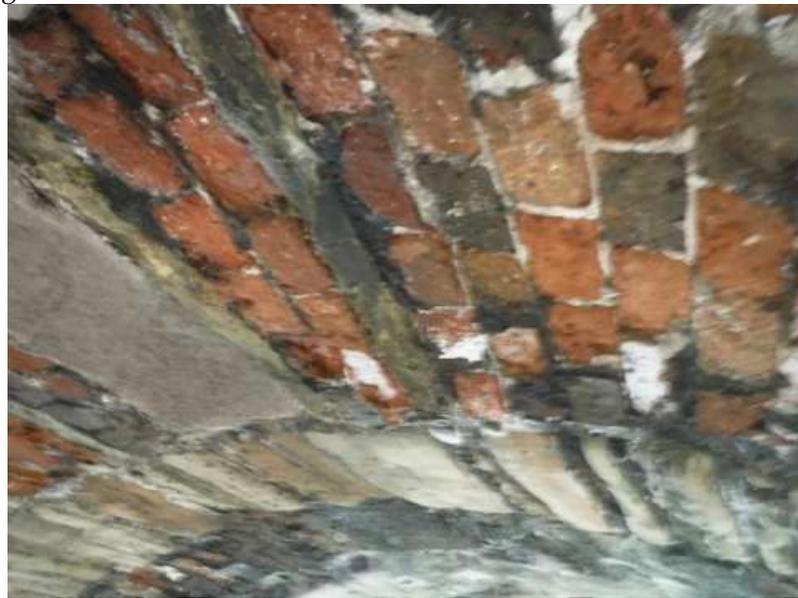
The cutwater to the west side remains substantially intact; only a stub of the same survives to the east side. All remnant cutwaters have been 'rough-racked' to greater or lesser extents, using the same cementitious mortar as above and being part of the same 'Ministry of Works' scheme. This has been less successful, inviting significant growth of vegetation, but remains substantially intact. Rough-racking extends above the more southerly arch to the west side, all but its lower order of voussoirs having been lost. The rough-racking in this location has been lost or is deficient and this should be re-consolidated (1) and only a single skin of brickwork survives at parapet level.

*Rough-racking to west side, to cutwaters and above disrupted arch*

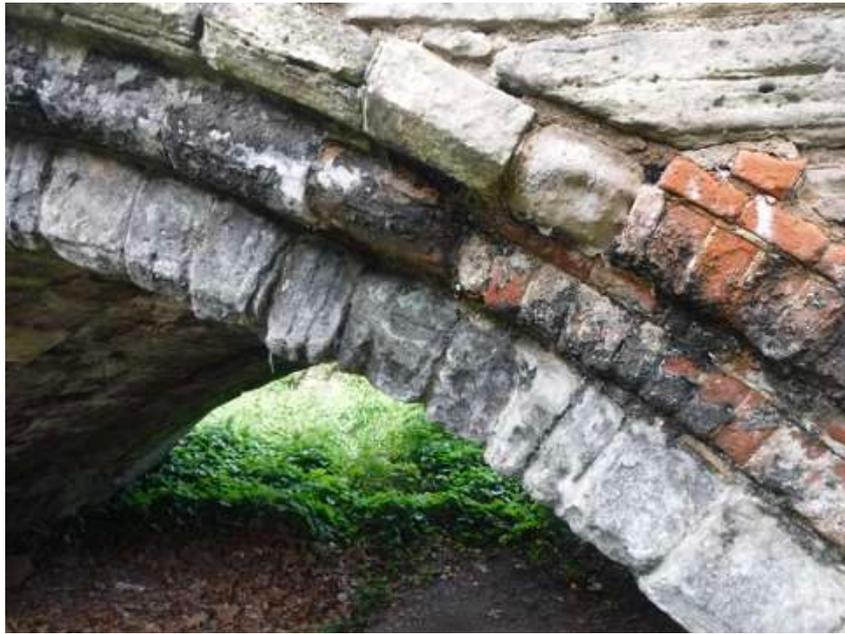
I)

The more sheltered faces of arch-stones to the west side have developed gypsum sulphate skins in response to air pollution. The monument is close to a busy road and is in a sunken area, where particularly diesel exhaust particles will accumulate and attach to the stonework, the more so the wetter the fabric of the bridge is. Where this stonework is not routinely rain-washed, these particles will react with lime in the stone, as well as with free lime that might be leached from lime or cement-lime mortars to the adjacent stonework, creating such skins. These will cause powdering of the stone face beneath. Their presence may suggest some calcareous content in the local sandstone used in the bridge.

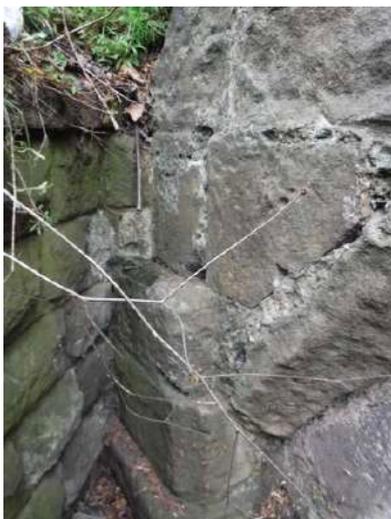
L)

There has been a general attrition of pointing mortars, except to the upper courses of the remnant parapet wall. In places, original pointing and/or bedding mortars are visible, cementitious repointing having fallen away. The original mortars were hot mixed directly from quicklime and were lime rich. They were likely based upon non-hydraulic lime, with some low level pozzolanic addition. Wood ash or brick dust and aggregate were the most commonly used pozzolanic additions in vernacular craft practice at the time that the bridge was built. Some charcoal inclusions may be discerned in exposed original mortars. Such inclusions have in the past be interpreted as fuel debris mixed with the quicklime from the kiln. This is generally unlikely, however. Even in primitive limekilns, the lump lime emerges clean, with 'lime ash' debris at the base of the kiln, a mixture of disintegrated quicklime and fuel ash. Such lime-ashes had specific uses, historically. Whenever charcoal is observed within a traditional lime-rich mortar, it is likely to have been a deliberate addition by the stonemason, offering a feeble hydraulic reaction, assisting (as a water retainer) the steady curing of the mortar. Whilst it assisted durability, recent research would suggest that it also enhanced capillarity, increasing effective porosity (Fusarde 2018).

*original or earlier lime-rich, hot mixed lime mortars*
