Trent Bridge, Nottingham. Survey of Masonry Condition

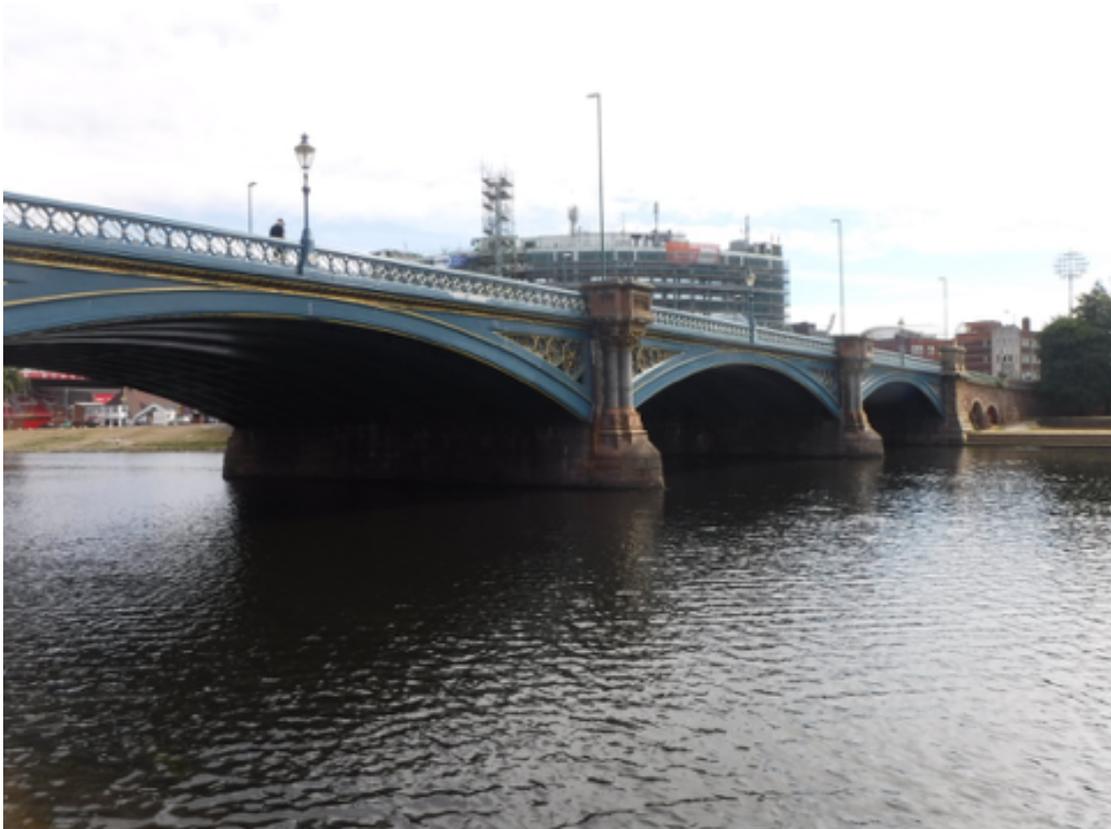
The overall condition of the masonry of the bridge is good, with some localised areas of concern, none of these structural, as yet. The masonry generally displays normal weathering patterns consistent with the age and location of the monument.
