Barn behind Cairnmoors and Preston Cottages, Main Street, Hutton Buscel.
Provisional assessment of materials of construction for Mr and Mrs R Crocker.

It is proposed to sympathetically convert the barn into a dwelling. Edward Freedman of the North York Moors National Park Authority has requested a provisional assessment of the materials and pattern of construction to inform the planning application and approach.

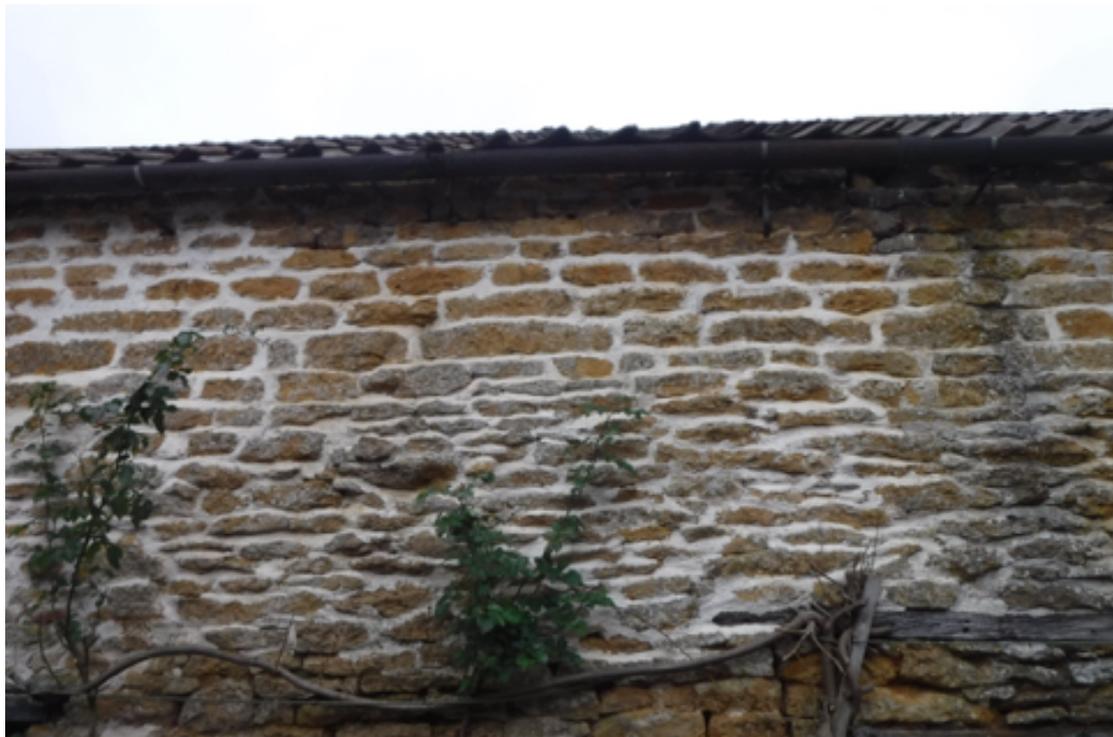
Whilst it is most likely that the walls of the building were always of stone, these have been raised in the past, carrying the roof away from the crucks, the primary structural purpose of which is now to carry the ridge and, to some extent, via chocks of wood, the purlins. The raising will have been carried out

in association with re-roofing in pantile and all rafters were replaced during this operation, creating a simple rafter roof. The raising occurred a long time ago – the stonework of this raising is bedded in an earth-lime mortar and plastering within, upon both original and raised walls is also of earth-lime plaster, with a limewash finish. Masons locally switched from earth-lime to sand-lime bedding mortars around 1800, although this gives only a probable ‘latest’ date for the changes to the roof. The current roof is much more recent than this date and laths laid over the rafters, which traditionally carried a haired lime mortar coating, are sawn, rather than riven. Sawn rafters became the norm towards the end of the 19thC. The sawn rafters here may be much more recent, displacing earlier riven rafters, and may not carry lime mortar. Certainly, the mortar that encapsulates the wall-plates is of Portland cement mortar, indicating relatively recent – and extensive – repair of the roof.

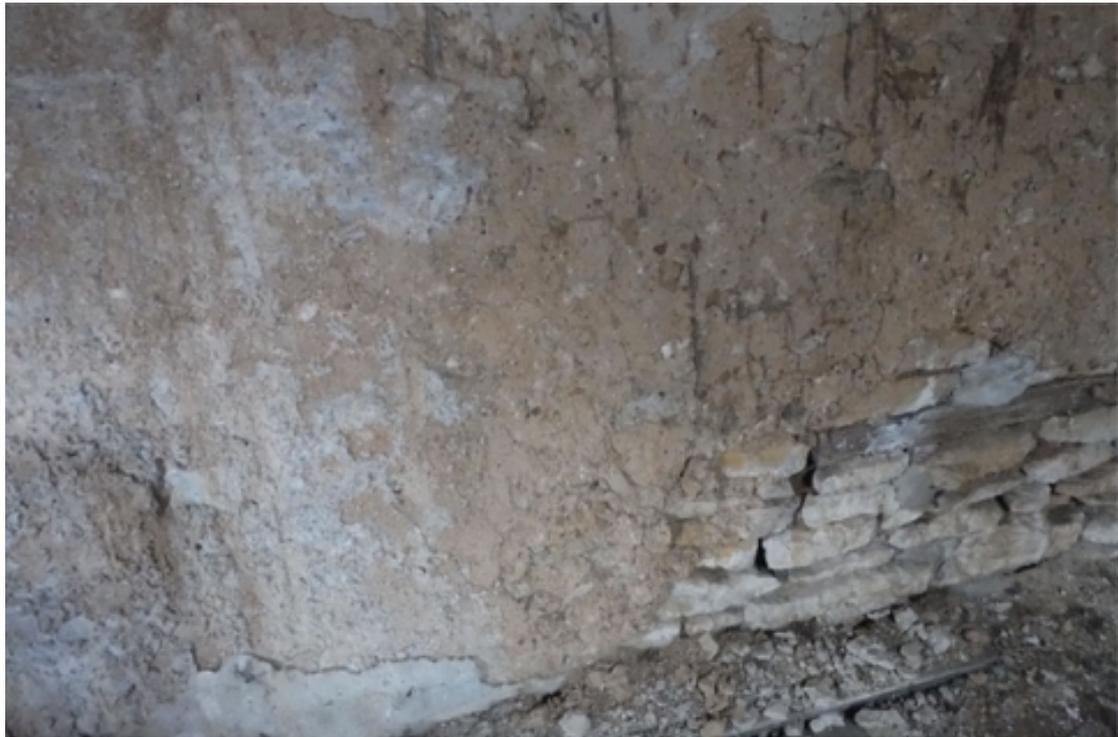
The stonework is bedded in an earth-lime mortar, the earth used having been very fine. This was an almost universal craft practice in the region, extending also to interior plaster base-coats. Typically, a lime-rich, haired pointing mortar was laid over the earth bedding mortars externally, and a typically 4mm – 8mm haired lime finish coat laid over earth-lime plasters internally. Some of the haired lime pointing survives to the exterior and much of the earth-lime plaster internally. This seems not to have been given a lime finish coat, but to have been limewashed only.

earth-lime plaster, with probable hay inclusion to reduce original shrinkage

It is essential that any building constructed with earth or earth-lime mortars is repointed or plastered with eminently breathable, effectively porous lime mortars. This will be typically made by hot mixing from quicklime and will have a high free lime content. Cement or Natural Hydraulic Lime mortars will be too hard, dense and brittle, as well as having a low effective porosity and would lead to accumulation of moisture within the fabric of the wall, as well as promoting localised decay of the stonework.

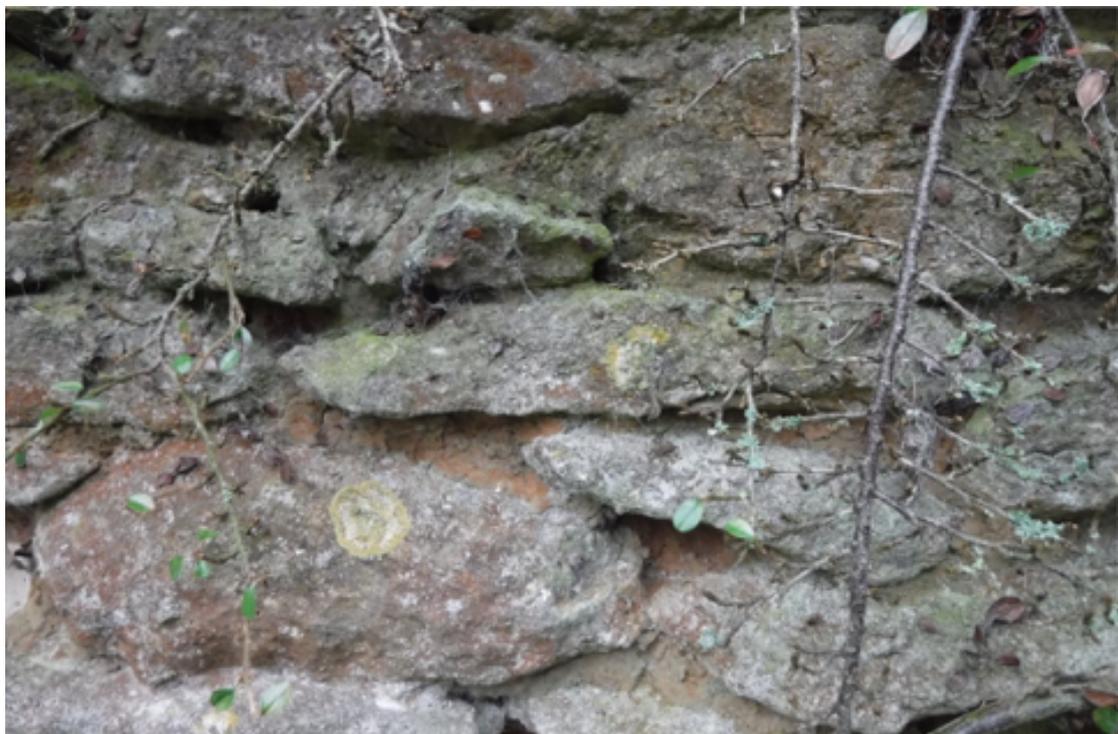
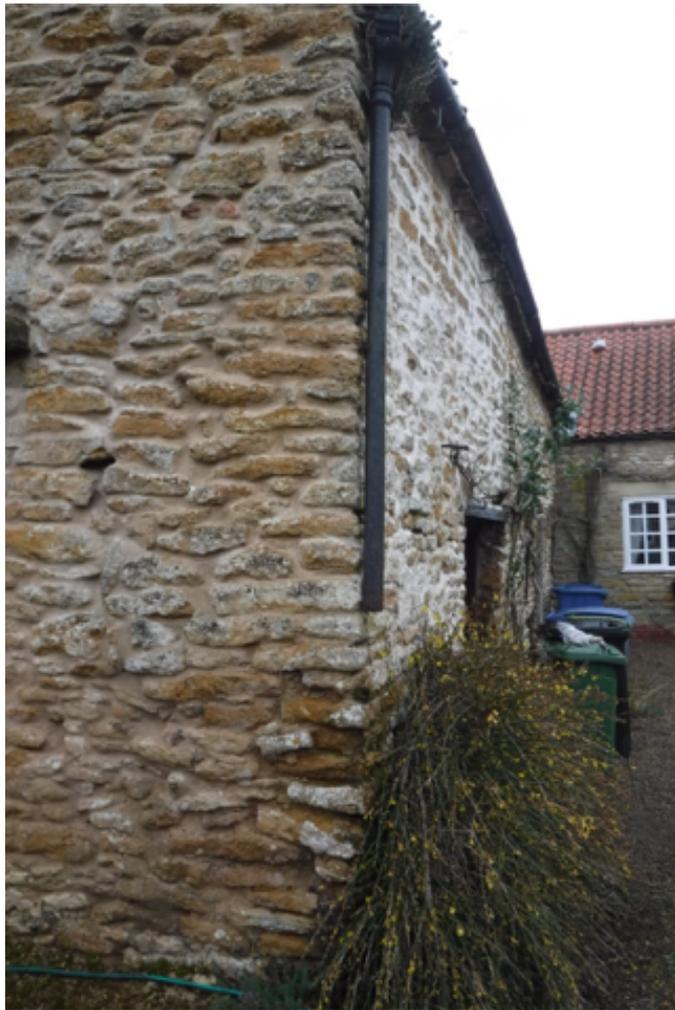
There has been extensive repointing with an NHL mortar to the South elevation. Such repointing should be removed before repointing of the whole with a hot mixed lime mortar.

The west gable wall has been repointed in the past with a cement-lime mortar. Ironically, this may be more breathable and less damaging to the stonework in the long run than a typical NHL mortar, depending upon the relative proportions of cement and lime, but it is not ideal.

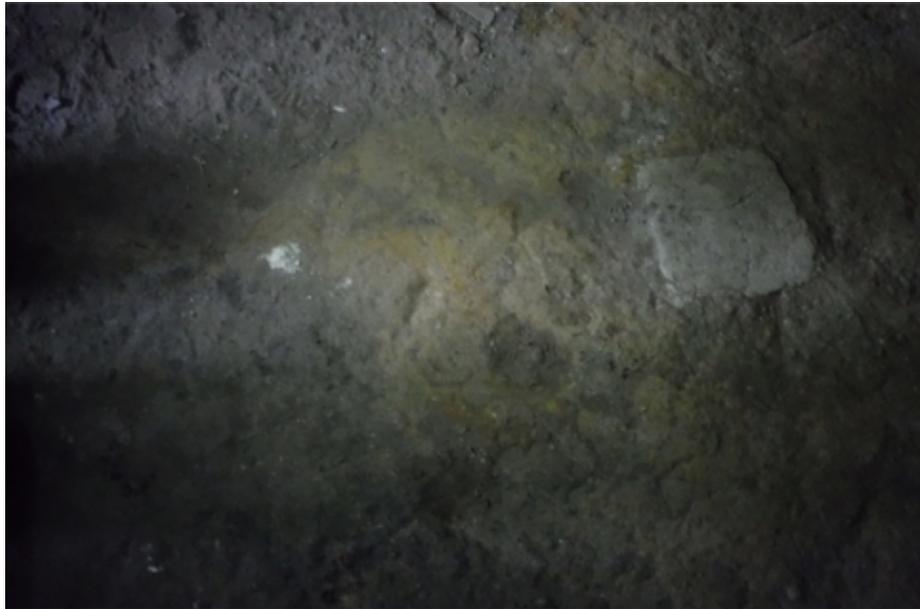
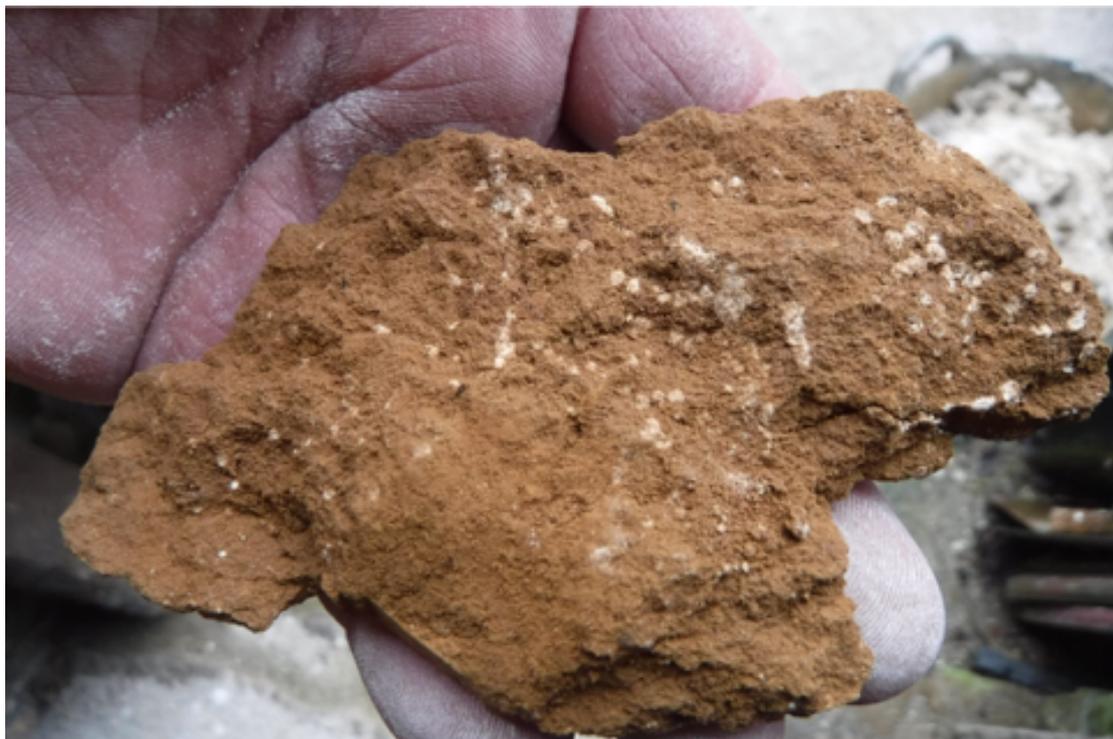
Within, the lower floor of the barn has remnants of a traditional earth floor. This appears to be of earth-lime mortar, around 4 inches deep over the natural soil layer. This may be seen as a relatively rare survival of a once very common flooring pattern in the region, although historic accounts of the making of such floors do not reference the addition of lime (Best 1641). The earth floor is much disrupted, surviving in best condition at the east end of the building. It offers inadequate head-room above to enable easy use of the building and any conversion proposal would inevitably require its removal to achieve necessary head-room. To the north-west corner, the earth floor has been displaced by cobbles associated with the use of this part of the building as a cow-byre or

sample of earth floor, displaying apparent lime lumps, though these may be salts.

milking parlour. It would be essential that the floor as a whole was properly recorded in context before any removal – a 3-D laser-scan of the interior, recording the extent of its survival, as well as a thorough analysis by a materials scientist, would likely be the minimum requirement. If removed, the floor should be set aside to make deeper repair mortars for works upon the stonework.

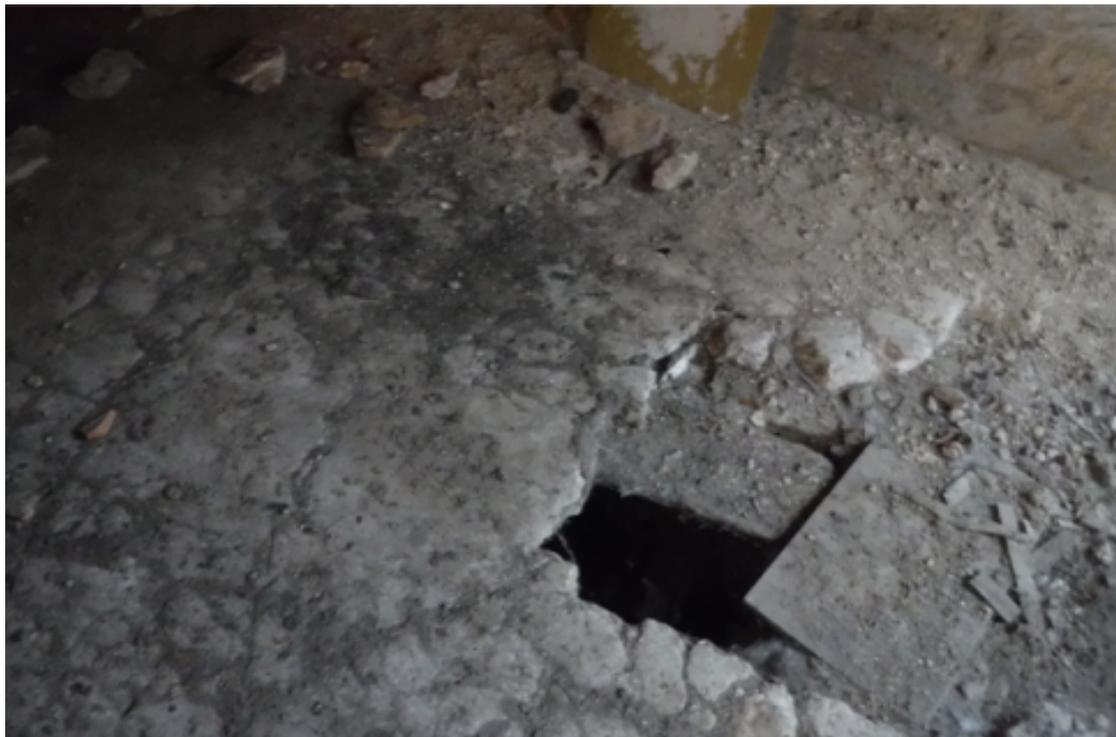
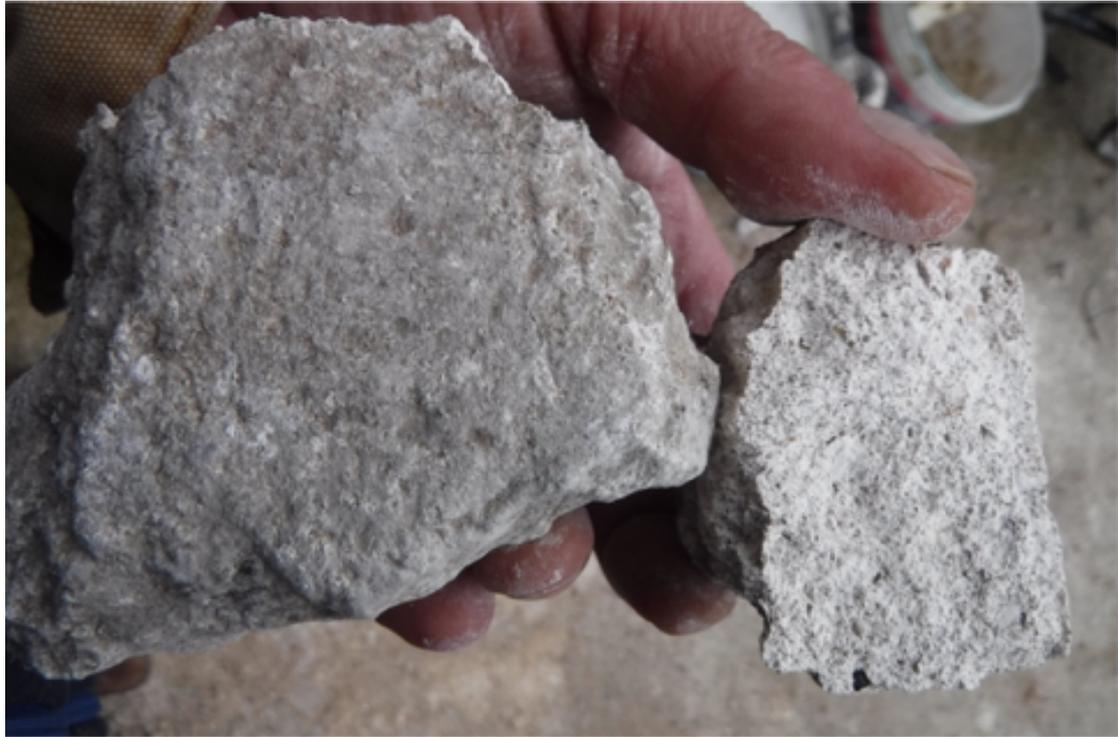
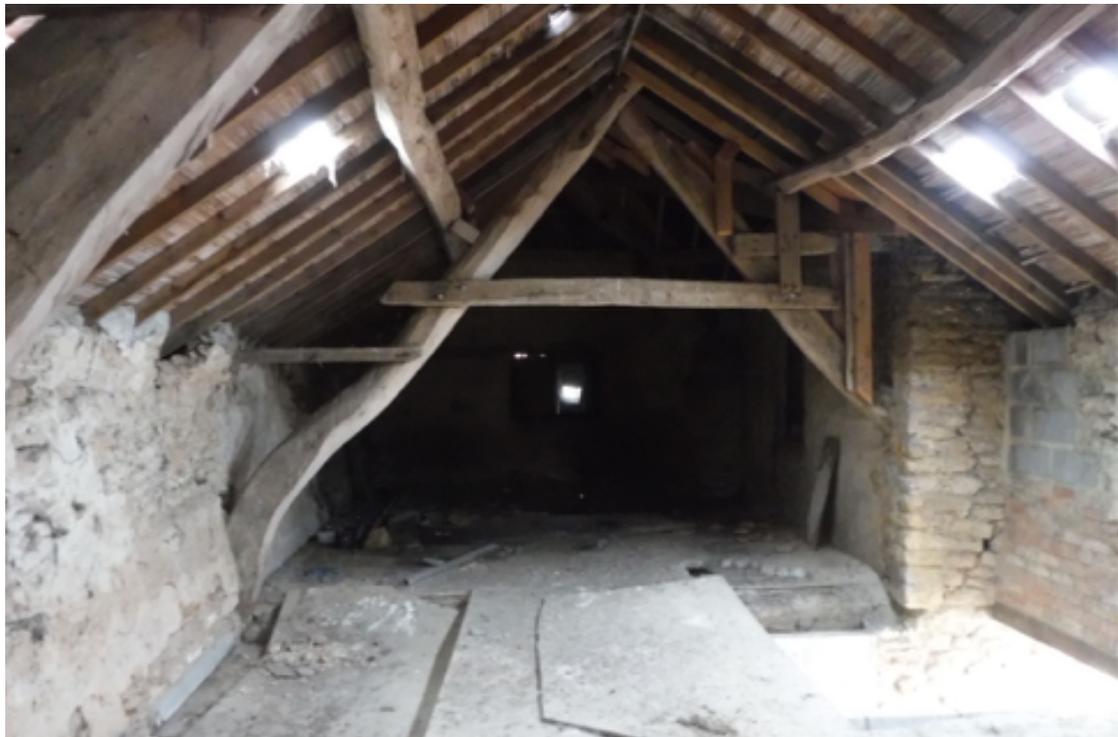
The upper floors are comprised mainly of tongue and groove boarding of dubious structural integrity. At the east end, however, the floor is of lime concrete, laid over wide boards. The lime concrete is unusually light-weight, suggesting the use of some wood ash aggregate, perhaps. It was hot-mixed from quicklime. The floor is much disrupted due to localised decay of supporting timbers beneath leaks in the roof, as well as by a general crazing into 'lime cobbles'. This floor is unlikely to be saved during repair or conversion works, due to the need to repair supporting joinery elements, as well as its general structural disruption. Again, similar recording as discussed above in the context of the earth floor would be recommended.

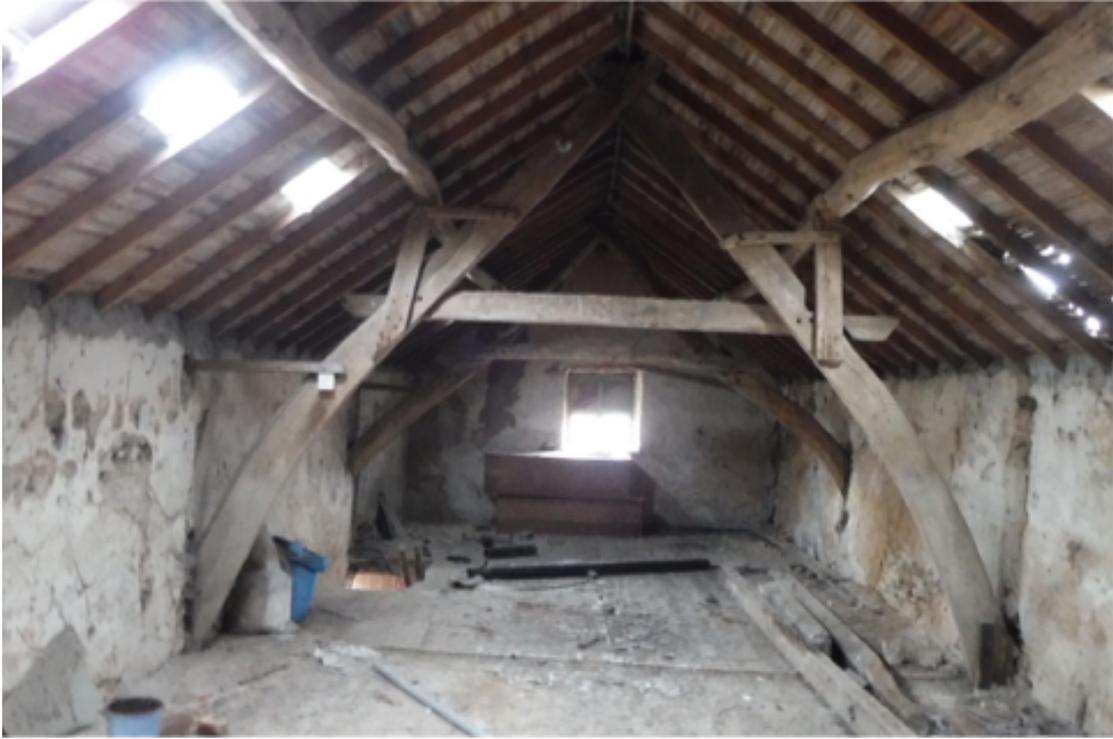
The crucks are very likely to be of similar age to the main, stone walls of the building. This age is currently indeterminate and dendrochronology would be recommended to establish their antiquity before any works commence. They are likely to date from the 16th or earlier 17th Century, but may be older than this. They may have been recycled from an earlier building on the site. Cruck construction was the most common house form in North East Yorkshire into the
