CERTIFICATE OF ANALYSIS ON A MORTAR SAMPLE FOR BINDER TYPE DETERMINATION & MIX COMPOSITION

Project Reference	:	60 Goodramgate, York
Sample Source	:	Brickwork Masonry from Eaves Level
Sample Description	:	Bedding mortar
Date Received	:	21 st January 2021
CMC Sample Ref	:	SR 2824 - S1
Method of Test	:	Mix composition by acid digestion, and binder type by XRD analysis by in-house procedures, with fabric condition from a thin section examination.

Earth, Stone & Lime Company.
 60 Goodramgate, York
 Brickwork Masonry Mortar from Eaves Level
 Examination and Analysis of the Bedding Mortar.

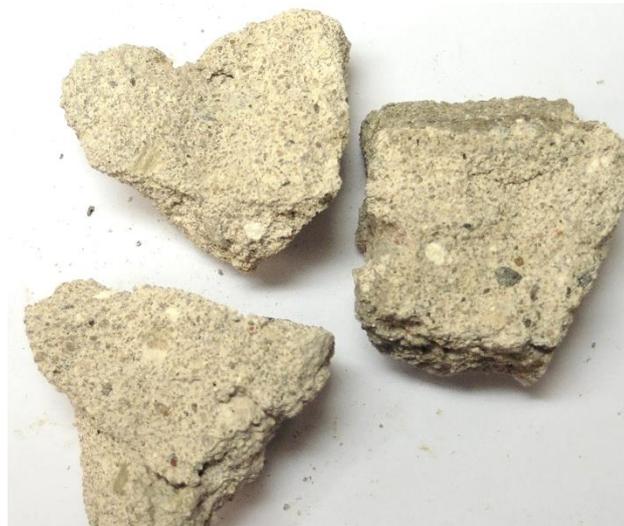
The sample consisted of three intact pieces of mortar all of which contained lime inclusions, which were noted to measure up to 7.3mm in size. The inclusions were mostly irregular though some were also noted to be sub-round to round in shape.

The mortar was moderately hard and well compacted with a low entrapped void content indicated. The voids appeared to be free of any redeposited material, or soiling, suggesting that water percolation through the mortar had not occurred, or was minimal.

Plate No. 1: The above plate shows the three pieces of mortar in the sample, as received. Note the presence of lime inclusion, irregularly distributed throughout the fabric. Soiling was evident, on the edge of one fragment, which was considered to be an outer joint face, see right particle in the plate.

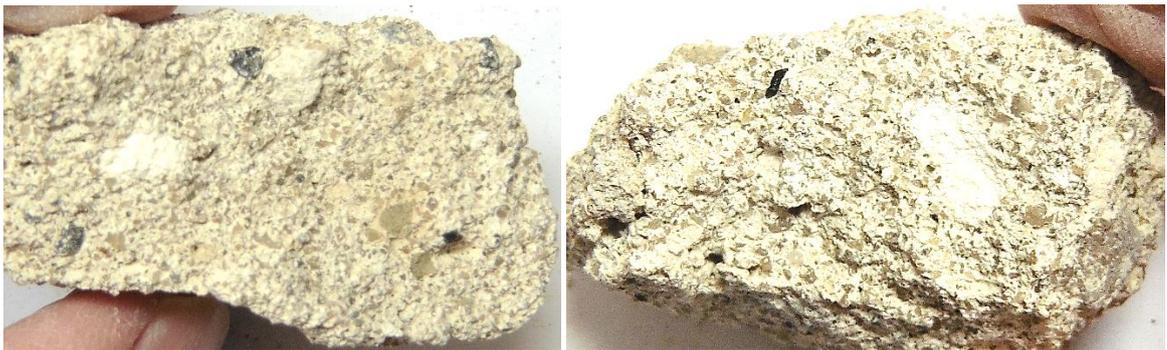
Plates No. 2 & 3: The above plates show freshly fractured surfaces, from two of the fragments. Lime inclusions can be seen in both pieces, with the inclusions having the appearance of having been formed from either a quicklime, putty lime, or both.

The aggregates within the body of the mortar had the appearance of natural fine grained sand, dominated by quartz grains along with minor lithic fragments, with a maximum particle size of 3.4mm in the sample examined. The aggregates were well distributed, but grain to gran contacts were noticeably low, and the mortar appeared to be binder rich.

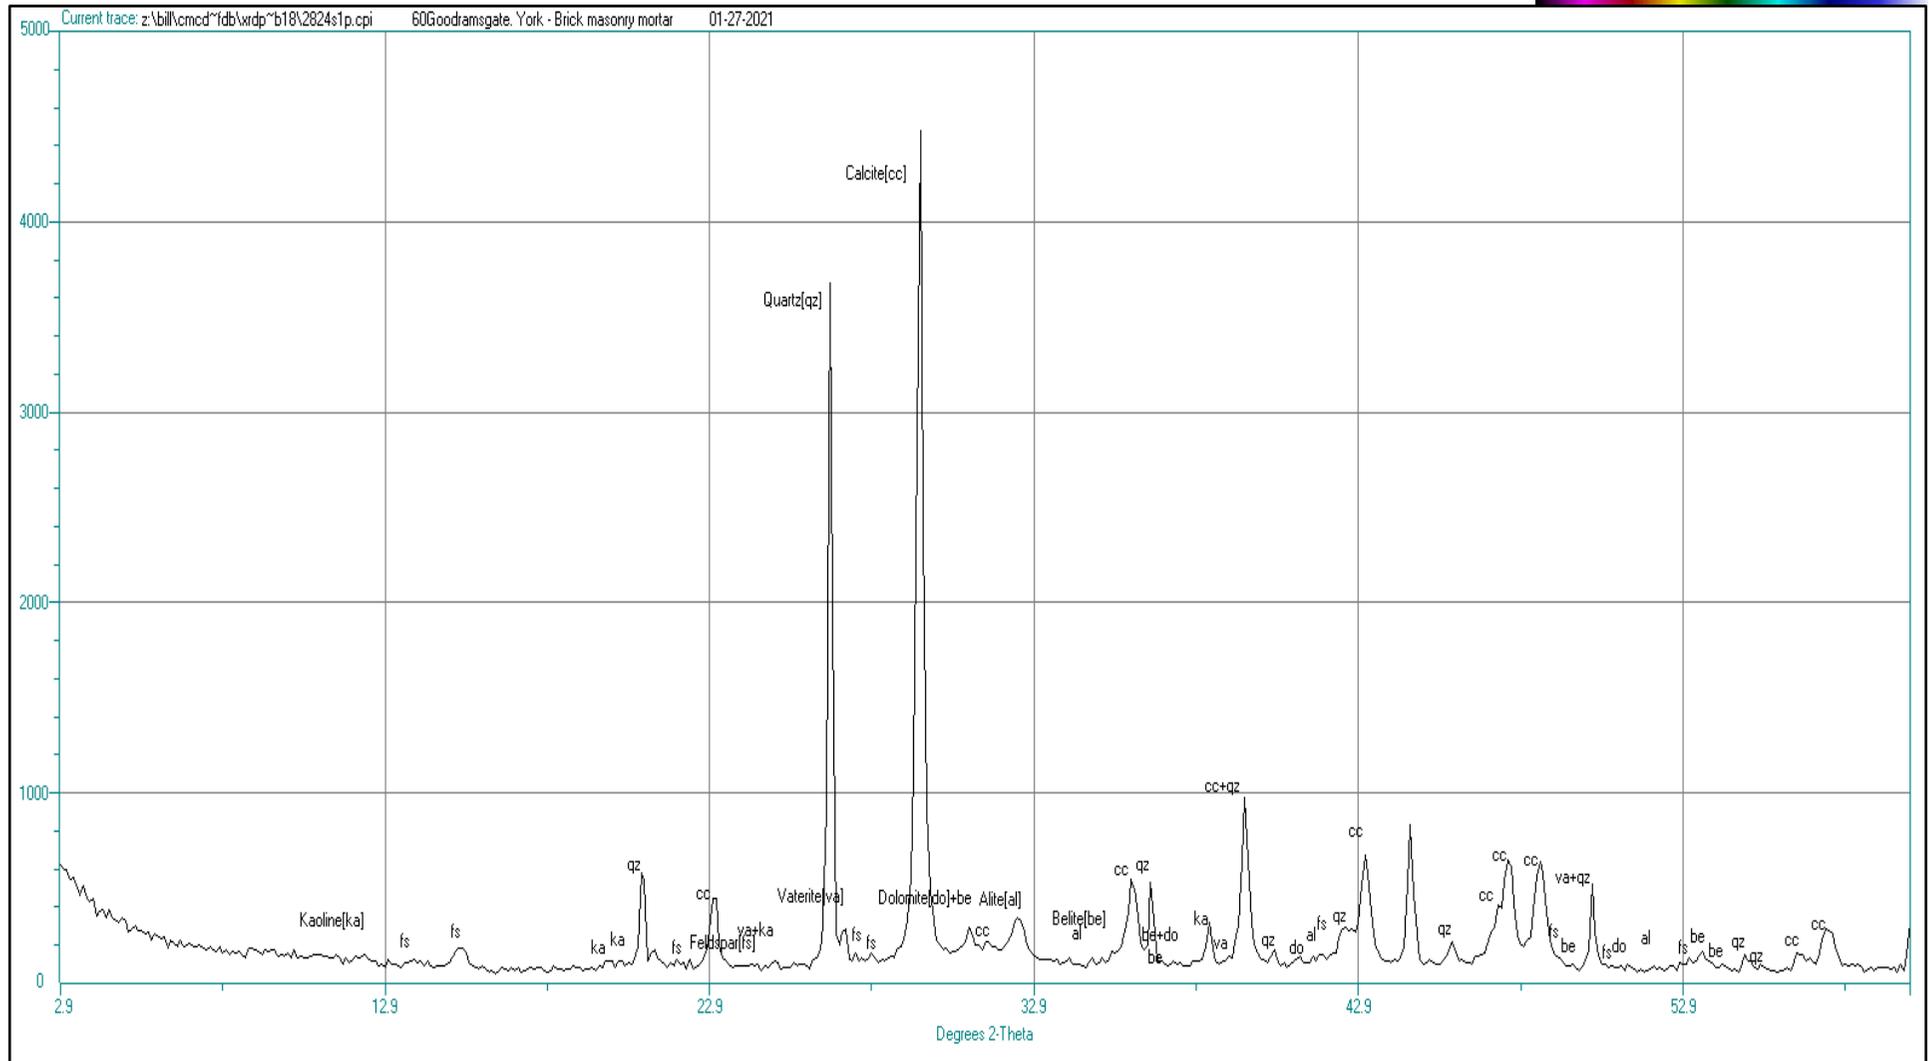
Figure No. 2: Sample SR2824-S1 – Binder rich fines from the bedding mortar sample.

- cc** = Calcite (CaCO_3) calcium carbonate, carbonated lime from binder, and this can also be present in any limestone the aggregate,
- va** = Vaterite (CaCO_3) another form of calcium carbonate, carbonated binder from lime binder, or in limestone aggregate, and also found in redeposited leached lime,

- be** = Belite (Ca_2SiO_4) *di*-Calcium Silicate, a hydraulic clinker component, common in Portland type cements and many hydraulic limes,
- al** = Alite (Ca_3SiO_5) *tri*-Calcium Silicate, another hydraulic clinker dominant in Portland cements and common in eminently hydraulic limes,

- qz** = Quartz (SiO_2) dominant component of the aggregate minerals in the sand,
- fs** = Feldspar, mostly of Albite of the Plagioclase group, with Sanidine, an alkaline feldspar, present as aggregate components,

- do** = Dolomite, (CaMgCO_3) present as a component of dolomitic lime or in the aggregate within any dolomitic limestone present,
- ka** = Kaolinite, clay mineral from the weathering/destruction of feldspar, present in the aggregate.

On the basis of the XRD analysis, it is indicated that the mortar sample was made from either a hydraulic lime or a High Calcium Lime/Hydraulic Lime blend, or a lime/cement binder. The mortar is fully carbonated, with no unhydrated lime present, and there was no evidence of the mortar having been affected by a reaction with any form of environmental sulphate, or other deleterious contaminant.

From the above it is confirmed that the sample contains hydraulic components, due to the binder containing both Belite and Alite. However, the ratio of the hydraulic components detected are such as to suggest that the binder was most likely a Hydraulic Lime/High Calcium Lime blend, rather than a Portland type cement and lime binder.
