Construction Materials Consultants Ltd.

Report on the Examination and Analysis of Pointing Mortar & Plaster Samples

*The Anglican Cathedral Church of the Redeemer
City of Calgary, Alberta, Canada*

Our Ref: M/1736/16
Your Ref:
Doc. Ref: M173616R1-rev1

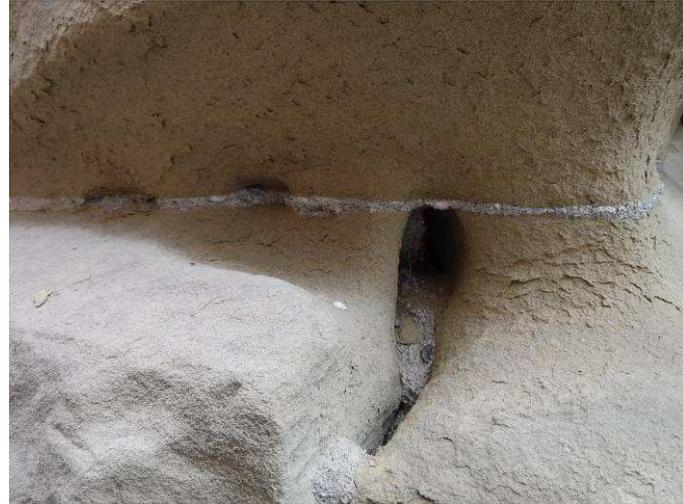
Plate No. 3: Close-up of eroded stone and bedding mortar

From an examination of the mortar joints in plates supplied it would appear that the pointing and bedding mortars contained either limestone aggregates or lime inclusions (unmixed binder) and if correct the latter could infer that the mortars were mixed as a "Hot Lime", however, to clarify this the samples received were to be examined in greater detail.

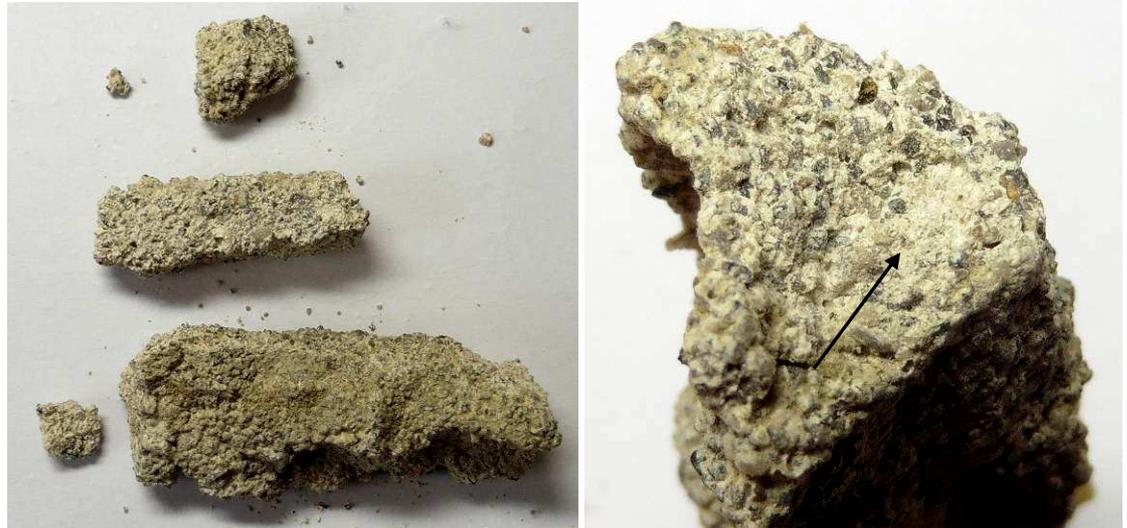
This sample is from a mortar that is firm, moderately hard and locally brittle. The mortar is well compacted with no obvious voids observed in the hand specimen, although the mortar was found, from a water droplet test, to display a well connected porosity. The mortar was noted to be binder rich and contain sparse light coloured inclusions, which measured up to 2.4mm, although the majority ranged from 0.2mm to 1.2mm in size.

There is also evidence of water percolation with localised leaching and redeposition of binder components within the near surface pore structure on one surface, presumably an outer, or possibly a masonry contact, surface, all other sample surfaces were free of any redeposited material.

Plates No. 4 & 5: The left plate shows the sample as received, with a lightly soiled surface with localised redeposited (leached) binder encapsulating the soiling on one surface. The largest mortar piece was firm to the touch but could be broken under firm finger pressure and once disrupted it could be further powdered under moderate finger pressure. The plate on the right shows a close-up of a freshly fractured surface through the largest fragment, where a sub-angular inclusion can be seen arrowed in the plate, with the inclusion surrounded by an area of paste rich matrix.

The intermediate sized piece retained a darker outer surface and this was also marginally harder than the other two pieces in the sample, but there is insufficient to permits its analysis on its own, The hardness may simply be due to a reaction with surface absorbed pollutants or the redeposition of binder leached from deeper within the joint.

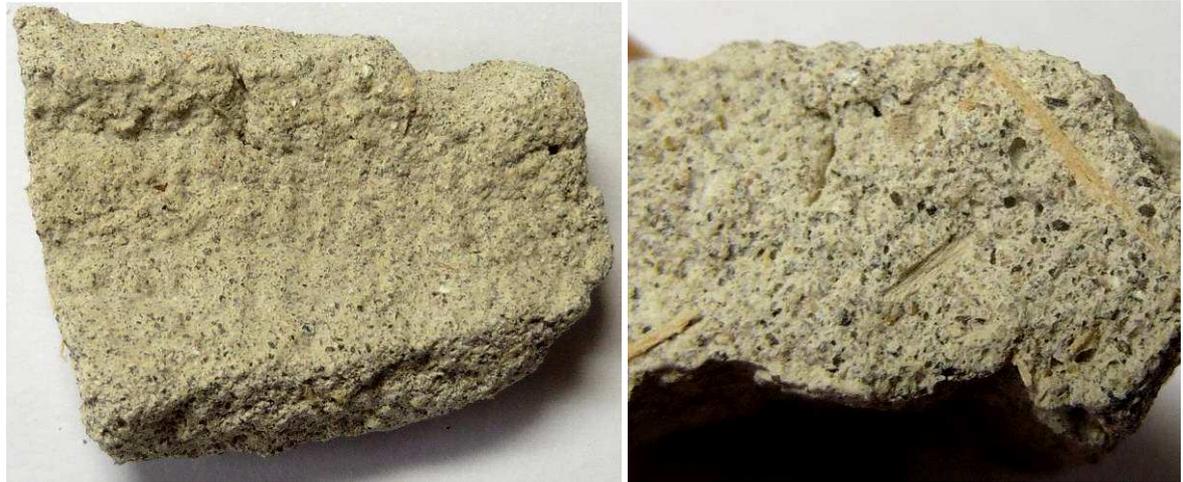
This sample consisted of a single piece of plaster which was again binder rich, visually richer than that in sample S1, with features that would infer that it had been perhaps also placed in a more workable (wetter) condition and the aggregates appeared finer graded. There was no evidence of inclusions in the hand specimen examined.

It was noted on fracturing that the plaster contained lengths of wood fibre, with these randomly orientated and randomly distributed throughout the sample received. It is, therefore, possible that the wood fibre (coarse sawdust) had been added to the plaster rather than be present as a contaminant. Perhaps added in lieu of hair, as a reinforcement. The wood fibres ranged in length from 3.8 to 7.2mm with widths ranging from 0.12 to 0.36mm. However, given the small size of the sample, it is possible that this was obtained from an area where the plaster that had been contaminated at time of placing.

Plates No. 6 & 7: The left plate shows the condition of sample S2 as-received, with the right plate showing a magnified view of a freshly fractured surface through the thickness of the plate, where it was noted that the mortar contained an abundance of fine wood fibres, which given its distribution may infer that had been added purposefully to the plaster.
