CERTIFICATE OF EXAMINATION AND ANALYSIS OF A SAMPLE OF BANK SLAG

Project Reference	:	North Yorkshire Moors – This Exploited Land of Iron
Sample Location	:	Bank Top Kilns (BTK-Slag)
Sample Description	:	Bank Slag & Ash - Waste Material adjacent to The Bank Top Kilns
Date Received	:	26 th March 2019
CMC Sample Ref	:	SR 2709-S1 Bank Slag ex BTK
Date Analysed	:	10 th to 18 th April and 20 th May 2019
Method of Test	:	Determination crystalline and mineralogical composition by X-Ray Diffraction analysis. Particle size distribution by wash grading and the microscopic examination of petrographic thin sections.

Bank Slag Adjacent to Bank Top Kilns
Examination and Analysis of Mortar samples.

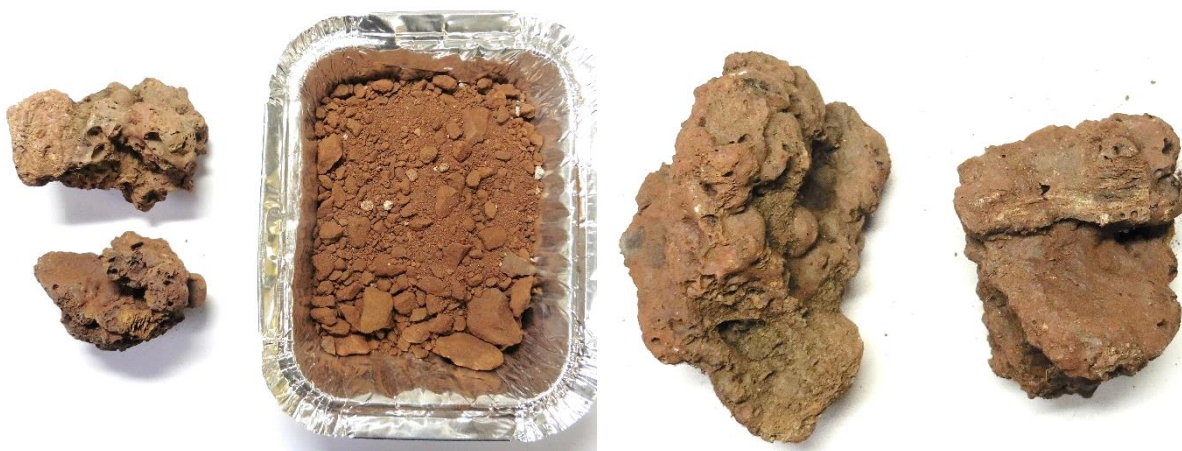
Plates No. 1 & 2: The sample received was a heterogenous material with several materials present. The left plate shows sample, as-received, with the two largest fragments separated from the remainder. The right plate showing a close-up image of the two largest pieces.

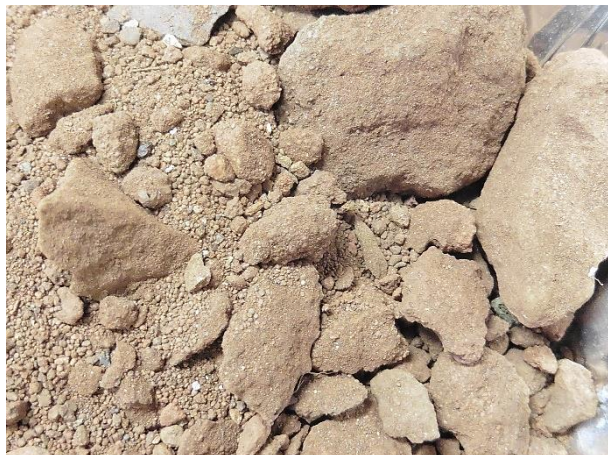
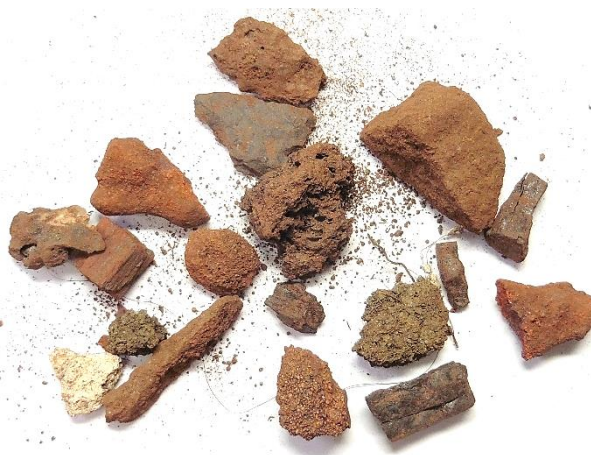
Plates No. 3 & 4: The left plate shows a portion of the bulk sample after drying with the right plate showing a selection of the different variants apparent after separation, with these selected by visual appearance, variation in weight, texture and property, i.e. magnetic attraction, hardness, density, streak on test tile and response to droplet tests using a range of reagents.

It was noted on examination that the larger fragments had the appearance of a metallic slag, with it indicated, on testing with a magnet, that they displayed a magnetic attraction. On separation of the fines for analysis it was also noted that these contained a high proportion of ferromagnetic materials and these could be separated from the mass by passing a magnet over the dried fines.

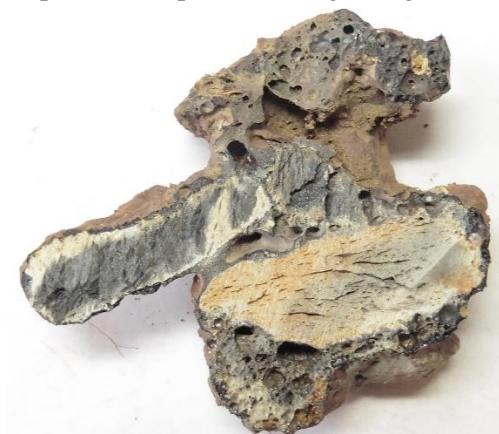
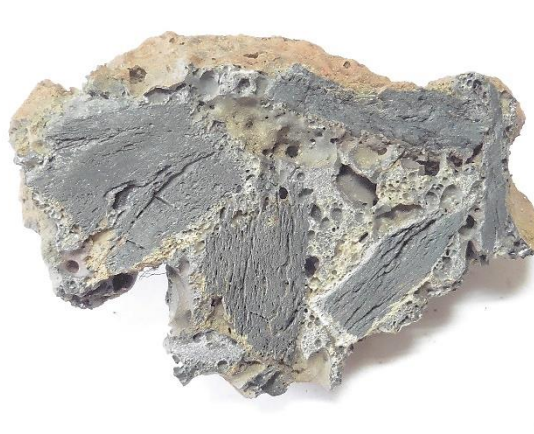
Plates No. 5 & 6: The above plates show freshly sawn surfaces cut through the two largest fragments. These are typical of old iron slags, with the material having been deposited as waste (slag) in the form of a partial melt.

On testing the surfaces of several fragments, with dilute hydrochloric acid, an effervescent reaction was observed on some of the slag particles, with a strong odour of H_2S evolved. This is not uncommon with iron slags and would infer that there are sulphate minerals present. The limestone fragments, and some small siltstone fragments also reacted with the acid test, and would indicate that the siltstone was also calcareous, at least in part.

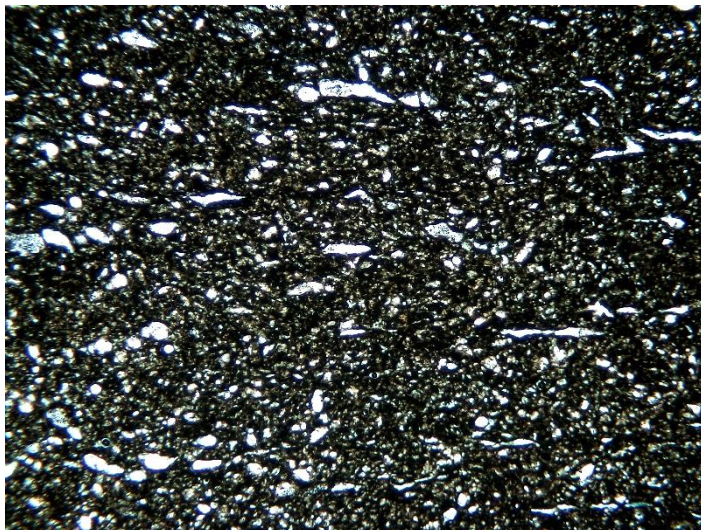
Plate No. 12: Sample “D”

A view in plane polarised light (ppl), of an area within a relatively fresh siltstone fragment. The elongated minerals are muscovite mica. Quartz shows as small sub-round to sub-angular white grains.

Porosity and voids are highlighted by the blue dyed resin. Field of view 1.2mm.

This sample is of a fine siltstone, containing fine quartz grains muscovite mica and clay minerals along with a low proportion of a ferruginous cement.

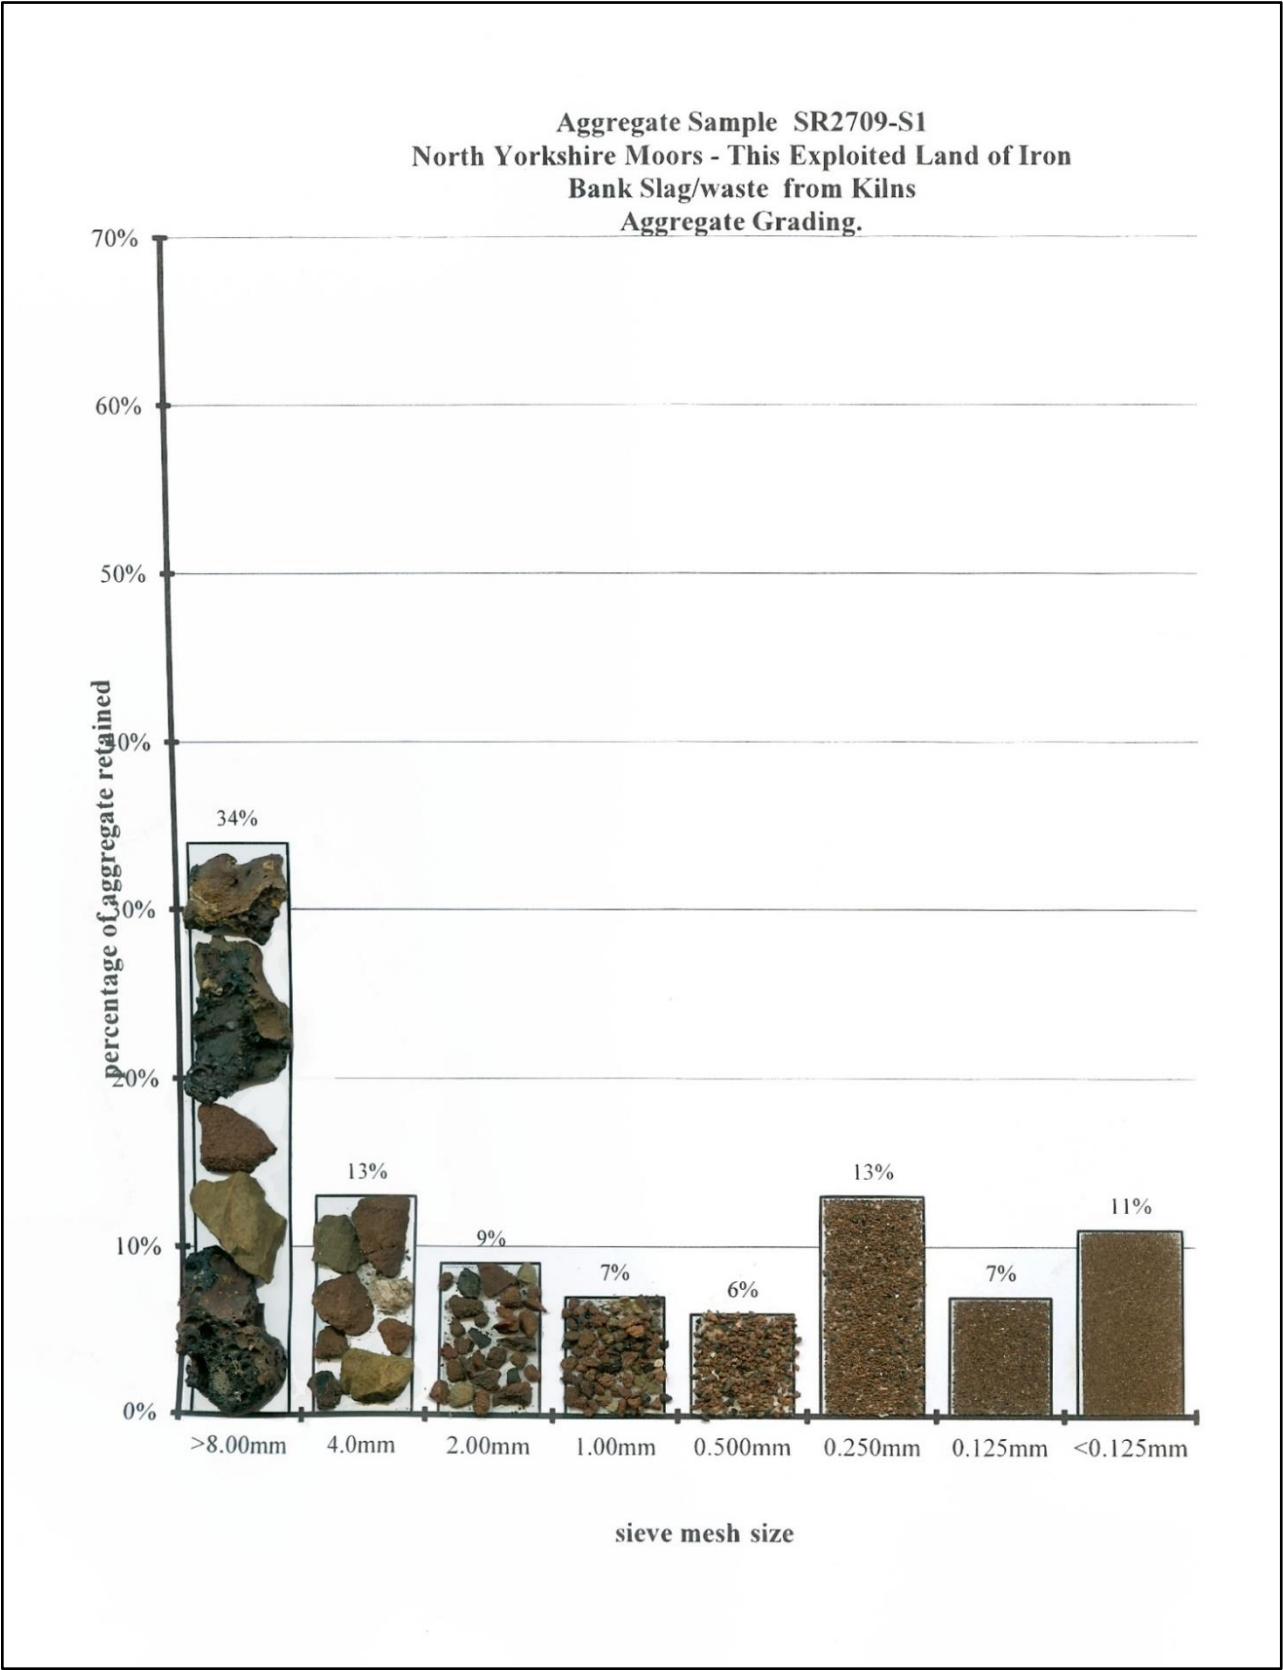
Figure No. 1: Aggregate Grading on Bank Slag sample from Bank Top Kilns.

Sample Reference	SR2709– S1 (BTK-Slag) Bank Slag	
British Standard Sieve Size	Percentage Retained	Percentage Passing
>8.00mm	34.2	65.8
4.00mm	13.1	52.7
2.00mm	9.3	43.4
1.00mm	7.4	36.0
0.500mm	6.2	29.8
0.250mm	12.5	17.3
0.125mm	7.1	10.2
0.063mm	2.5	7.7
Passing	7.7

The results of the grading analysis are presented in the following table and in the form of an aggregate filled histogram, see Figure No. 1 appended to this certificate.

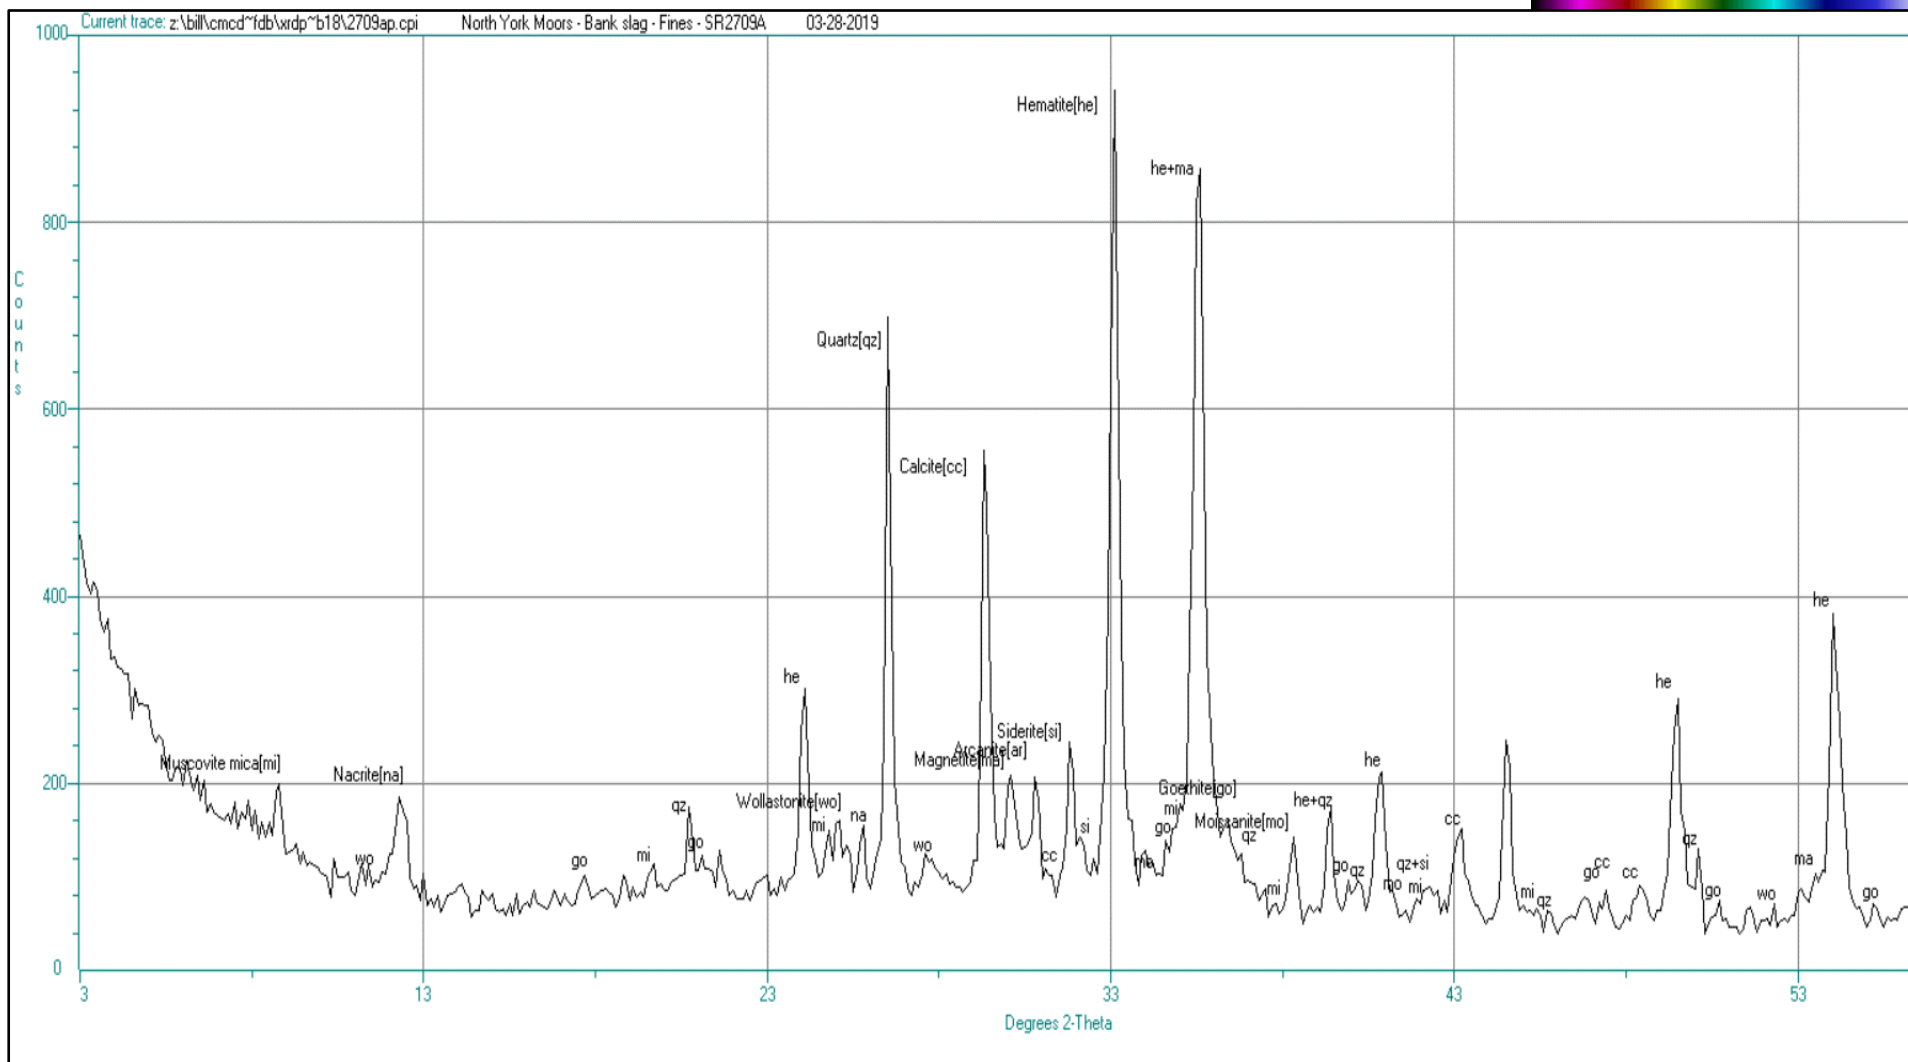
Figure No. 2: SR2709-S1A - Representative sample of the Fines material <0.500mm sieve,

From the XRD analysis, it is indicated that all of the components detected, with the exception of sample “D”, which is a stone sample, are typical of what could be expected to be found in bank slags, with a number of these components being high temperature minerals, i.e. Wollastonite, Mullite, Nacrite and Moissanite. The presence of these along with the high glass (amorphous) content would confirm that there is an abundance of components present that could act as pozzolans in the lime mortars and impart the strength, observed in some of the mortar samples.

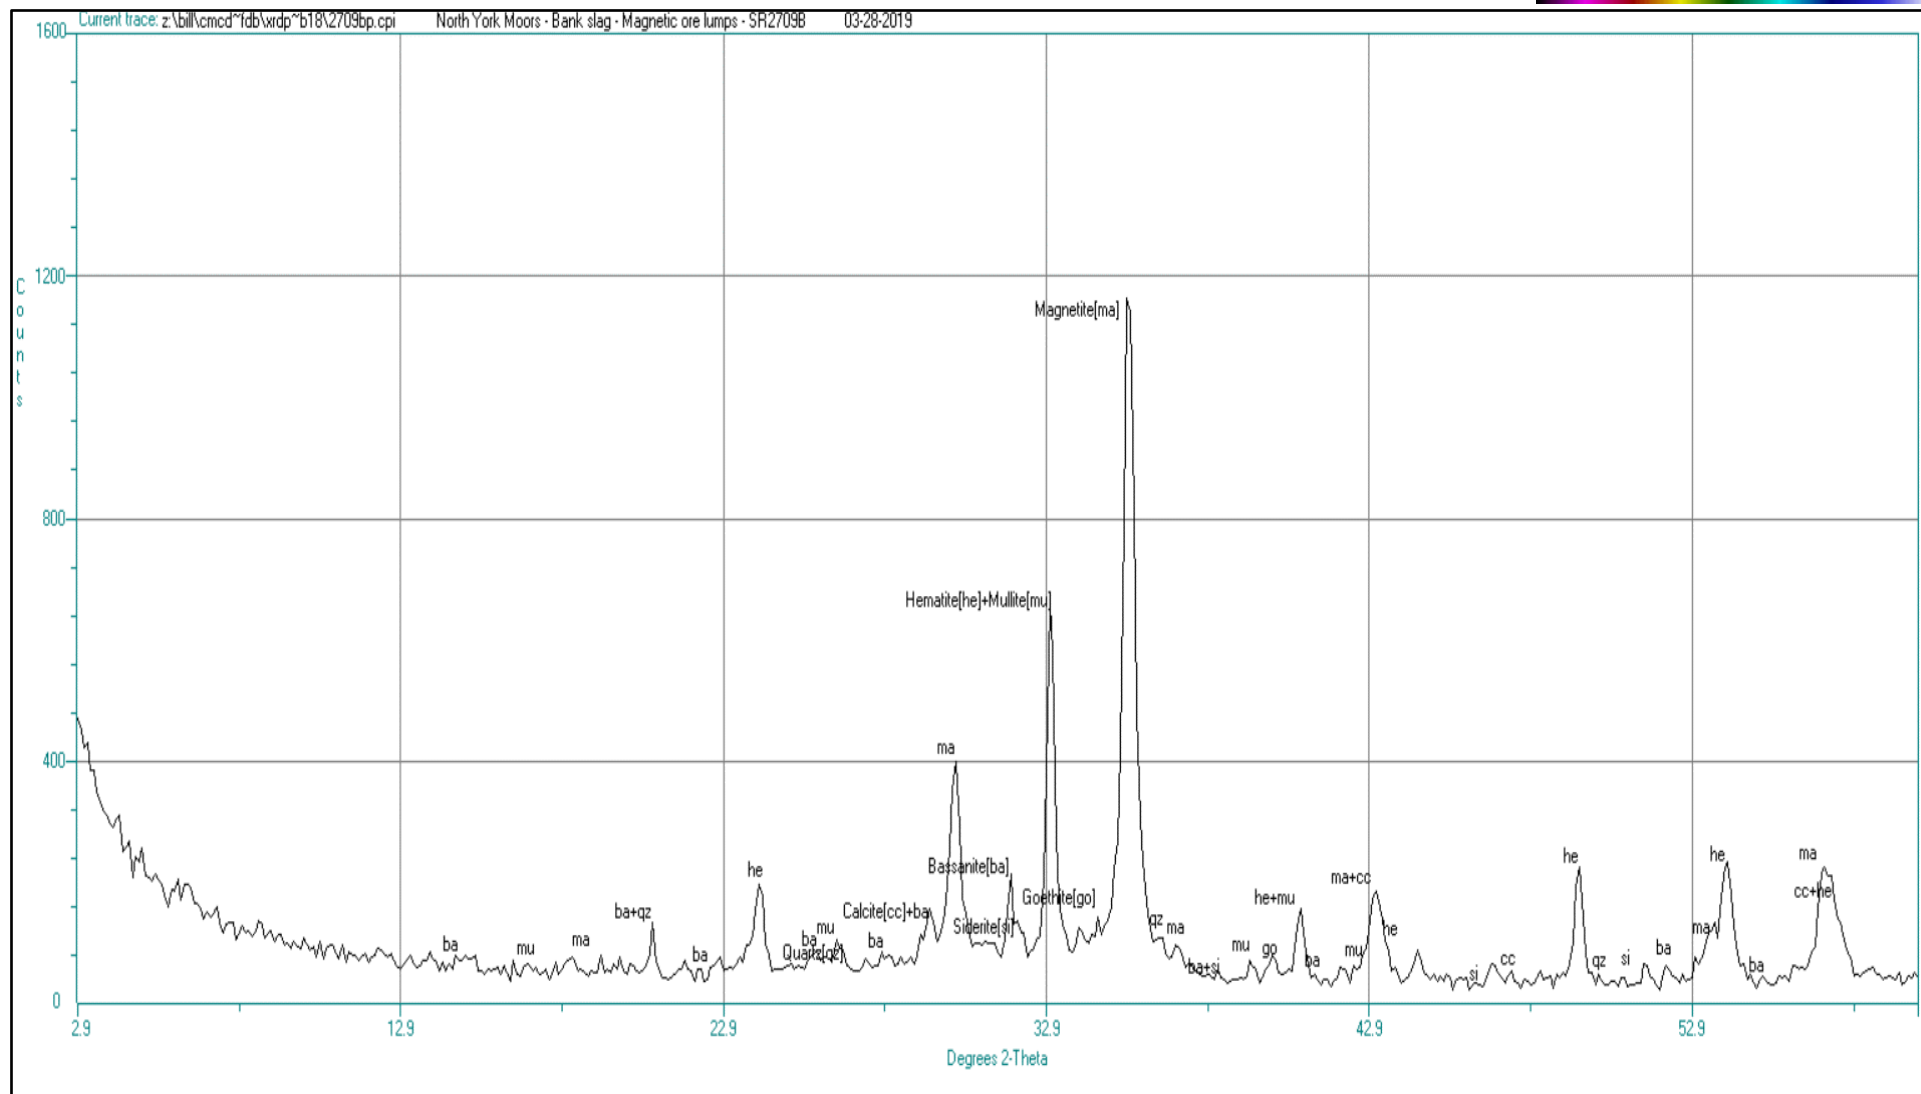
Figure No. 3: SR2709-S1B - Sample of slag – crushed magnetic fragments,

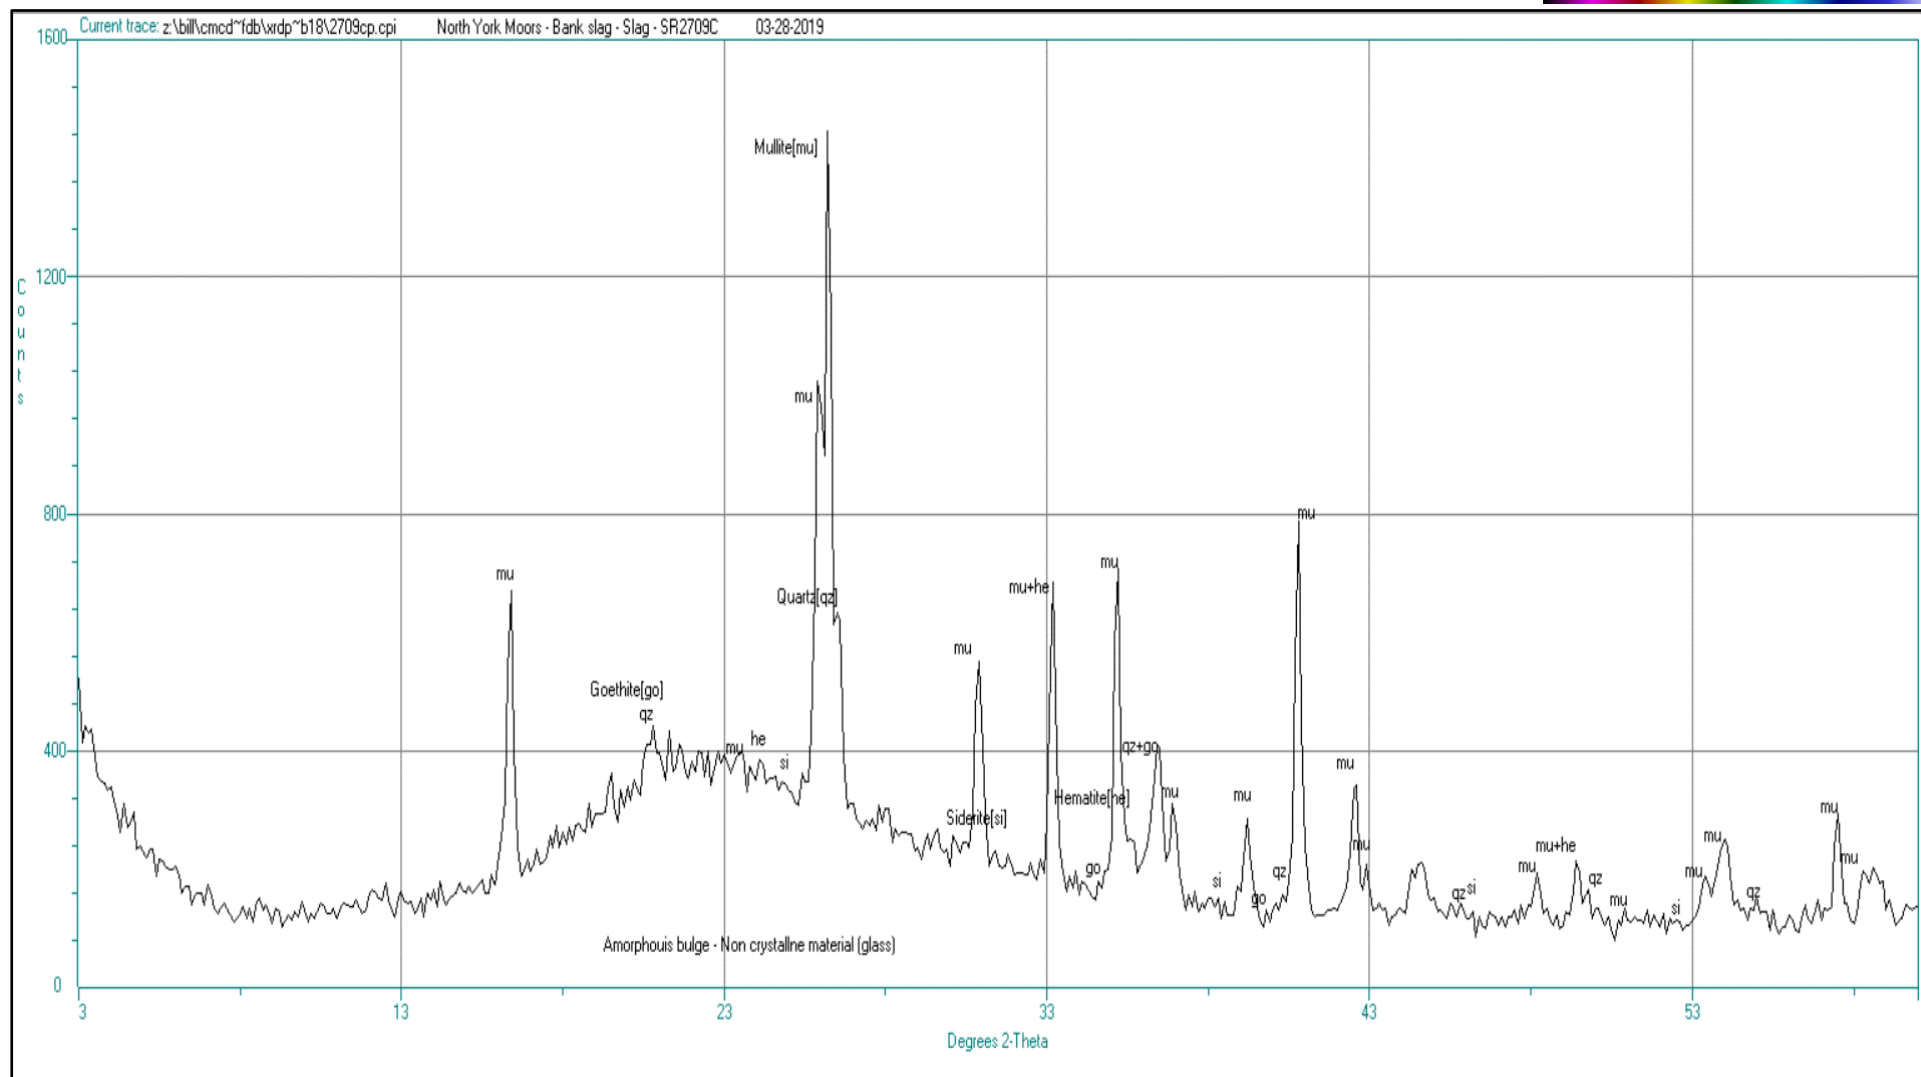
Figure No. 4: SR2709-S1C - Representative sample of the vitreous slag particles,

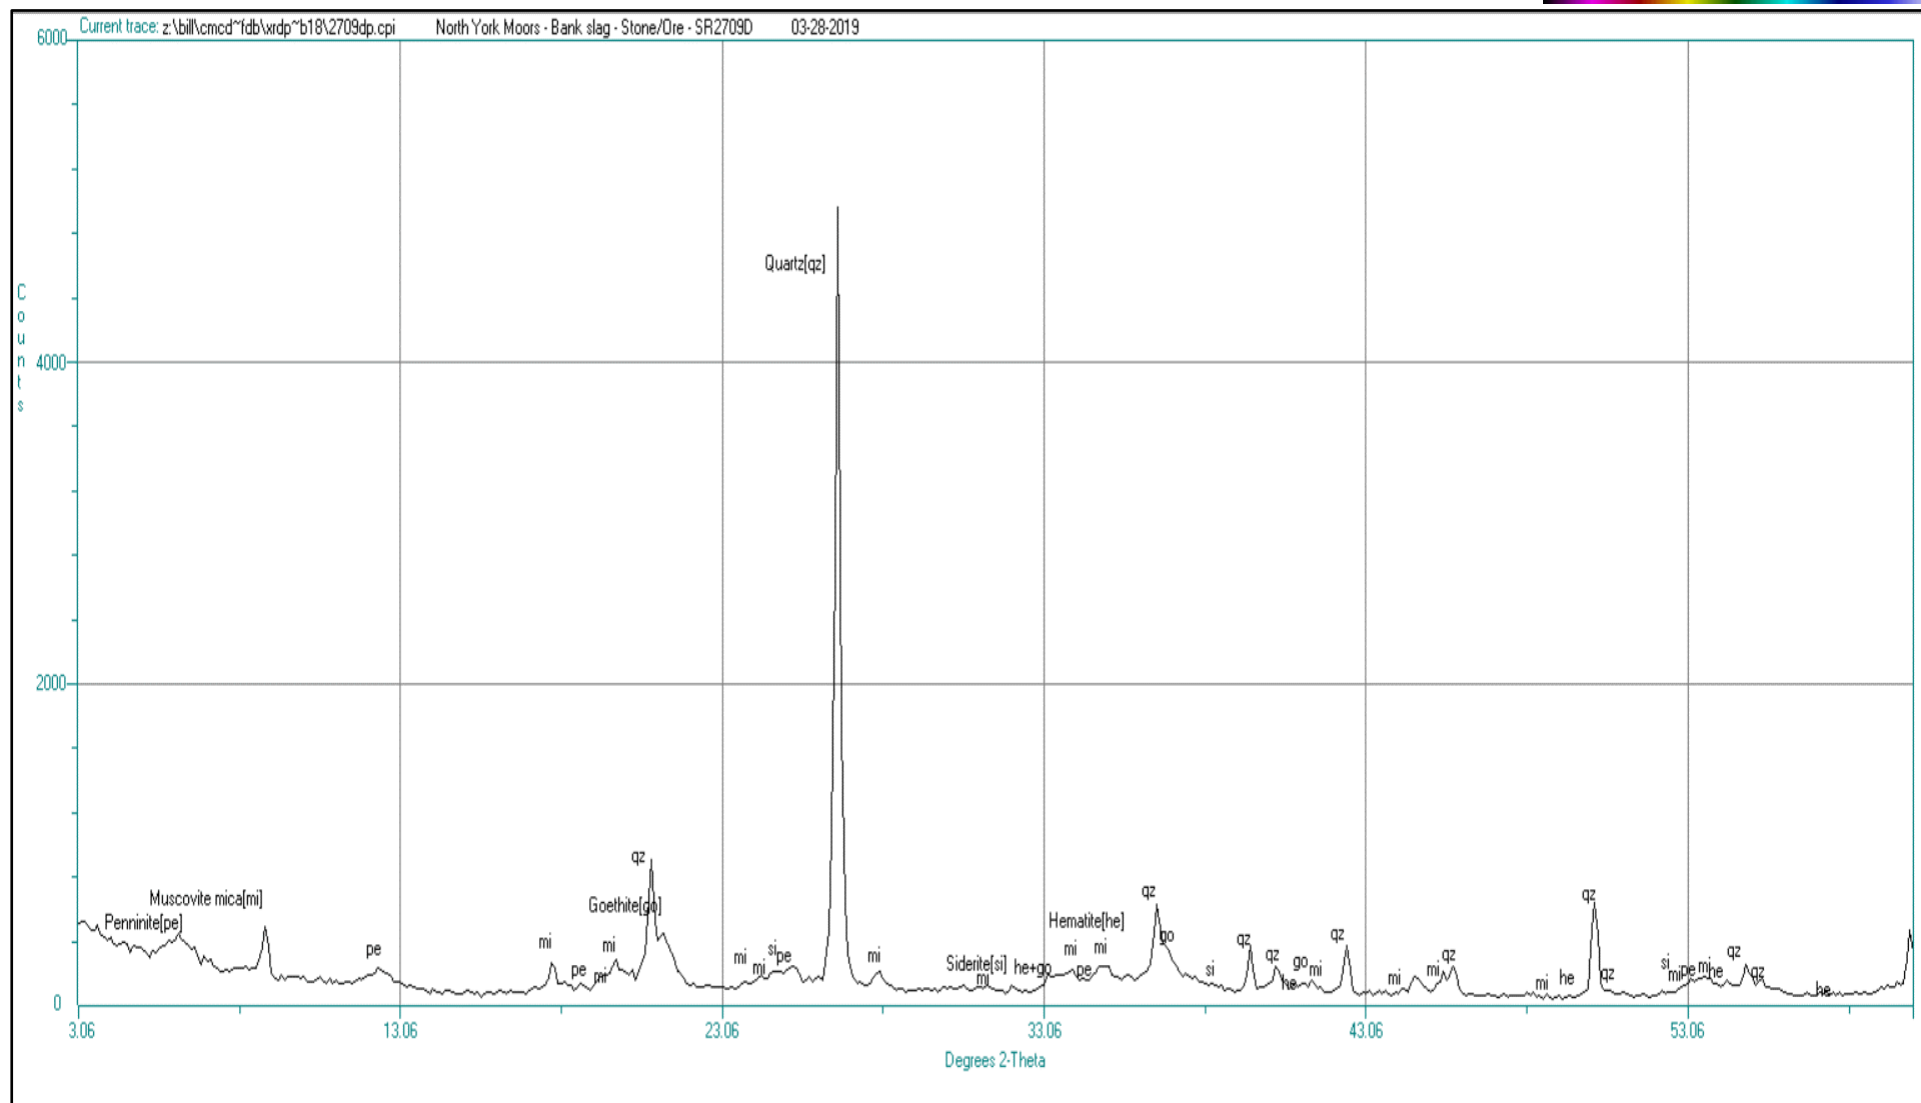
Figure No. 5: SR2709-S1D - Sample of a stone fragment.
