## CERTIFICATE OF ANALYSIS OF MORTAR SAMPLES FOR DETERMINATION OF MIX COMPOSITION & BINDER TYPE

Project Reference	:	North Yorkshire Moors – This Exploited Land of Iron
Sample Location	:	Bank Top Kilns
Sample Description	:	BTK1A – Typical Vault, Stonework mortar sample BTK1B – Typical Vault, Brickwork mortar sample BTK2 – Rear Retaining Wall, masonry mortar BTK3 – Front Wall/Facing, masonry mortar
Date Received	:	12 <sup>th</sup> March 2019
CMC Sample Ref	:	SR 2705 – S1A = BTK1A – Vault, Stonework mortar sample SR 2705 – S1B = BTK1B – Vault, Brickwork mortar sample SR 2705 – S2 = BTK2 – Rear Retaining Wall, masonry mortar SR 2705 – S3 = BTK3 – Front Wall/Facing, masonry mortar
Date Analysed	:	13 <sup>th</sup> March to 26 <sup>th</sup> May 2019
Method of Test	:	Determination of binder type by X-Ray Diffraction analysis. Mix composition by acid digestion with grading analysis of recovered aggregate, and thin section examination.

**Bank Top Kilns**

Examination and Analysis of Mortar samples.

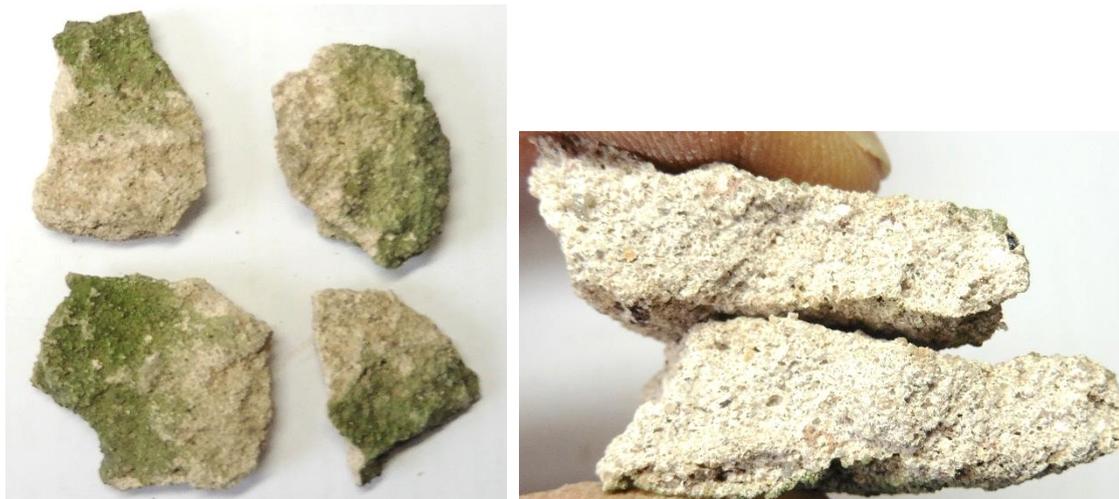
**Plates No. 1 & 2:** The left plate shows the intact pieces of mortar in the sample, as received, with the right plate showing a magnified image of a freshly fractured surface through the thickness of the sample. It was noted that the lime inclusions observed were small and randomly distributed throughout.

From the examination it was indicated that the mortar displayed the characteristics of a non-hydraulic lime mortar, with an abundance of small lime inclusions which are randomly distributed throughout the fabric. The inclusions appearing to have formed from a mixture of unmixed quicklime and fully encapsulated ‘balled’ lime hydrate.

The aggregates appear to be dominated by quartz with minor indeterminate lithic fragments also present, with rare small weathered brick fragments, up to 1.7mm in size, noted along with small slag or clinker fragments. The latter ranging from 0.5mm to 5.4mm in size.

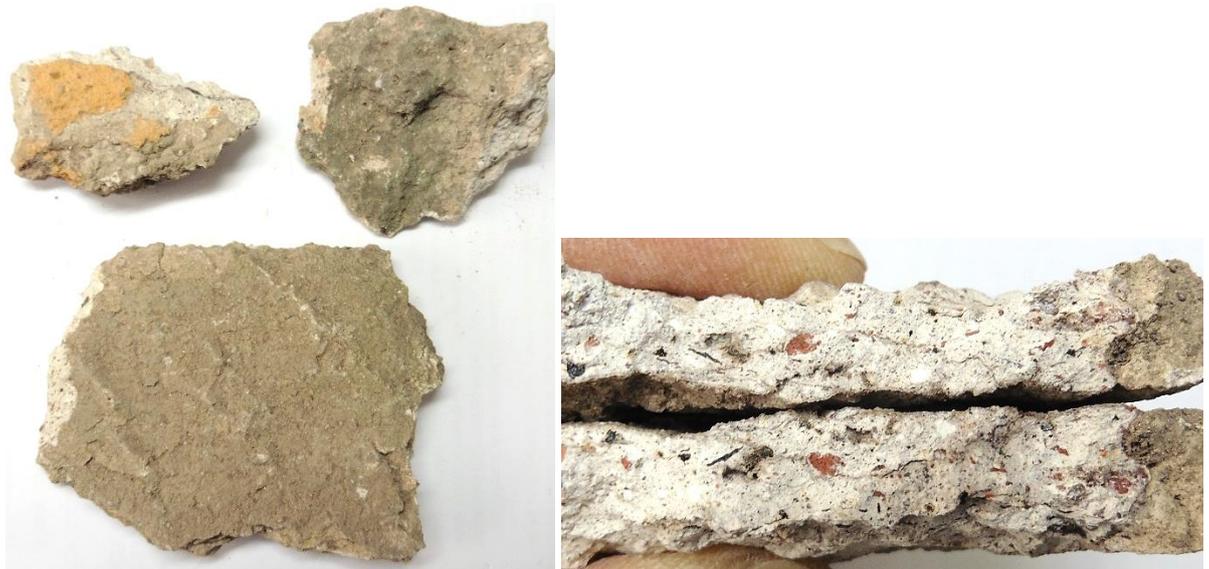
**Plates No. 3 & 4:** The left plate shows the three pieces in the sample received. These all displayed one face that was heavily soiled, with the soiling locally encapsulated with a coating of redeposited calcite. The right plate shows a freshly fractured surface through the thickness of the larger intact fragment, note the presence of an abundance of lime inclusions, with dark slag fragments and red brick fragments distributed throughout the mortar.

On testing freshly fractured surfaces with a phenolphthalein indicator solution, the mortar fragments tested were found to be carbonated throughout their thickness. Water droplets placed onto the outer soiled surfaces were supported for a period prior to being slowly absorbed, whereas, those applied to fractured surfaces were rapidly absorbed and diffused throughout the fabric of the mortar, to depth, indicating a well-connected pore structure within the mortar.

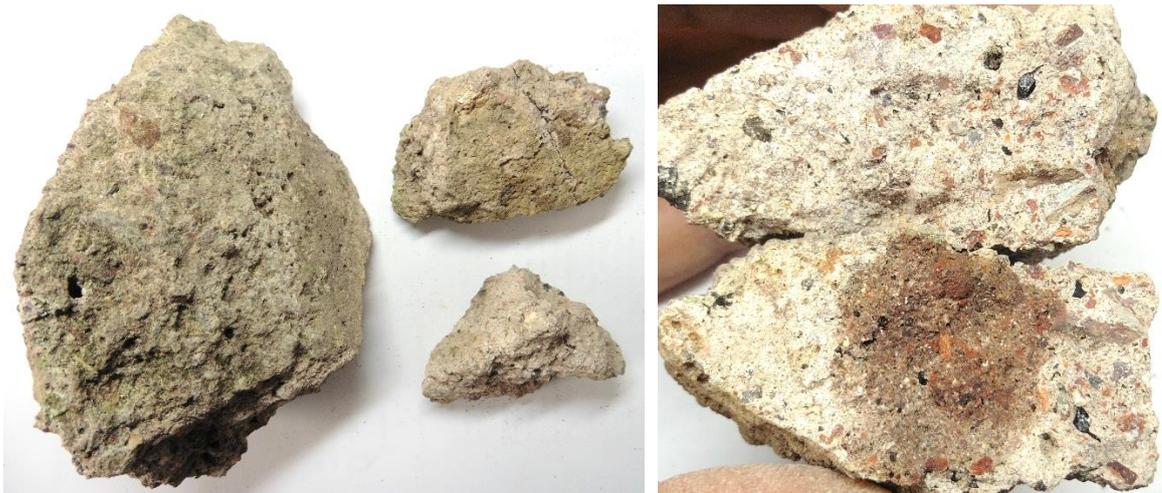
**Plates No. 5 & 6:** The left plate shows the three intact pieces of mortar in the sample, as received. The right plate shows a close-up of a freshly fractured surface, where the dense condition of the fabric can be seen. Note the abundance of small white lime inclusions, randomly distributed throughout. The lower piece is discoloured where it had been tested with the phenolphthalein indicator solution, with no colour observed in the paste, suggesting that the mortar was fully carbonated.

From the water droplet test it was indicated, by placing droplets onto the outer surfaces, that the droplets were supported for an extended period, thereby confirming surface pore blocking in response to soiling and pore blocking due to the presence of redeposited calcite. Whereas, when droplets were placed onto freshly fractured surfaces, these were quickly absorbed, again confirming the presence of a well-connected pore structure within the thickness of the mortar.

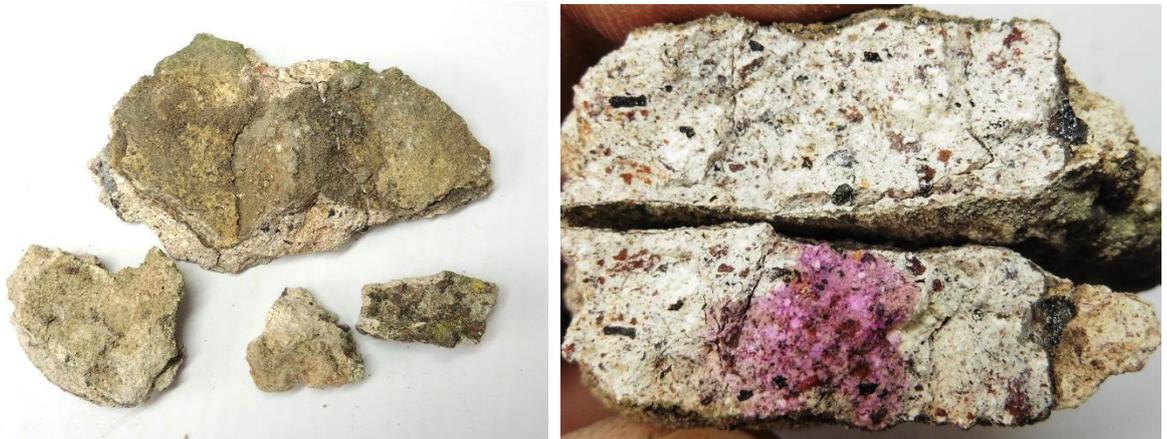
**Plates No. 7 & 8:** The left plate shows the intact pieces of mortar in the sample received. With the right plate showing a close-up of a fractured surface, through the largest intact piece, where the dense condition of the fabric is seen, along with an abundant of lime inclusions. The lower fragment is shown after testing with a phenolphthalein indicator, note pink colour.

The above right image shows that on testing a freshly fractured surface with a phenolphthalein indicator solution, the mortar was found to be only partially carbonated, with the carbonation being invasive from the outer surfaces whilst within the centre of the largest fragment it was noted to be patchy. This may infer that the mortar was maintained in a damp condition over most of its service life, the presence of a prolonged high moisture content inhibiting carbonation.

It was noted from the water droplet test that droplets placed onto the outer surfaces were supported for an extended period, whereas those applied to sawn and fractured surfaces were quickly absorbed. This indicated that the mortar had a well connected pore structure and that water vapour could migrate through the mortar, with the low porosity demonstrated by the outer surfaces being due to the sealing of the outer, soiled, surfaces with redeposited calcite, again inferring that the masonry had been affected by water percolation over time.

On examination of the fractured surfaces an abundance of white lime inclusions were observed, with these measuring up to 5.8mm in size. The inclusions are angular to sub-round in shape and have the appearance of being formed from quicklime.

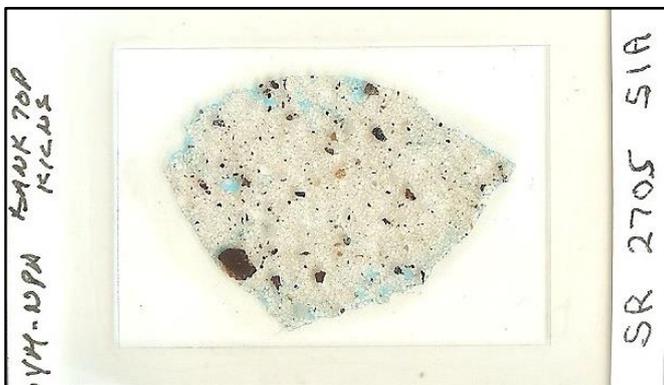
**Plate No. 9:**

Thin section prepared from mortar sample SR2705-S1A (BTK1A).

The coal fragments appear fresh with no evidence of them having been burnt and it is most likely that the coal is a component of the aggregate and not a contaminant from the lime kiln, added to the mortar with the lime.

The aggregates are sub-angular to sub-round in shape, and all show evidence of water worn surfaces. The aggregates are similar in appearance to those observed in lime mortars samples submitted from other structures sampled as part of this programme, and therefore may be from a source local to the kilns.

The natural aggregates range in size from <0.01mm to 1.2mm (very fine silt/clay to coarse sand) in the section examined, with coal fragments up to 3.4mm in size. The presence of the clay or fine silt materials observed within the sample would infer that aggregate was probably used in the as-dug condition, rather than having been washed and processed.

The binder is a non-hydraulic lime, with the presence, and abundance, of lime inclusions observed suggesting that the mortar had been mixed as a hot mixed mortar (HMM).

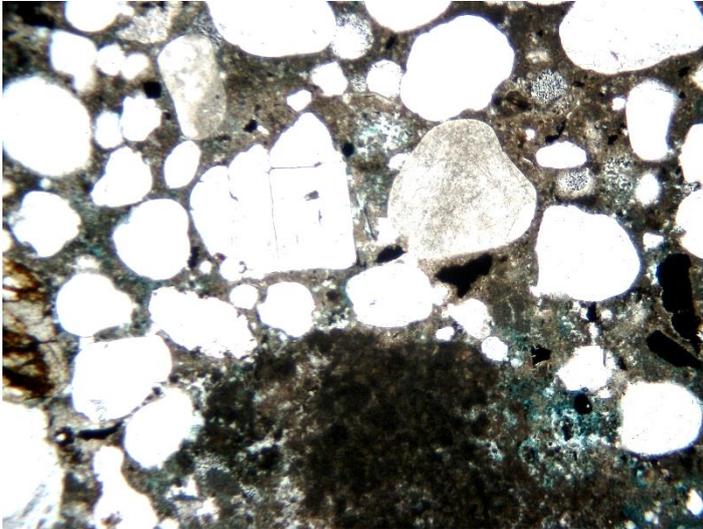
**Plate No. 10:**

A view in plane polarised light (ppl) showing a typical area of the mortar, with a partially hydrated inclusion seen in the lower centre of the plate. The paste is dense and fully carbonated, with no evidence of hydraulic clinker observed within the section. The aggregates are dominated by quartz, white and grey in this view, with minor lithic grains. The opaque particles (black in image) are coal with the localised clusters of fine material being ash particles.

Porosity is highlighted by the blue dyed resin. Field of view 2.4mm.

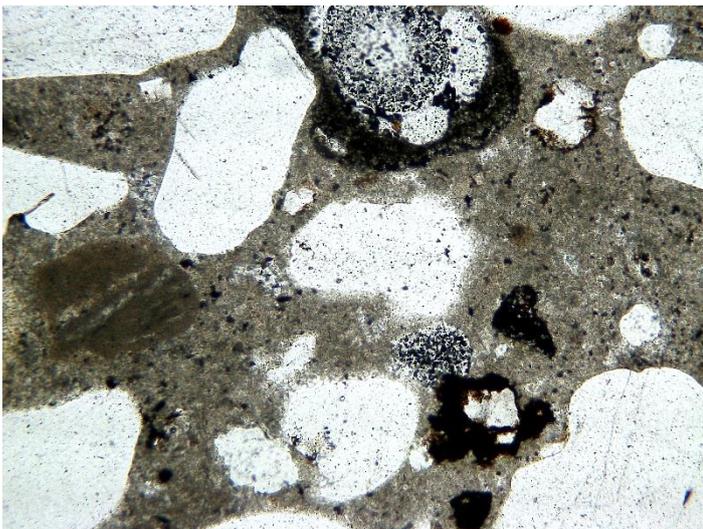
**Plate No. 11:**

A magnified view in ppl, of an area of paste where two inclusions can be seen, centre left and upper centre. That in the top part of the plate is heavily depleted, with that in the left being sub-angular in shape and retaining an imprint of the relic rock fabric. The paste is dense and fully carbonated, with localised evidence of leaching, with minor fringes of redeposited fine calcite observed lining the perimeter of voids, see void in the centre and lower centre. Aggregates in view are mostly quartz, with minor lithic grains and opaque minerals.

Porosity and voids are highlighted by the blue dyed resin. Field of view 1.2mm.

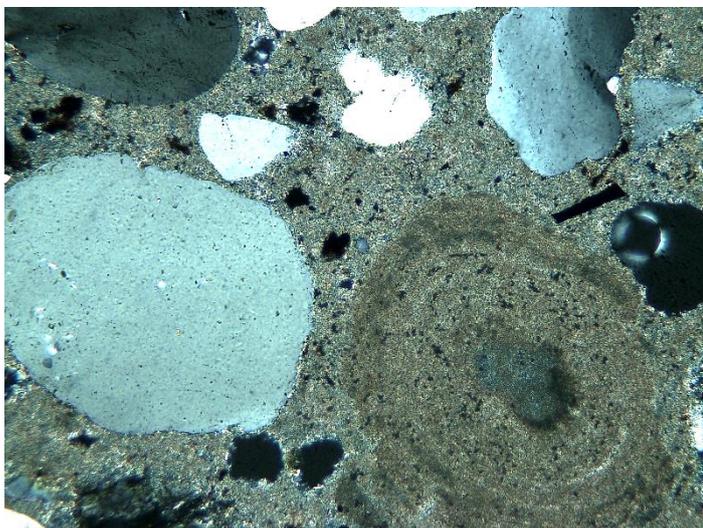
**Plate No. 12:**

A view in cross polarised light (xpl), of an area of dense fully carbonated paste. A rounded lime inclusion can be seen in the lower right, Aggregates in view consist of quartz grains, with minor opaque minerals.

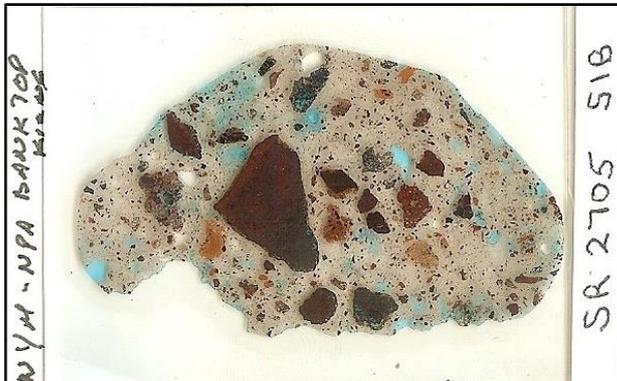
**Plate No. 13:**

Thin section was prepared from the intact piece of mortar in sample SR2705-S1B (BTK1B).

This mortar sample differs totally from the mortar in sample S1A (BTK1A), in that the particles observed are dominated by opaque minerals which were observed to be composed of coal, ash clinker (partially burnt coal), ironstone with small weathered brick fragments.

The processed material was observed in the thin section mostly in the form of opaque particles, with these dominated by coal fragments which contained a significant proportion partially burnt coal, along with coal ash, slag and brick fragments.

The presence of the slag and ash will have resulted in the mix having a high pozzolan content. With this reacting with the lime binder imparting the strength noted the mortar received. The brick fragments are too large to have been added as a pozzolan and are most likely contaminants in the waste from the kiln lining, or as waste materials from the construction.

The paste in this sample is generally dense, though locally patchy, with evidence of leaching of lime from inclusions and paste. A proportion of the lime inclusions present have formed from incompletely slaked non-hydraulic quicklime, with both a low abundance of over and under burnt limestone fragments also observed. This presence of slaked and incompletely slaked, but incompletely mixed inclusions would infer that the mortar had been mixed as a Hot Mixed Mortar (HMM), though not necessarily placed whilst hot.

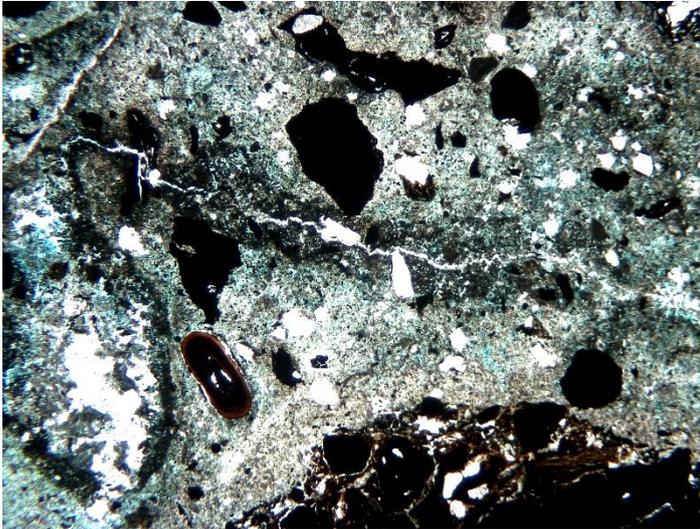
**Plate No. 14:**

A view in plane polarised light (ppl) of a typical area of the mortar. This shows the dense fabric with alteration of paste adjacent to crack paths, most marked across the centre of the plate. The aggregates in view are a combination of coal, ironstone and slag, with an abundance of ash particles in the upper right and left of centre. Minor quartz grains (white in plate) are also apparent. A partially depleted lime inclusion can be seen in the lower left side of the plate. Cracks are typical of shrinkage cracks, with evidence of water migration along the centre crack.

Porosity is highlighted by the blue dyed resin. Field of view 2.4mm.

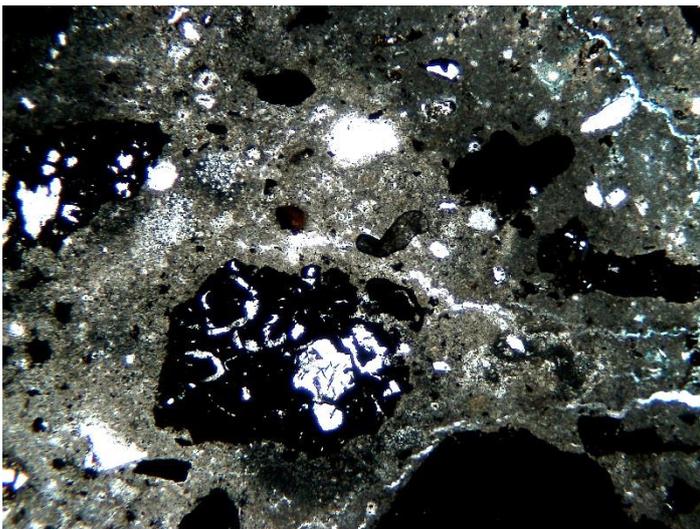
**Plate No. 15:**

A magnified view in ppl of an ash and slag rich area of fabric. An ironstone fragment can be seen in the lower centre. The paste is dense throughout, with patchy microporosity apparent, and is transected by a number of fine shrinkage cracks. Ash and fine slag particles show evidence of having reacted with the paste, most noticeable, upper left and upper and lower centre in plate. The cracks in view are mostly free of secondary minerals, although small voids are rimmed with redeposited coarse calcite. Porosity and voids are highlighted by the blue dyed resin. Field of view 1.2mm.

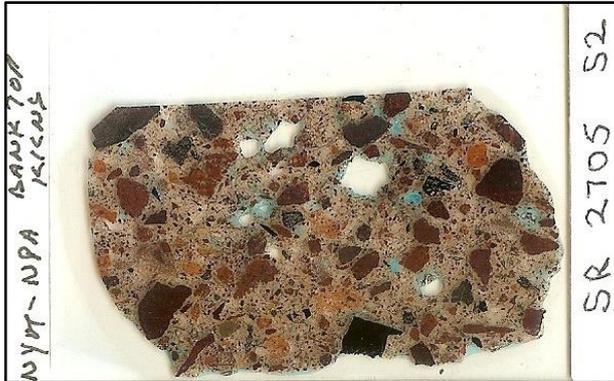
**Plate No. 17:**

This thin section was prepared from an intact piece of mortar from sample SR2705-S2 (BTK2).

The aggregates are dominated by angular to sub-angular and locally irregular shaped particles and the maximum size of the aggregate is 8.0mm but mostly finer than 2mm down to <0.02mm (medium silt to very coarse sand). The presence of an abundance of silt sized grains observed is consistent with aggregates being dominated by ash and crushed, or ground, coal clinker and slag.

The paste in this sample is patchy, ranging from localised zones that are particularly dense with these most apparent adjacent to lime inclusions, suggesting that the mix had been mixed and placed as a Hot Mixed Mortar (HMM), and still expanding. Outwith these zones the paste is microporous and adjacent to crack paths, is locally depleted. Although most of the inclusions observed in the section are fully slaked, there is a significant proportion where the lime in the inclusion had not diffused into the paste, and these have therefore performed as aggregates in the mortar. From an examination of the lime inclusions, some of which retained a faint imprint of the original rock fabric, it is indicated that the source of the lime was a calcium limestone, displaying micritic and bioclastic forms. No Dolomitic limestone was detected in the sample examined.

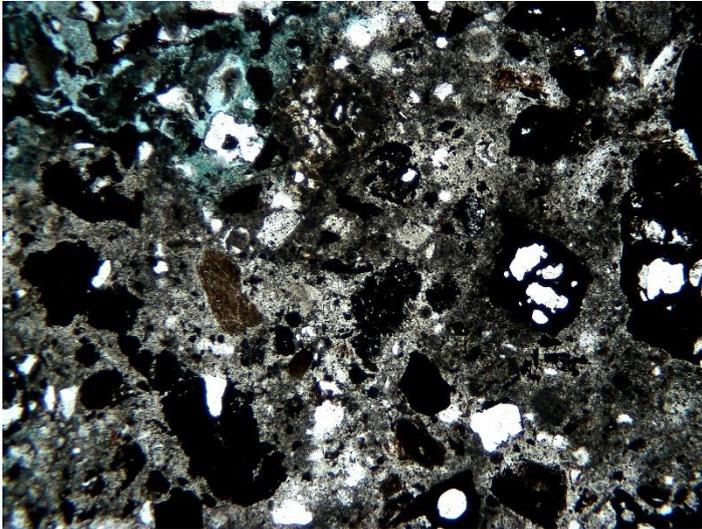
**Plate No. 18:**

Very fine shrinkage cracks are apparent, upper left, lower centre.

Porosity is highlighted by the blue dyed resin. Field of view 2.4mm.

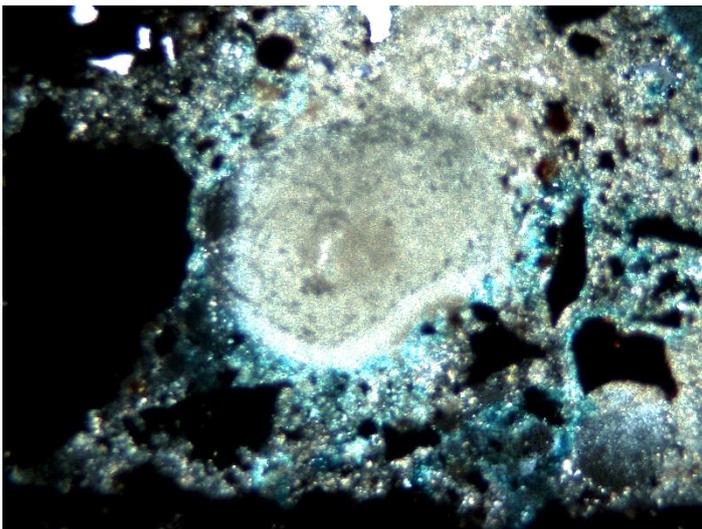
**Plate No. 19:**

Porosity, the blue impregnating resin and opaque minerals all appear black in xpl. Field of view 2.4mm.

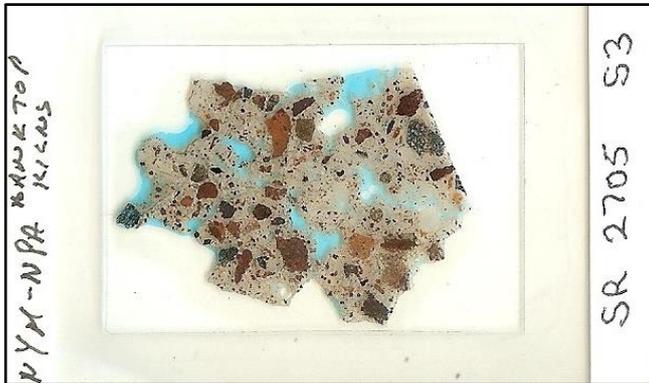
**Plate No. 21:**

The condition of the fabric and the evidence of delayed expansion, with subsequent shrinkage would infer that this mortar had been both mixed and placed as a hot mixed mortar (HMM).

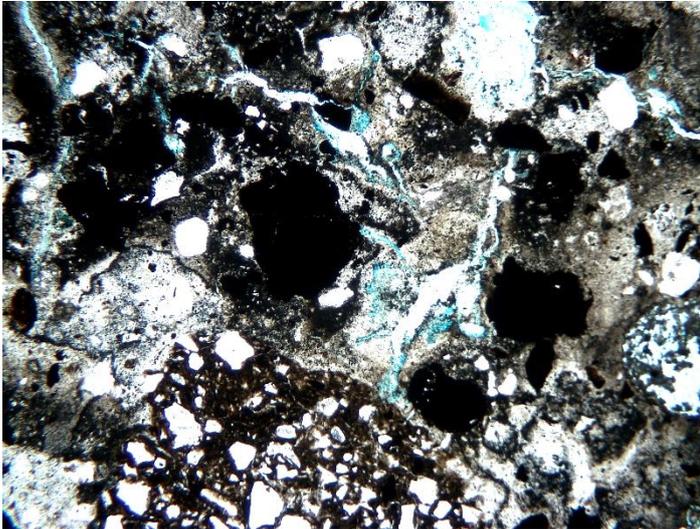
**Plate No. 22:**

Porosity is highlighted by the blue dyed resin. Field of view 2.4mm.

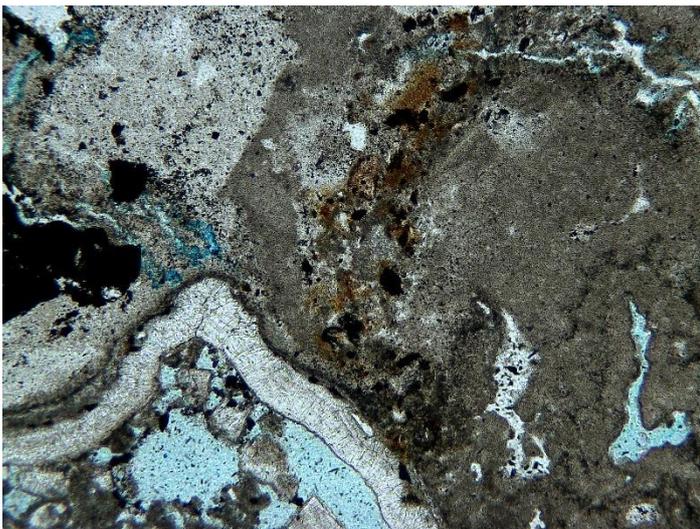
**Plate No. 23:**

Porosity and voids are highlighted by the blue dyed resin. Field of view 1.2mm.

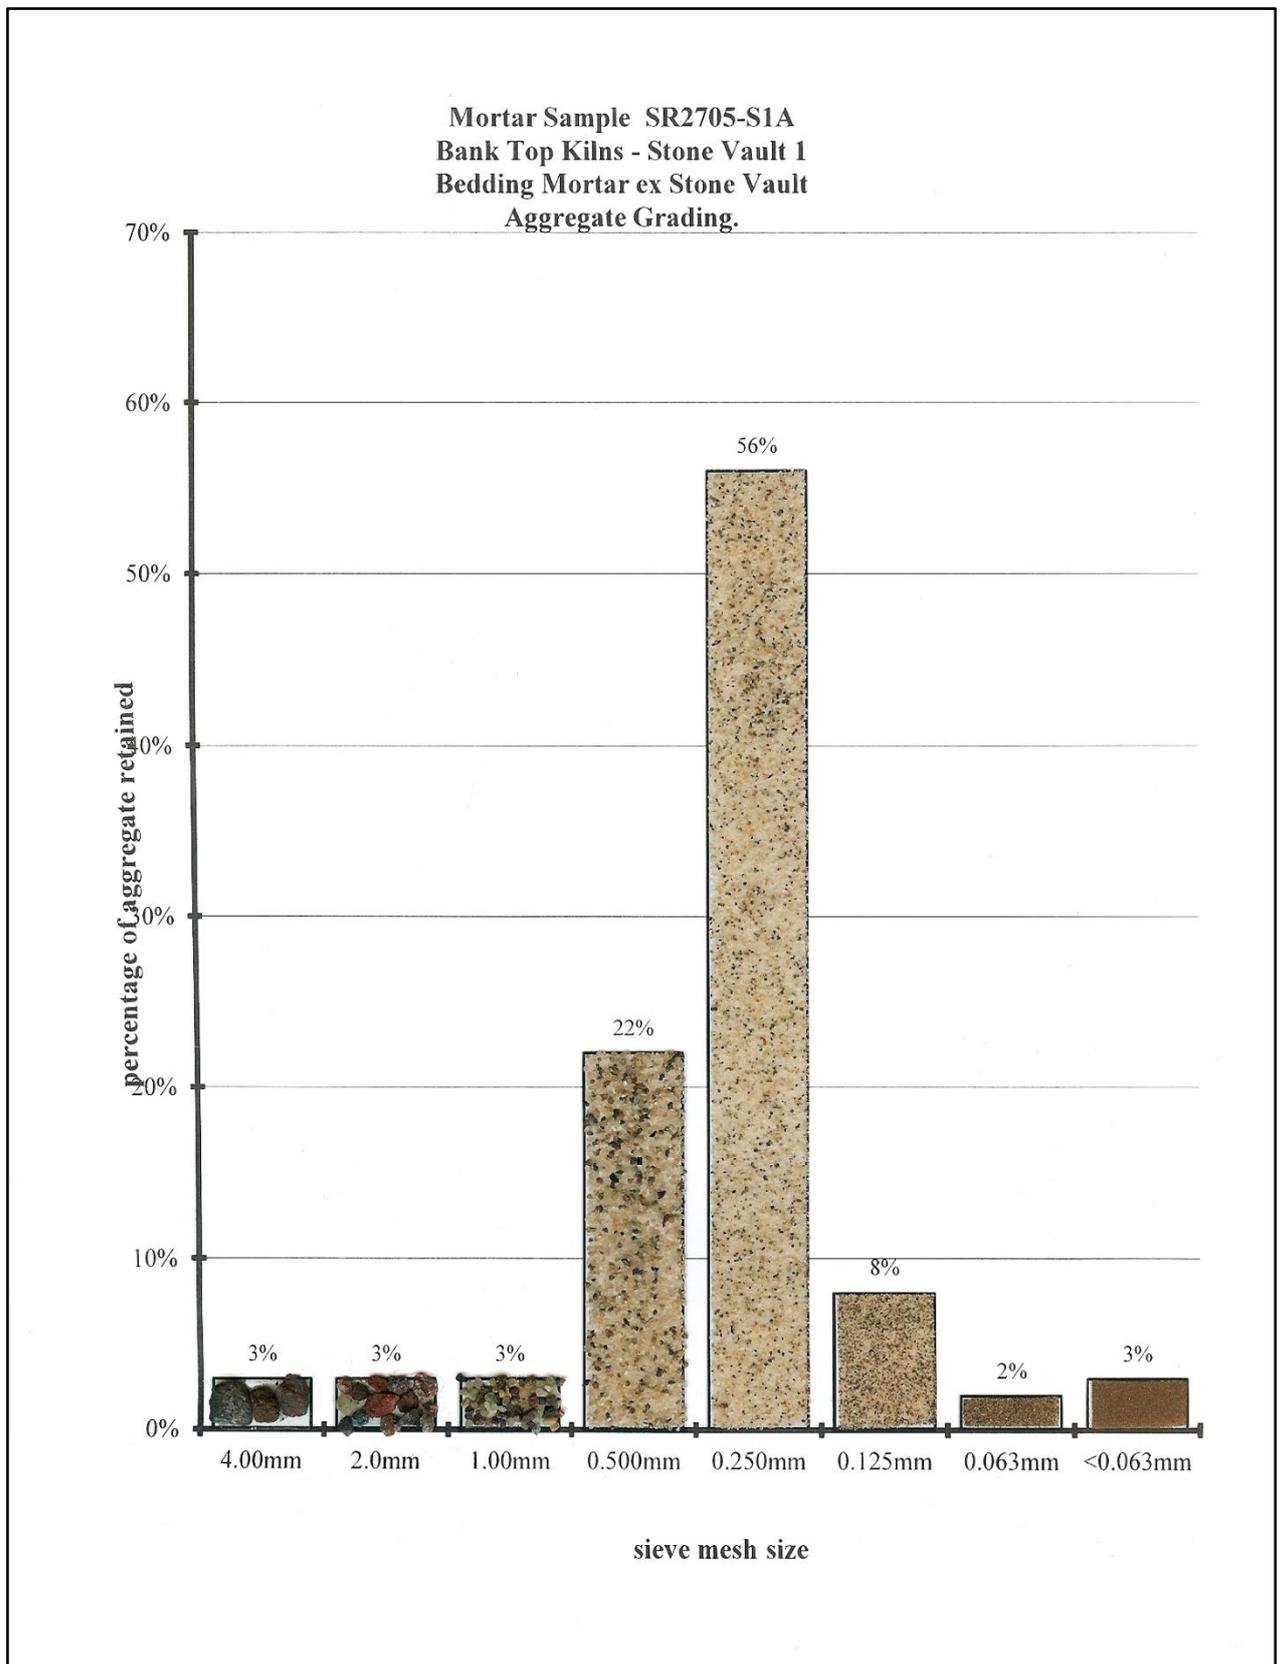
**Figure No. 1:** Aggregate Grading on Aggregate recovered from sample BTK1A.

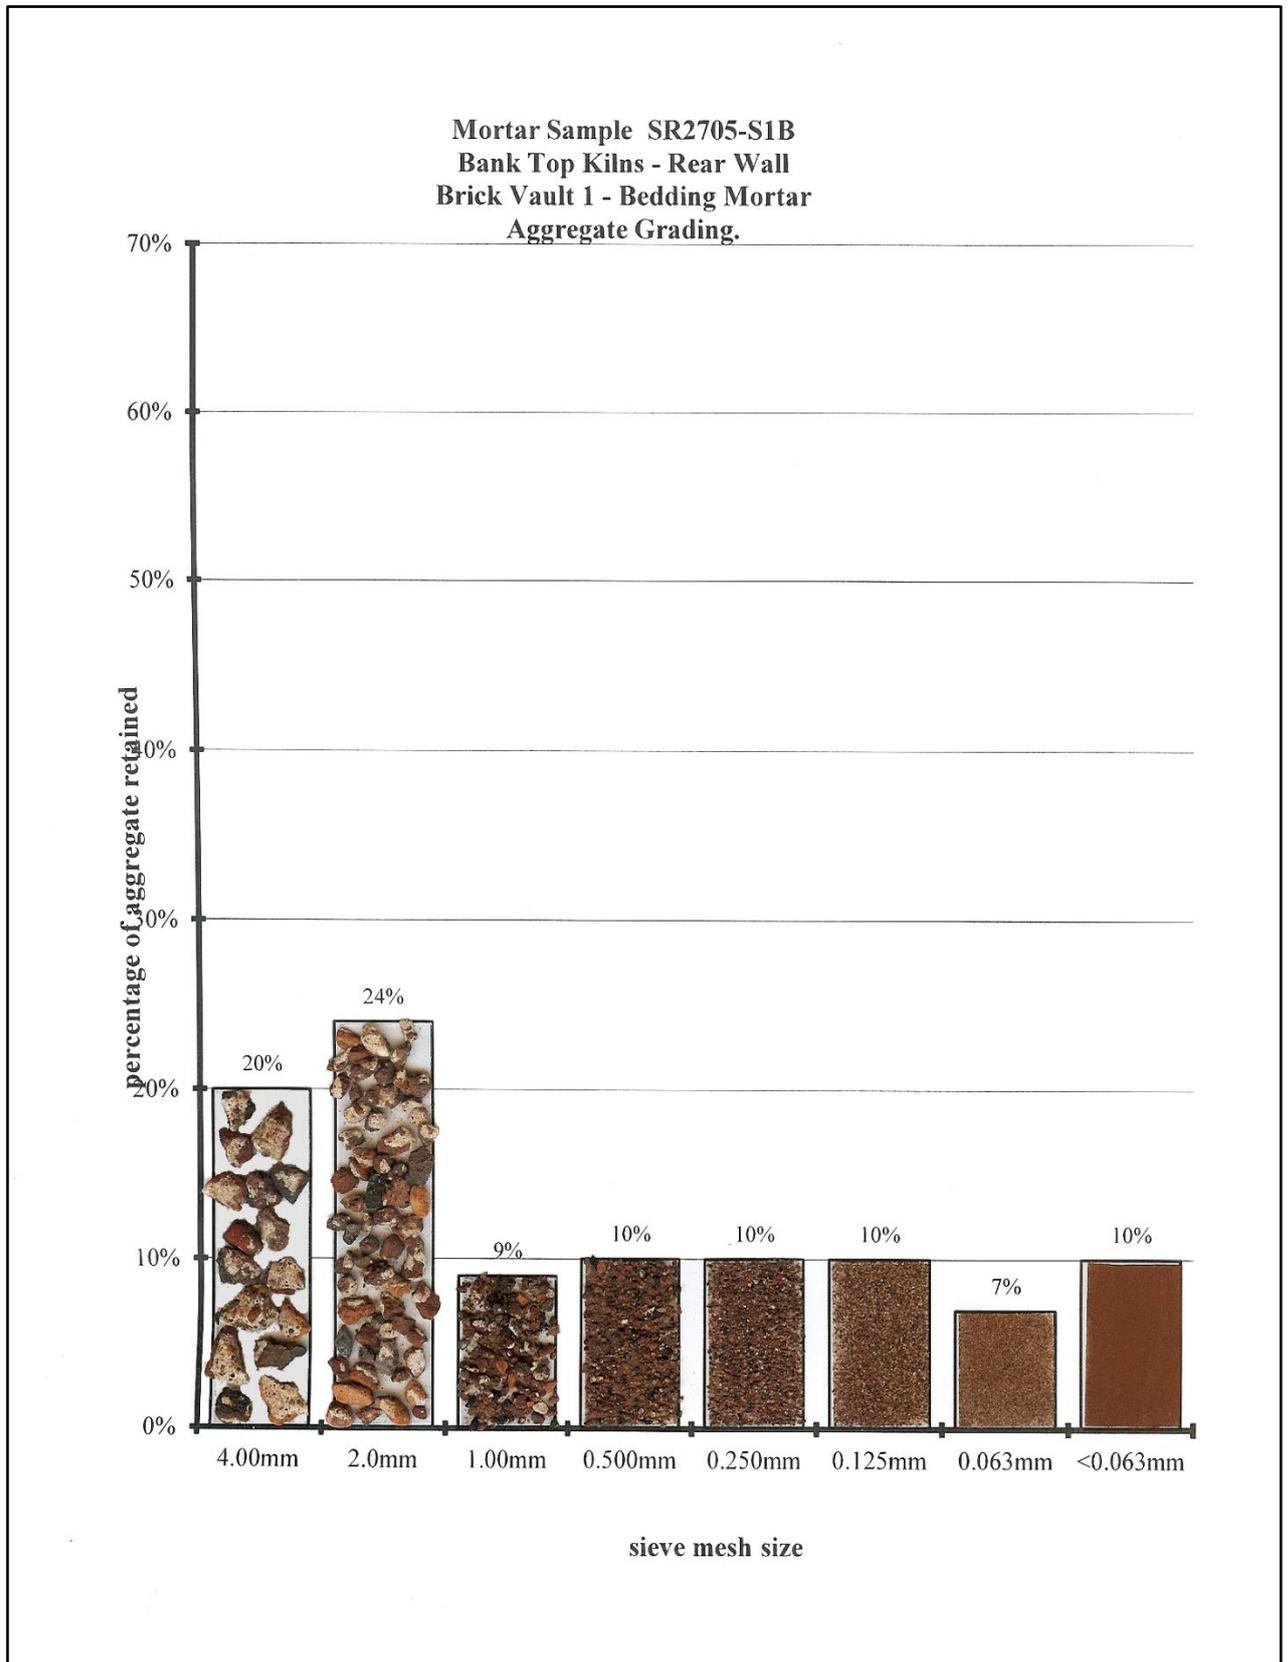
**Figure No. 2:** Aggregate Grading on Aggregate recovered from sample BTK1B.

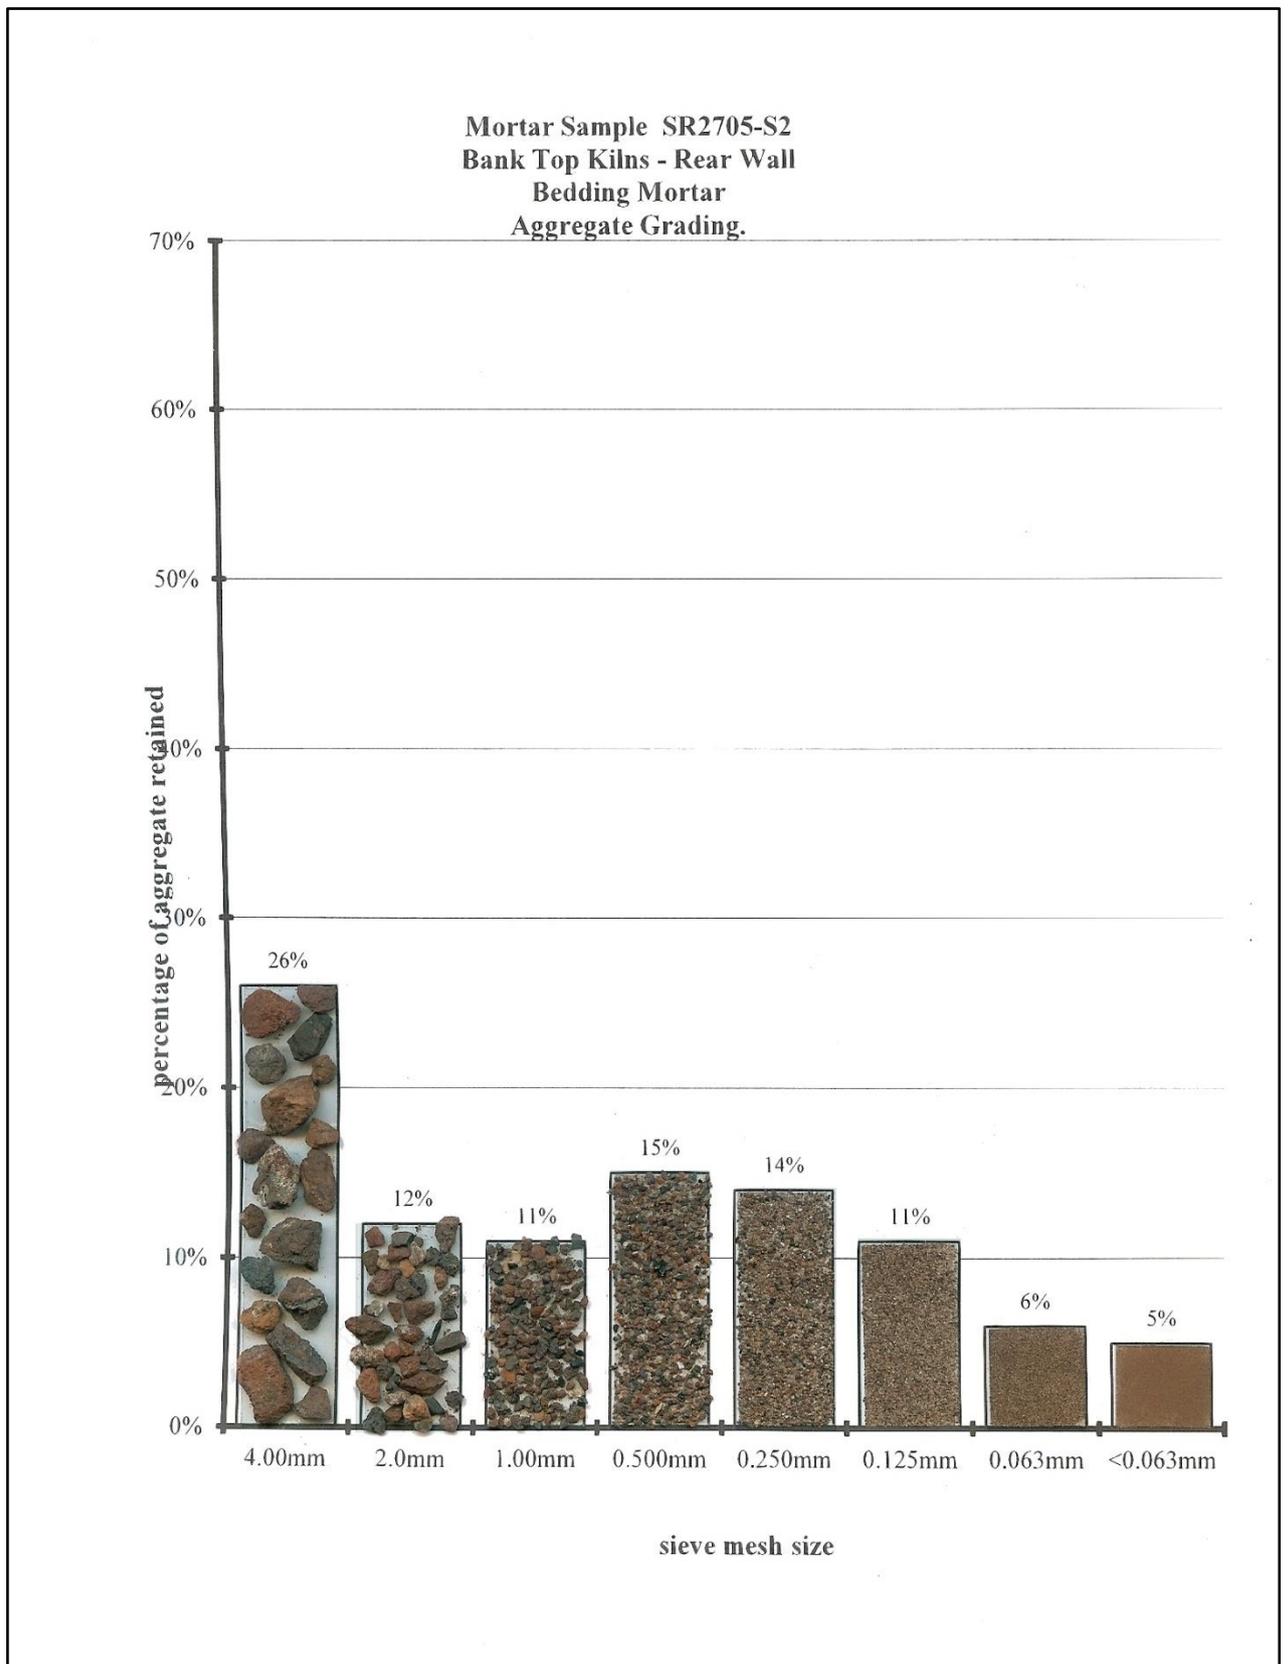
**Figure No. 3** – Aggregate Grading on Aggregate recovered from sample BTK2.

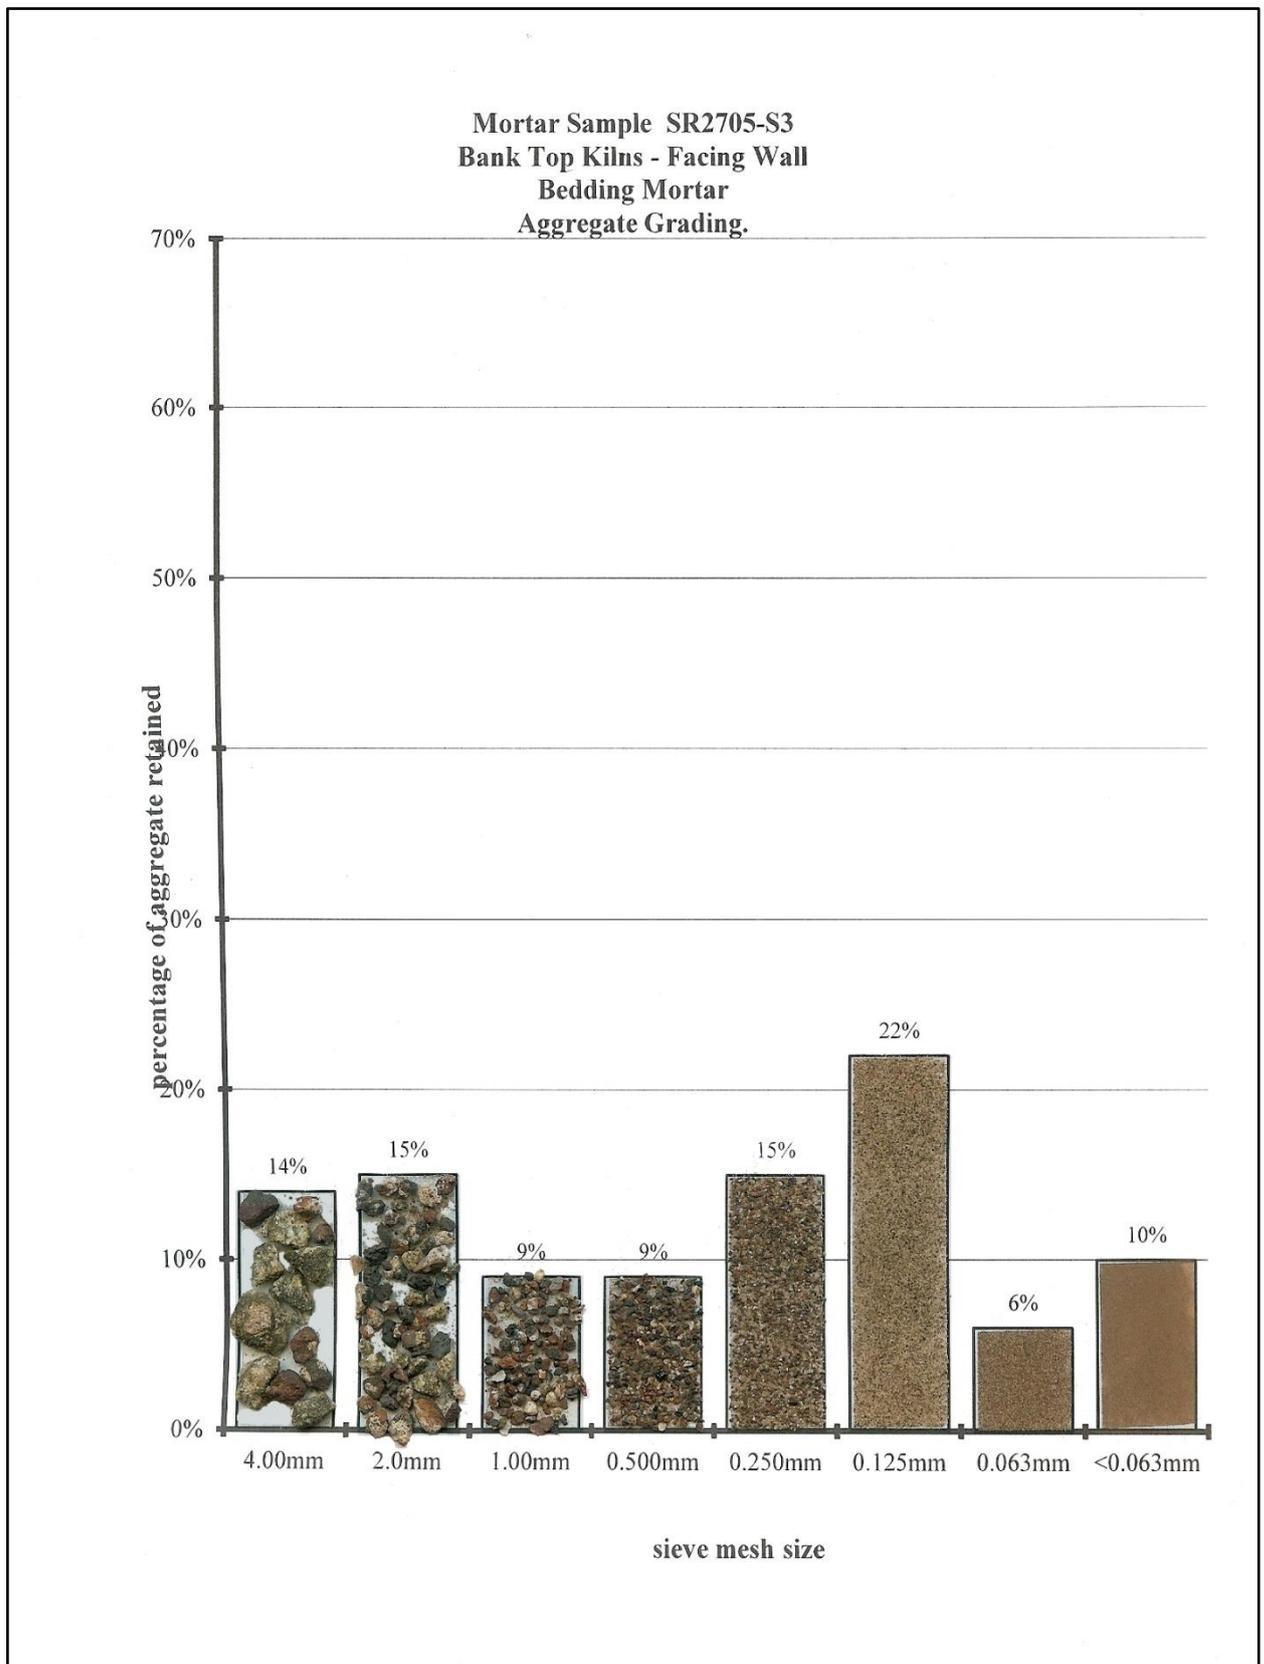
**Figure No. 4** – Aggregate Grading on Aggregate recovered from sample BTK3.
