CERTIFICATE OF ANALYSIS OF A MORTAR SAMPLE FOR DETERMINATION OF MIX COMPOSITION & GRADING ANALYSIS

Project Reference	:	Clay Mortar from Normandy
Sample Description	:	T/F Infill
Date Received	:	29 th August 2018
CMC Sample Ref	:	SR 2621 – S1
Date Analysed	:	11 th to 13 th September and 9 th & 10 th October 2018
Method of Test	:	Mix composition with grading of recovered aggregate Binder type Identification by X-Ray Diffraction, with quantification analysis and thin section examination following standard petrographic procedures.

Earth, Stone & lime Company.
Clay Mortar from Normandy
Examination and Analysis of a Mortar sample.

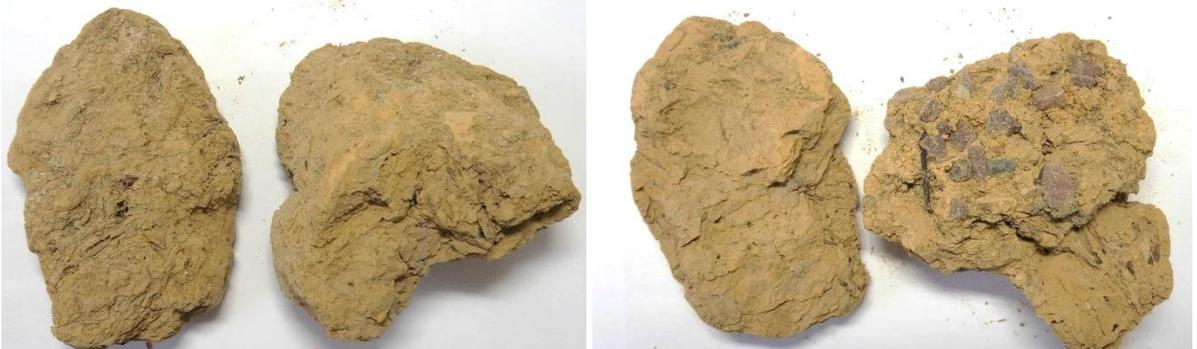
Plates No. 1 & 2: The above plates show the intact pieces of mortar as received, with the left plate showing one of the larger surfaces of the intact pieces, with the right plate showing the opposite face. Note the presence of a crushed aggregate chips in the surface of one fragment (right piece).

The sample received consisted of two large pieces of a well bound clay mortar and a small quantity of loose fines.

The mortar was well compacted but relatively soft and the intact pieces could be broken under light finger pressure and once disrupted the mortar was very easily powdered. The mortar in both pieces, although well compacted, was noted to contain an abundance of irregular shaped voids, which have the appearance of placing artefacts, due to air entrapped within the mortar as it was placed, and from subsequent drying.

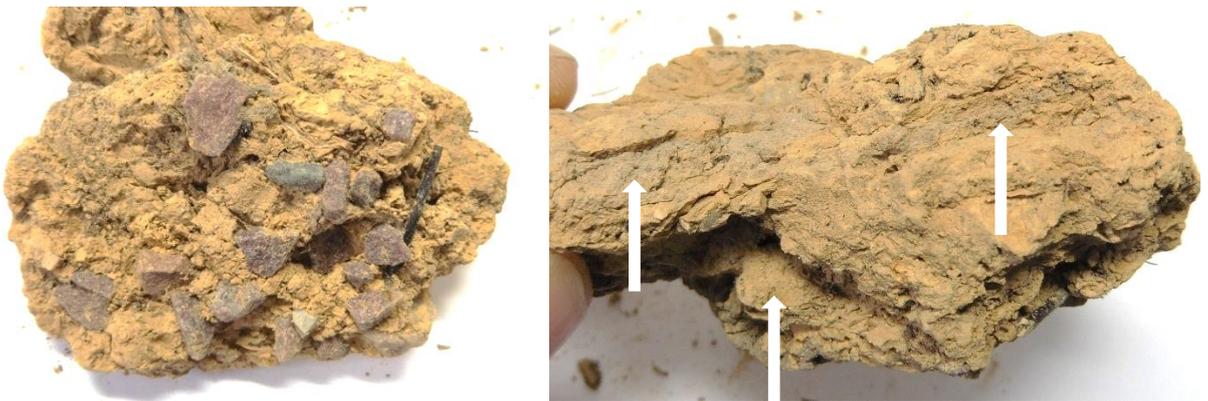
Plates No. 3 & 4: The left plate shows a close-up of the aggregate embedded in the surface of one of the pieces, with the aggregate appearing to be a crushed pink granite chip. The right plate shows a fractured edge where sandy lenses can be seen within the thickness of the mortar, these are more grey in colour, arrowed in the plate.

The mortar is comprised of clay and a fine sand, which although generally well mixed, was observed to contain a number of thin lenses of unbound very fine sand grains. An abundance of chopped fibre was observed to be present, with this including straw and various grasses (stalks), with this locally appearing in clusters, albeit these are well distributed throughout the mix. The fibres range in width from 0.08 to 4.24mm and 4.16mm to 19.8mm in length, within the sub-sample examined.

One of the fragments retained small reddish aggregates embedded in one of its larger surfaces, possibly the outer surface. The chips were of a crushed pink granite and may be the residue from a surface coating (Dash aggregate, Harl or similar).

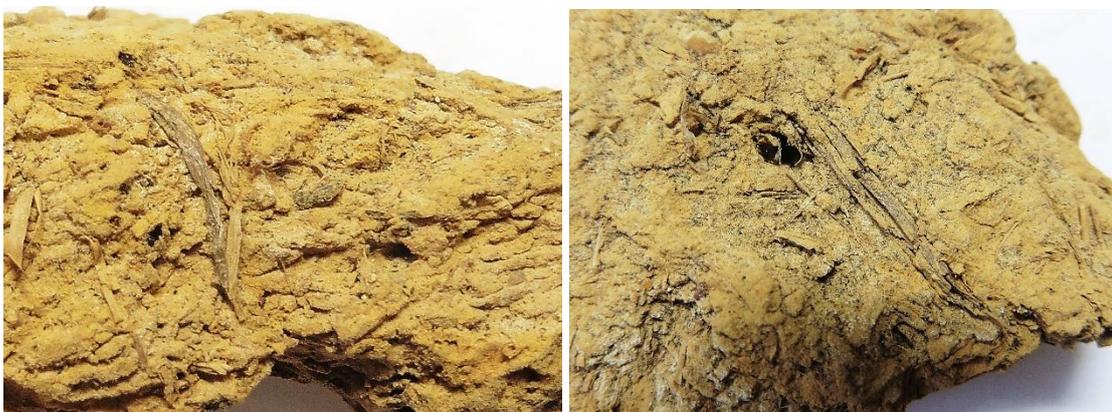
Plates No. 5 & 6: The above plates show fractured surfaces in which the abundance of fibre can be seen, with straw and grass stalks both apparent.

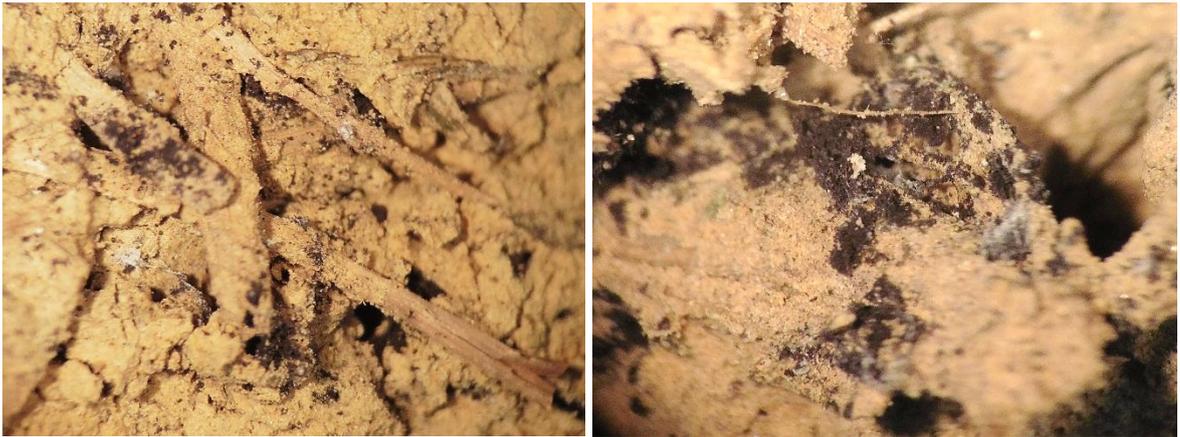
Plates No. 7 & 8: The above plates show microscopic images. The left image shows of the fibre within the mortar, and the dark clusters commonly associated with these. The right plate is a magnified area adjacent to a fibre, where insect web material can be seen within the dark mass.

There was also small dark fragments and clusters randomly distributed throughout the mortar, which ranged in size from 0.06mm to 5.8mm. These had the appearance of globular masses, some of which contained clusters of very fine fibrous material, possibly indicative of insect activity, within the mortar. On examining these dark inclusions tended to disintegrate on probing and were very soft and appeared to possibly be organic in origin. Without further analysis it is not possible to conclusively identify this material, however, it is considered, given its occurrence in association with the straw and grasses, that it may be indicative of animal manure having been incorporated within the mortar.

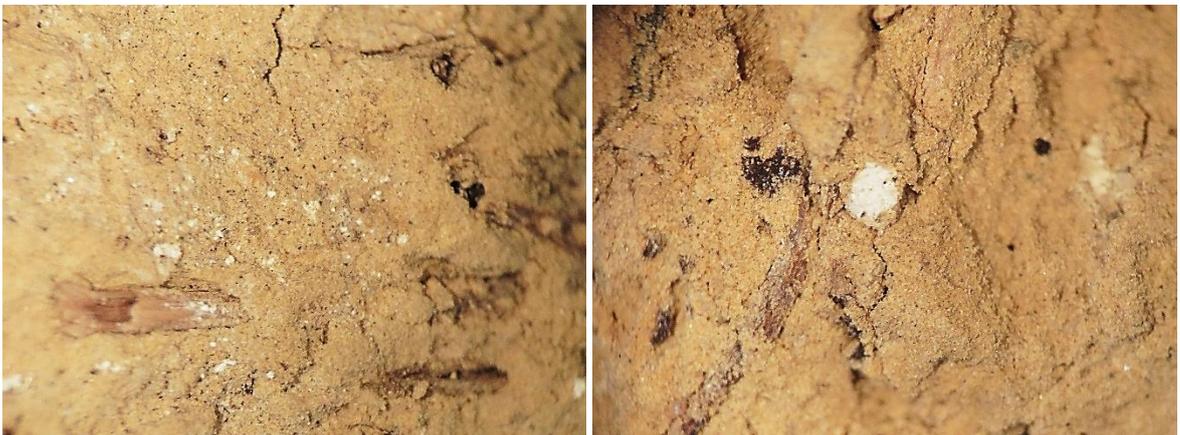
Plates No. 9 & 10: The above plates show examples of a rare location within the sample where lime was apparent, with the left plate showing fine inclusions of lime (white in image), with the right plate showing two of the larger inclusions, with the larger (right) inclusion measuring 0.7mm in diameter.

Lime inclusions were noted within the mortar, but these were sparse and very localised in occurrence, with that observed forming very small inclusions, typically less than 0.1mm in size but locally up to 0.7mm.

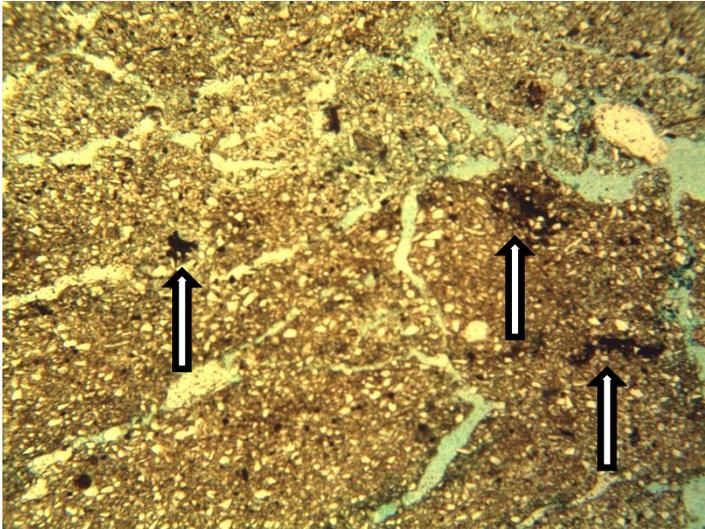
Plate No. 11:

A view in plane polarised light (ppl) showing a typical area of the mortar, with the area in view being dominated by fine sand bound in a clay matrix. The area in view is transected by an abundance of elongated voids and shrinkage cracks, not uncommon in clay mortars.

The dark areas, arrowed, appear to be concentrations of an amorphous material, within which some sand grains can also be seen, these are perhaps organic in form.

Porosity is highlighted by the blue dyed resin. Field of view 2.4mm.

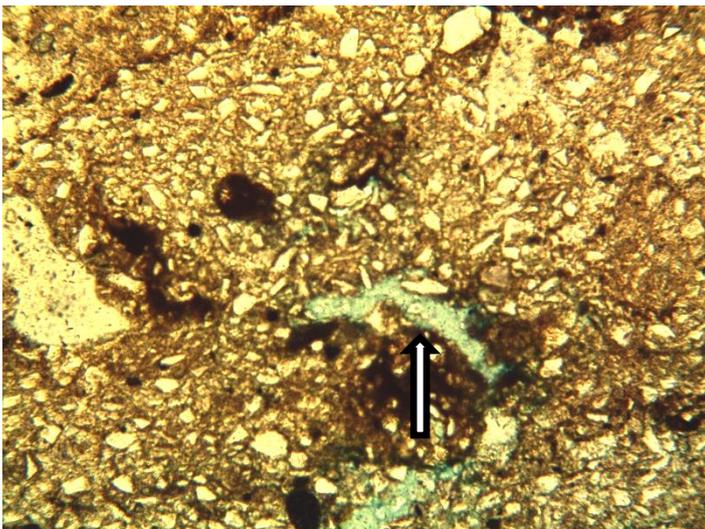
Plate No. 12:

A magnified view of another area of the mortar, again in ppl.

In this view there are some larger lithic fragments, centre left and upper right (chert). There is also a void formed from the decay of a fibrous material, arrowed in plate. Concentration of opaque material is also present in this view, and again these contain sand grains, inferring that it was of a plastic consistency when incorporated within the mortar.

Porosity and voids are highlighted by the blue dyed resin. Field of view 1.2mm.

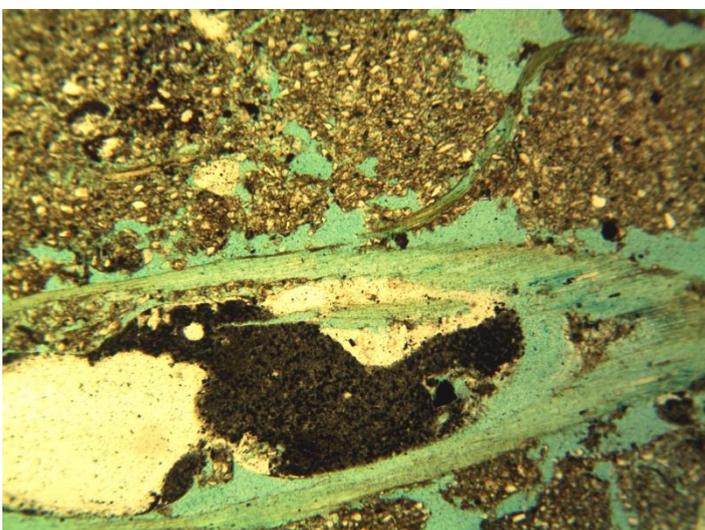
Plate No. 13:

Another view in ppl, of an area incorporating a disrupted wide straw fibre, which is fully encapsulated within the mortar. Note the concentration of opaque material in close proximity, and below the fibre. With it exposed where the fibre was cut during section preparation. The fibre had also started to separate during mixing, see upper edge.

Note the abundance of voids in the upper part of the plate

Porosity and voids are highlighted by the blue dyed resin. Field of view 2.4mm.

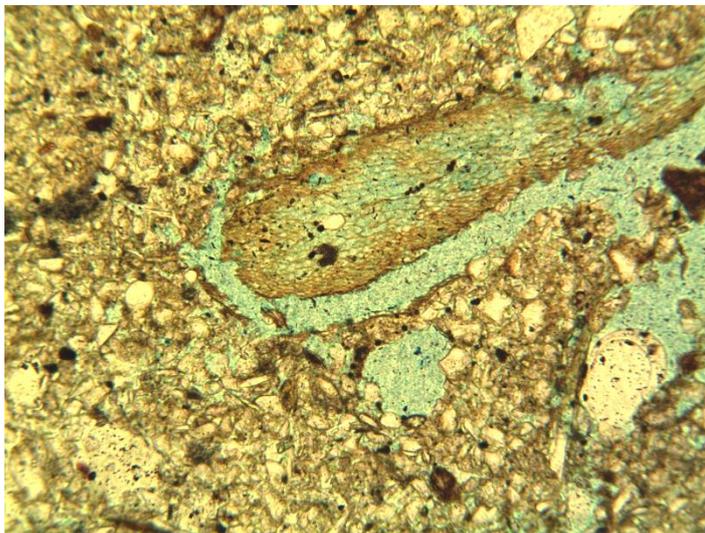
Plate No. 14:

Another view in Plane Polarised Light (ppl), showing a fibre cut at an angle to the plane of the slide.

There is a longitudinal void in the paste adjacent to the fibre indicating that some shrinkage, most likely in the fibre, had occurred after placing. The remainder of the mortar is relatively dense and typical of the mortar in the sample examined.

Porosity and voids are highlighted by the blue dyed resin. Field of view 1.2mm.

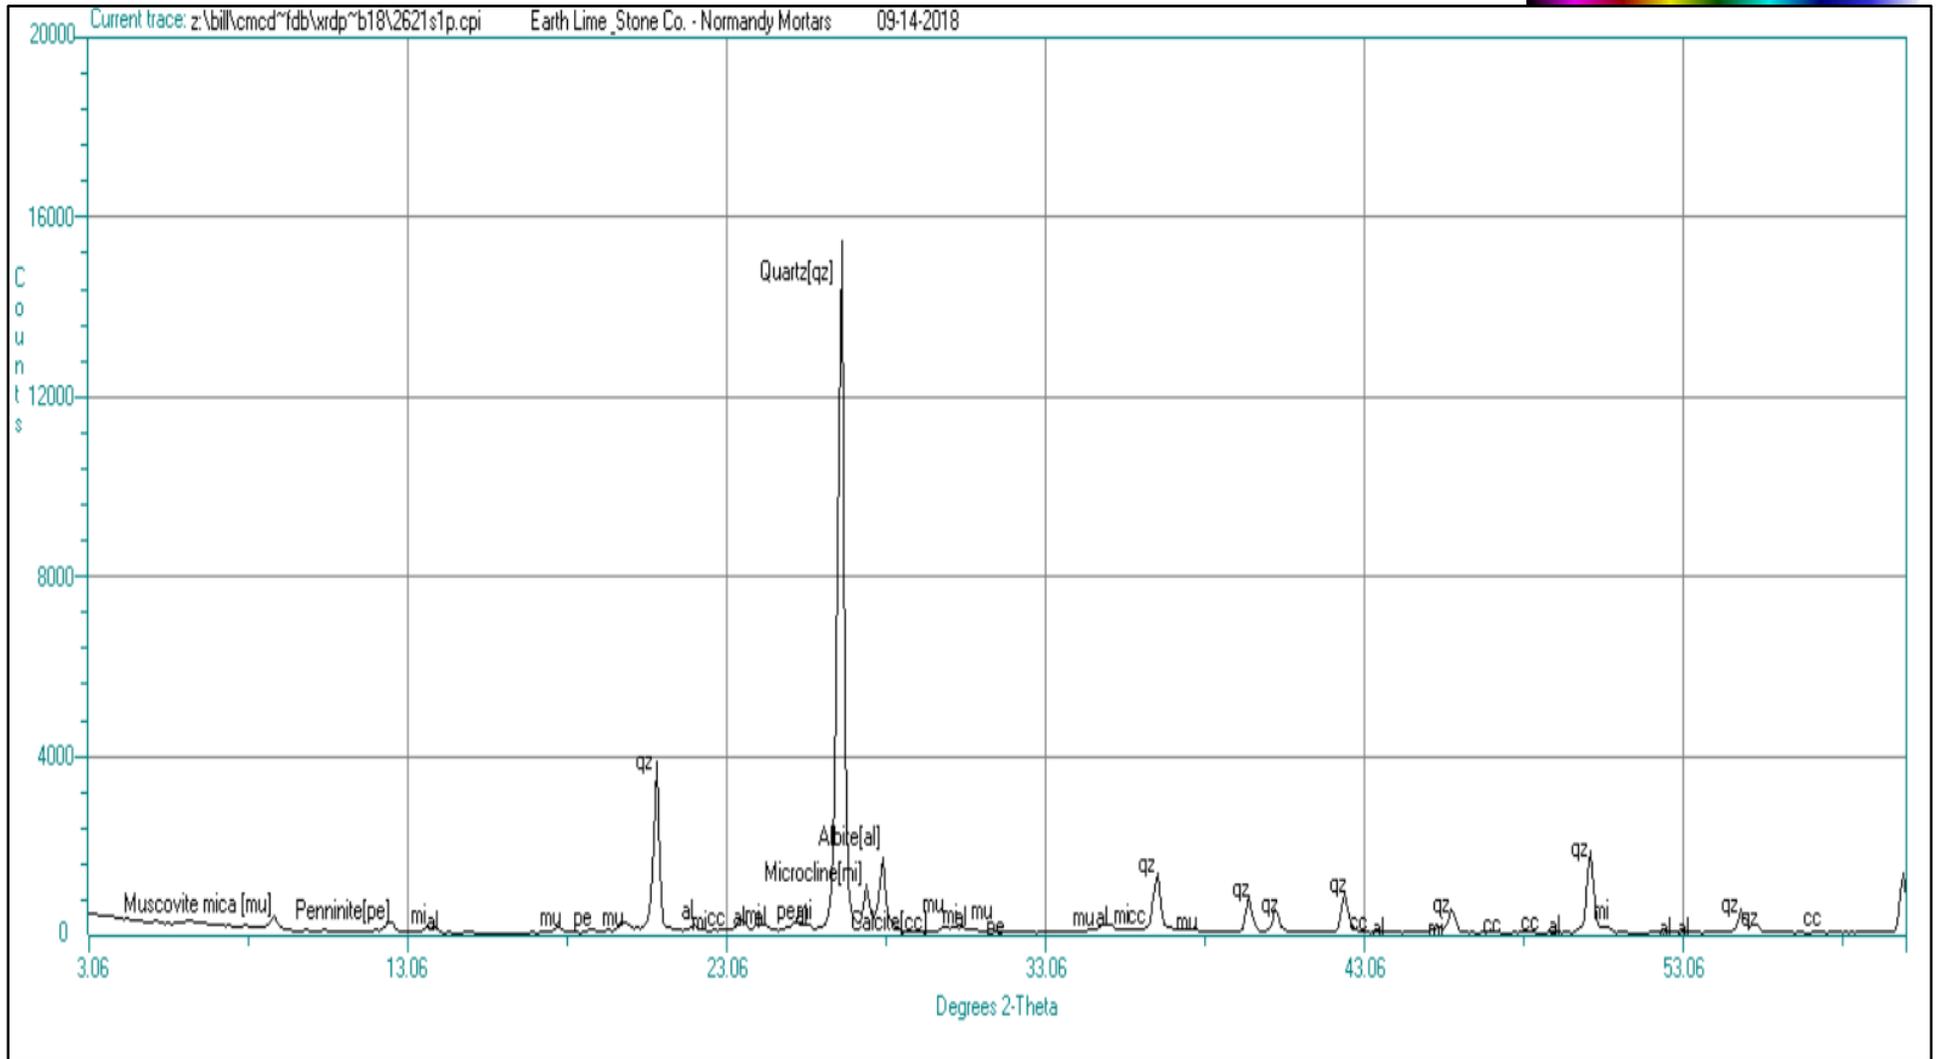
Figure No. 2: Sample SR2621-S1, Powdered sample of clay mortar ex Normandy.

The abbreviations used on the chart, to identify peak positions, are as follows:

- cc** = Calcite (CaCO_3) calcium carbonate, carbonated lime from lime binder, or limestone,
- qz** = Quartz (SiO_2) dominant component of the sand aggregate in the mortar,
- fs** = Feldspar, common rock forming minerals, with mostly Albite and Microcline identified,
- pe** = Penninite, layer-lattice clay mineral of the chlorite group of minerals,
- mi** = Muscovite mica, common rock forming mineral, commonly found in clays.

The data from the XRD Analysis was processed further by Rietveld refinement to enable quantification of the crystalline components present, with the following results:

Based on the XRD analysis, it is indicated that the mortar is essentially a clay sand mix, with a trace proportion of lime, with the lime being a high calcium lime. This analysis procedure does not determine the presence or proportion of organic components present in the sample analysed.
