CERTIFICATE OF ANALYSIS OF A MORTAR AND PLASTER SAMPLE FOR DETERMINATION OF MIX COMPOSITION, GRADING ANALYSIS AND BINDER TYPE

Project Reference : 1729 Farmhouse, Malton, North Yorkshire
Sample Description : S1 – Original Masonry Bedding Mortar
S2 – Original Plaster Mortar.
Date Received : 18th July 2019
CMC Sample Ref : SR 2740 – S1 and S2.
Method of Test : Determination of mix composition by acid digestion with grading of recovered aggregates. Mineralogical composition and binder type by X-Ray Diffraction, with the form of binder and fabric condition assessed from a thin section examination.

Earth, Stone & Lime Company.
1729 Farmhouse, Malton, North Yorkshire
Examination and Analysis of Original Bedding and Plaster Mortar samples.

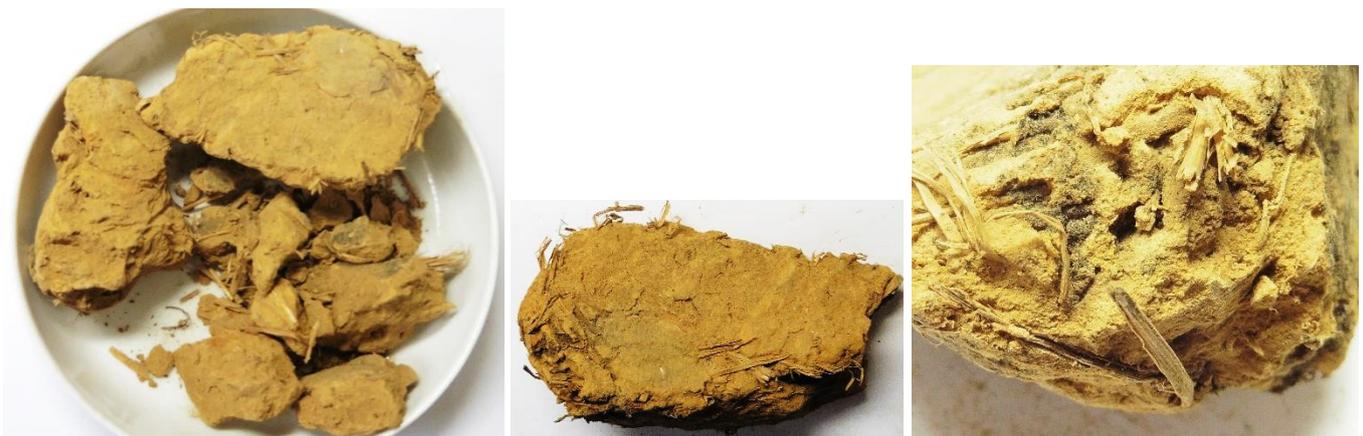
Plates No. 8, 9 & 10: The left plate shows the sample as received, with the centre image showing an intact piece of plaster, with straw well bound within the clay, with the right plate showing a magnified image of a freshly fractured surface to show the density of straw fibre within the plaster.

The intact fragments were found to be finger friable and the lumps could be reduced to powder under moderate to moderately light finger pressure. On examination of the lumps under the stereo-binocular microscope it was noted that the mortar was free of lime inclusions, or large limestone fragments, with no positive reaction observed when droplets of dilute hydrochloric acid were placed onto the mortar surface.

An abundance of straw material was observed within the plaster and it is considered that this was added as a reinforcement, in lieu of animal hair, which, dependent on the geographical area and the status of the building, is not uncommon in clay bound plasters.
