Construction Materials Consultants Ltd.

CERTIFICATE OF ANALYSIS ON A MORTAR SAMPLE FOR BINDER TYPE DETERMINATION & MIX COMPOSITION

Project Reference	:	Thornton Lime Mortar
Sample Source	:	Hall Farm, Maltongate
Sample Description	:	11-month-old Plaster mixed from lime produced by burning local Oolitic Limestone
Date Received	:	8 th April 2021
CMC Sample Ref	:	SR 2834 - S1
Method of Test	:	Binder type by XRD analysis by in-house procedures, with fabric condition and mix composition from thin section examination.

Earth, Stone & Lime Company.
Plaster prepared from Calcining a
Local Oolitic Limestone
Examination and Analysis of a Plaster Sample.

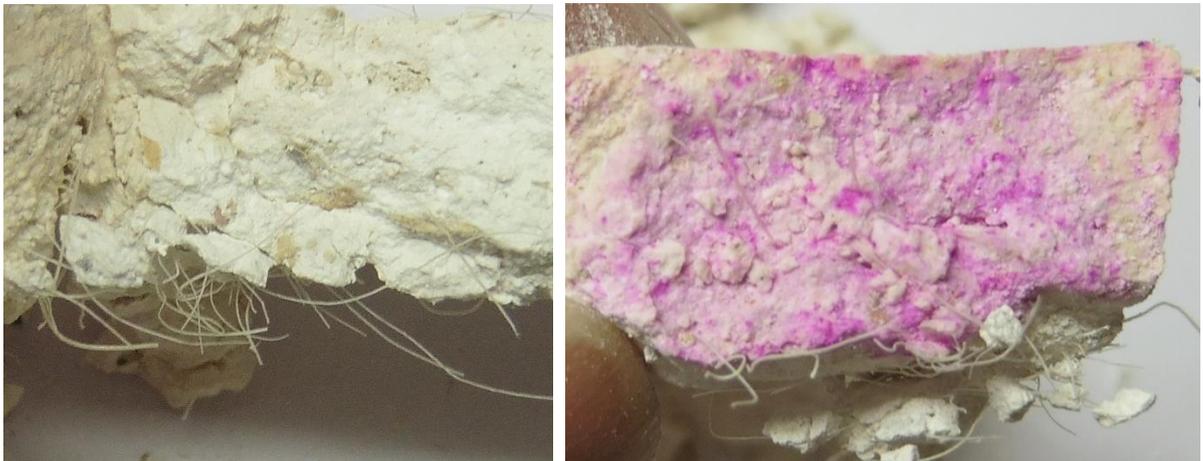
Plates No. 3 & 4: The above plates show two of the fractured edges of the sample, with the left plate showing the fibre added to the plaster, which has the appearance of a synthetic fibre. The right plate shows the result of the phenolphthalein indicator test, the colour change indicating incomplete carbonation.

On testing a freshly fractured and sawn surfaces with a phenolphthalein indicator solution the plaster, was found to be only partially carbonated, with a patchy colour change observed.

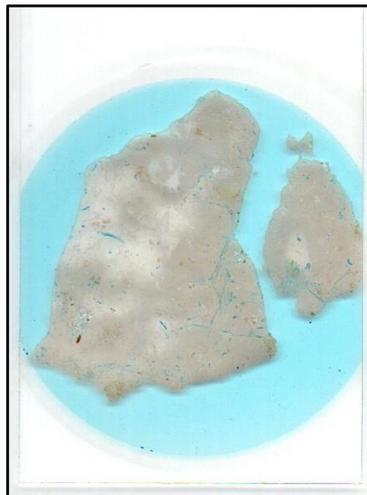
Plate No. 5:

The plate opposite shows the thin section made from the Plaster for examination in the polarised light microscope.

To provide information on the form and condition of the binder and permit comment on the plaster fabric a petrographic thin section was prepared from an intact piece of the sample.

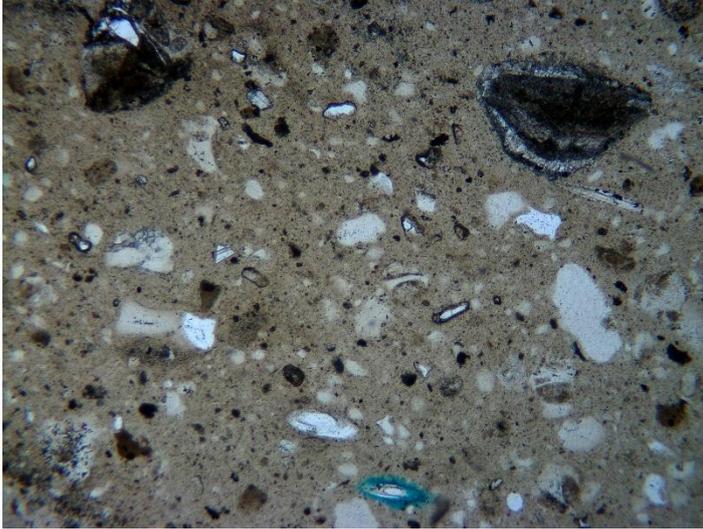
Plate No. 6:

A view in plane polarised light (ppl) of a typical area within the plaster. The paste is relatively dense and is partially carbonated in this view. There is a quantity of very fine limestone dust fragments distributed throughout, brown in image, along with two larger limestone fragments, upper left and right. The voids are a mixture of small entrapped air voids with some also the imprint of the hair fibre included in the paster. Where cut perpendicular to the plane of the slide, they appear as round to elliptical holes. Porosity and voids are highlighted by the blue dyed resin. Field of view 2.4mm.

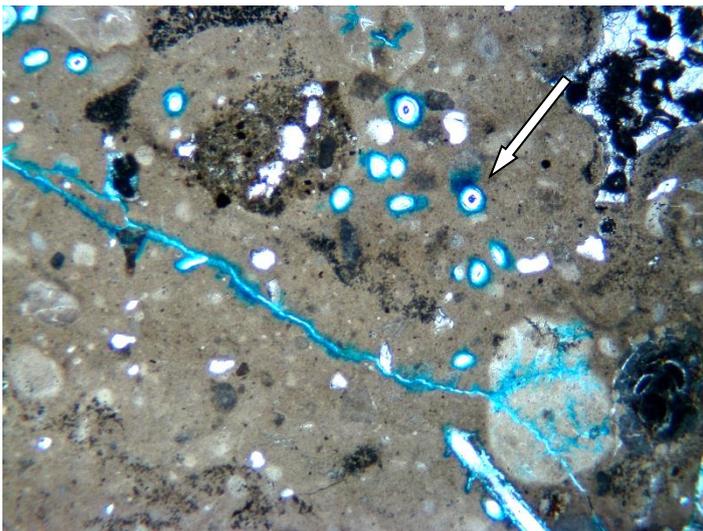
Plate No. 7:

Another view in ppl, where a limestone inclusion can be seen in the upper right. This inclusion appears not to have been calcined, whereas that in the lower right is fully calcined and slaked inclusion is present as a porous putty inclusion. A crack transects the plate, with no evidence of moisture percolation through it. A cluster of hair fibres can be seen in the upper centre, one example is arrowed in the plate. An overburnt particle can be seen lower right with an ash cluster in the upper left. Porosity and voids are highlighted by the blue dyed resin. Field of view 2.4mm.

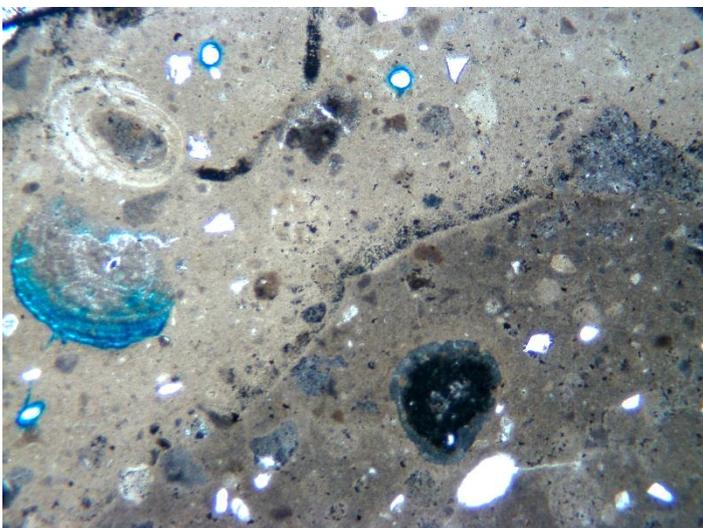
Plate No. 8:

A view in plane polarised light, ppl, of the interface between carbonated paste, light brownish grey, and uncarbonated lime, dark greenish grey, lower right side of plate. These are separated by a distinct boundary which would infer that the uncarbonated paste is due to the denser fabric, formed by an incompletely slaked dense lime inclusion. Note the presence of two Ooliths, upper left, which are encapsulated within the fully slaked and carbonated encapsulating paste. Porosity and voids are highlighted by the blue dyed resin. Field of view 1.2mm.

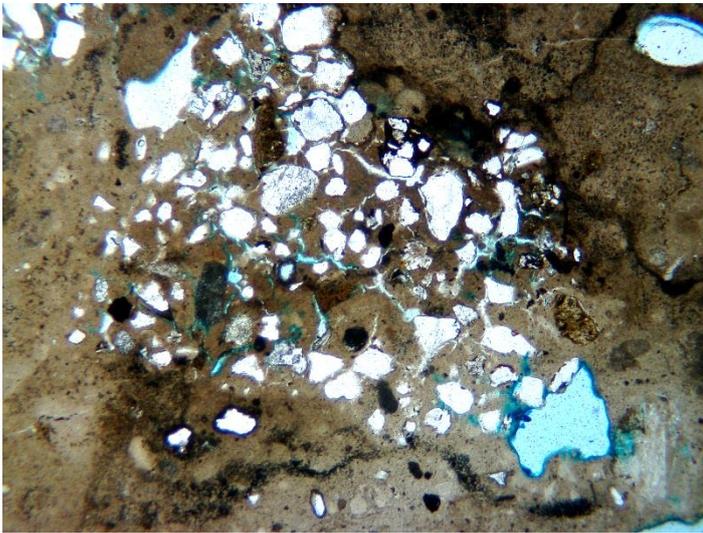
Plate No. 9:

A view in plane polarised light (ppl) of an aggregate rich partially calcined fragment of limestone. Its outer margin is highlighted by a dark rim, which is lost on the left side where it merges into the surrounding paste. The aggregates are of quartz and feldspar and do not show any evidence of reacting with the lime, though if temperature had been higher at time of calcining, there would have been the potential for reactions to produce hydraulic components. Porosity and voids are highlighted by the blue dyed resin.

Field of view 2.4mm.

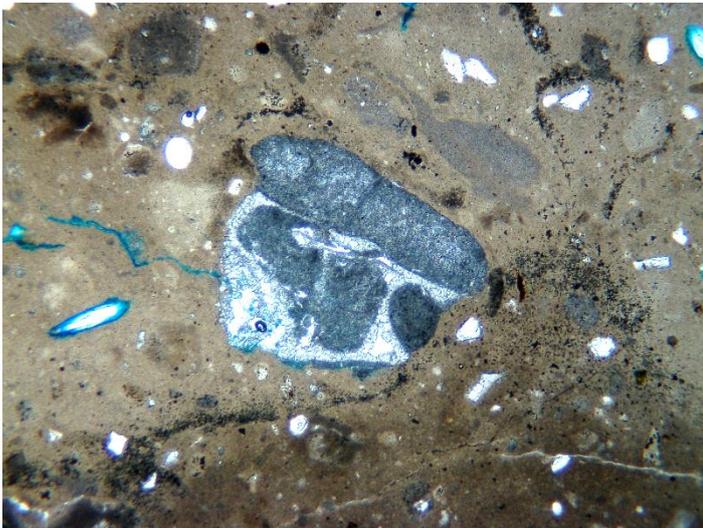
Plate No. 10:

Another view in plane polarised light, ppl, showing a limestone fragment, in the centre of the plate, which shows no evidence of alteration or burning, and this had perhaps been from the core of a lightly calcined fragment or incorporated from an area of unburnt limestone.

The paste in the upper part of the slide is partially carbonated whereas that in the lower part is uncarbonated.

Porosity and voids are highlighted by the blue dyed resin.

Field of view 1.2mm.

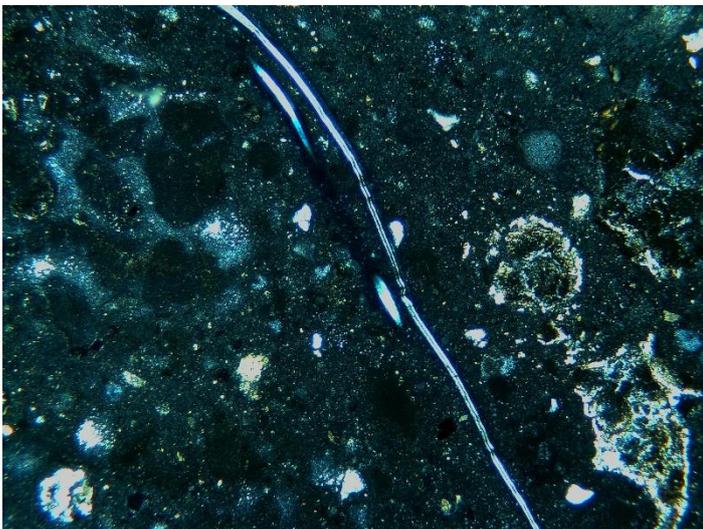
Plate No. 11:

A view in cross polarised light, xpl, of an area of the paste that shows minimal carbonation. The white speckles seen distributed throughout the slide are carbonated grains of lime, and are either fine limestone dust or carbonated Portlandite. Uncarbonated paste appears opaque in xpl. Two hair fibres transect the slide from upper left to lower right. Fragments of unburnt limestone can be seen in the lower right.

Porosity, voids, impregnating resin and opaque minerals all show dark in xpl.

Field of view 1.2mm

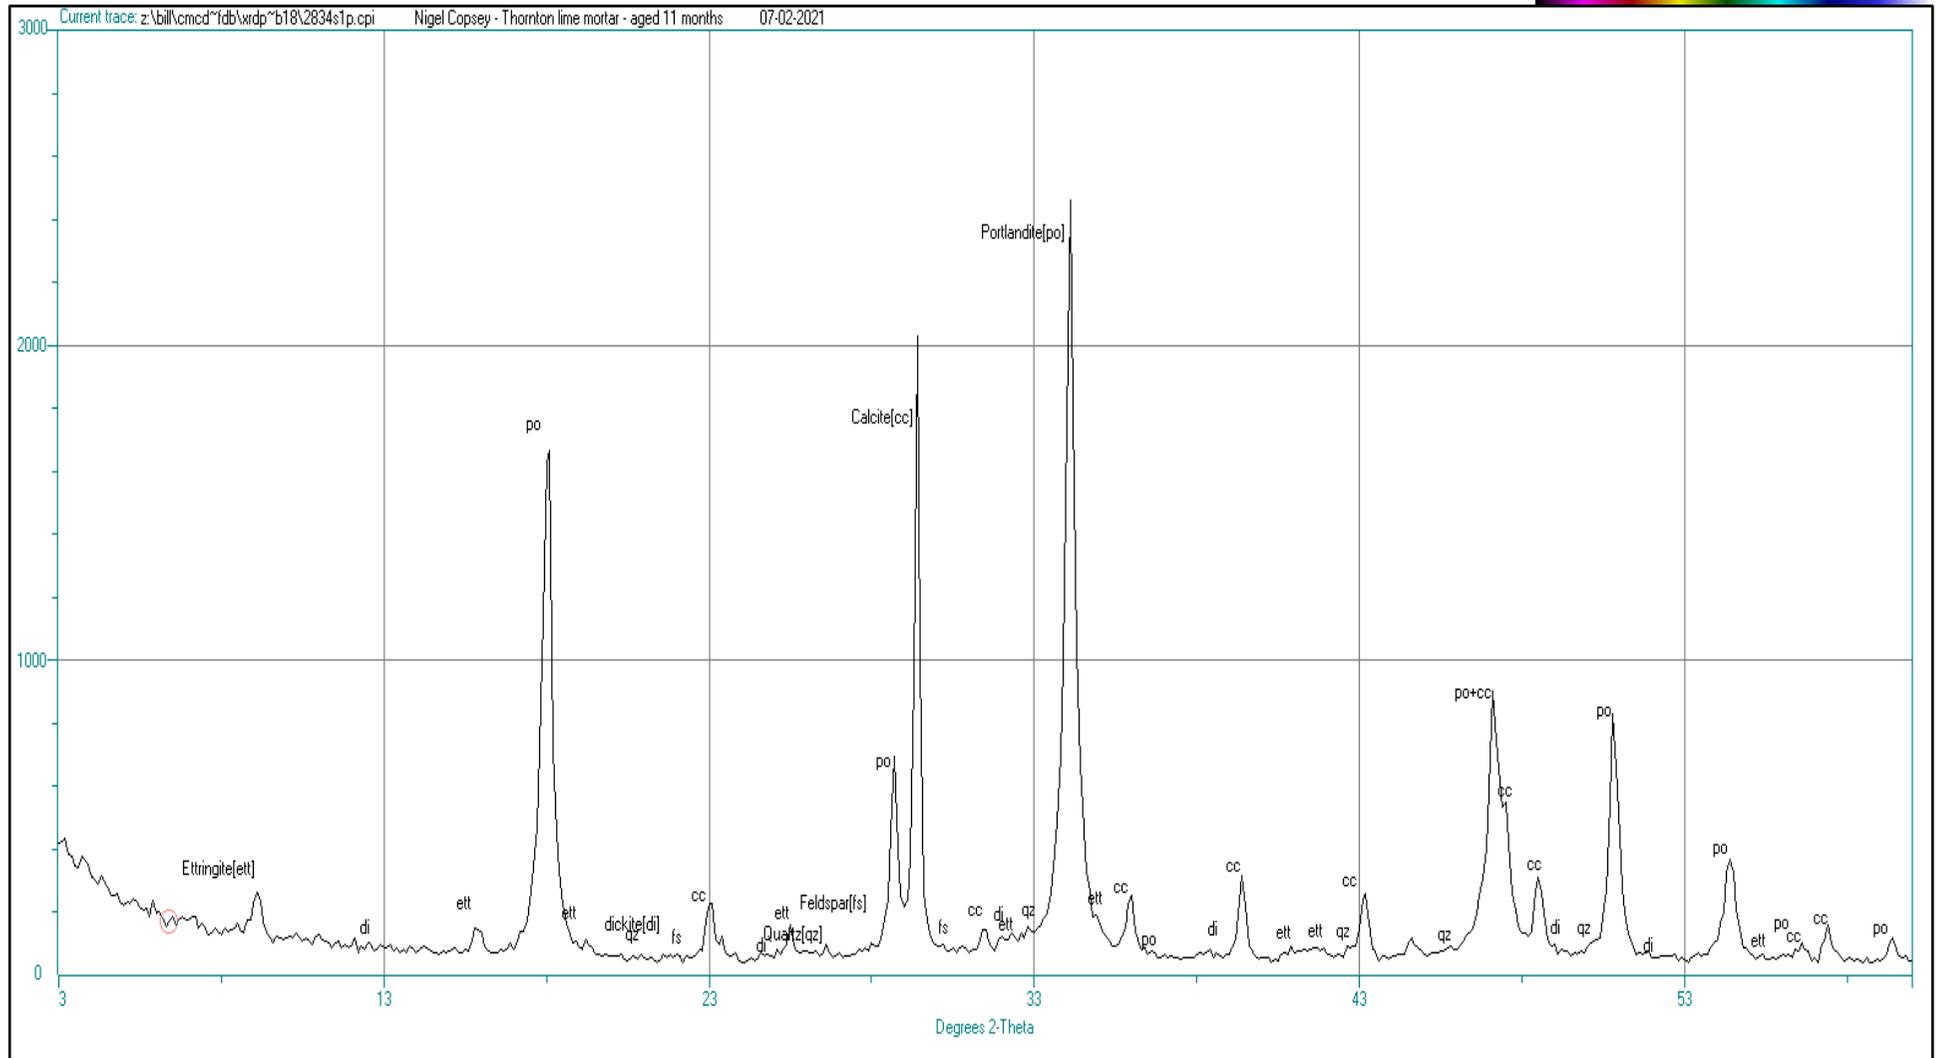
Figure No. 1: Sample SR2834-S1 – Binder from plaster made at Hall Farm, Maltongate.

The results of the analysis are presented in the following Figure, in the form of a labelled X-ray Diffractogram:

The abbreviations used on the chart, to identify peak positions, are as follows:

- po** = Portlandite ($\text{Ca}(\text{OH})_2$) calcium hydroxide, form of lime after slaking and before carbonation,
- cc** = Calcite (CaCO_3) calcium carbonate, carbonated binder from lime plaster, and also any limestone present as aggregate,
- qz** = Quartz (SiO_2) component of any the aggregate, can also be present within some limestones,
- fs** = Feldspar, mostly of Anorthite of the Plagioclase group of minerals, trace proportions only, probably present as a contaminant in the limestone.
- di** = Dickite, clay mineral of the Kaolinite group, present in trace proportions, within limestone,
- ett** = Ettringite ($\text{Ca}_6\text{Al}_2(\text{SO}_4)_3(\text{OH})_{12}26\text{H}_2\text{O}$) Calcium Aluminium Sulphate Hydroxide Hydrate, present as a reaction product from the impact of environmental sulphates, or a contaminant.

On the basis of the XRD analysis, it is confirmed that the plaster sample was made from a non-hydraulic, high calcium, air lime. The plaster is only partially carbonated, which given its age, is expected. However, the presence of Ettringite was unexpected, and would only be expected had there been a gauging of a hydraulic component or the plaster had been in contact with a cementitious material and/or been affected by environmental sulphates. Alternatively, the components necessary for its formation may be present from the burning process, with these introduced into the quicklime from the burning of coal, if the fuel used to fire the kiln was indeed coal.
