CERTIFICATE OF ANALYSIS OF A MORTAR SAMPLE FOR DETERMINATION OF MIX COMPOSITION & BINDER TYPE

Project Reference	:	North York Moors NPA – This Exploited Land of Iron
Sample Location	:	Combs Wood Ironstone Mine and Processing Facility, Becks Hole, Goathland, North Yorkshire.
Sample Description	:	Bedding Mortar from Wheel-pit masonry
Date Received	:	29 th June 2020
CMC Sample Ref	:	SR 2802-S1
Date Analysed	:	8 th to 10 th , 21 st , 23 rd and 28 th July 2020
Method of Test	:	Determination of binder type by X-Ray Diffraction analysis. Mix composition by acid digestion with grading analysis of recovered aggregate, and thin section examination.

Combs Wood Ironstone Mine & Processing Facility
Examination and Analysis of a Bedding Mortar sample.

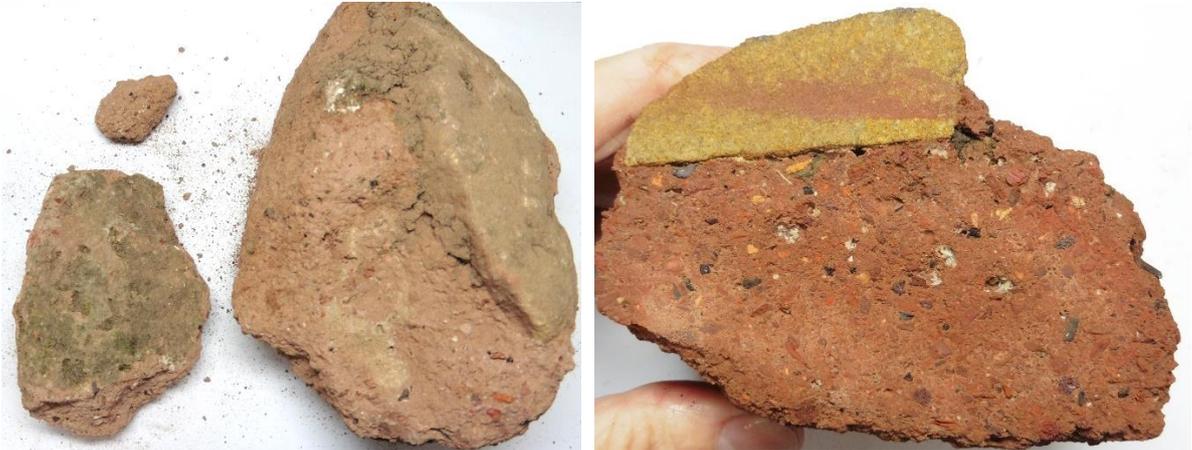
Plates No. 1 & 2: The left plate shows the intact pieces in the mortar sample, as-received, note the sandstone fragment adhering to the larger fragment on the right. With the right plate showing a close-up image of a freshly sawn surface cut through the thickness of the sample, after washing to remove cutting dust. Note compact nature of the mortar and the sandstone fragments adhering to the upper surface of the mortar, to which it was very well bonded.

The aggregates appear to be dominated by reddish brown minerals with coal and brick fragments also apparent. With the largest aggregate particle observed being in the region of 3.7mm in size, however, most of the aggregate particles are smaller than 0.5mm.

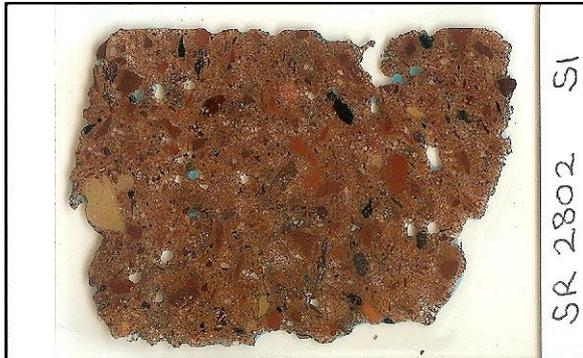
Plate No. 3:

Thin section prepared from mortar sample.

To achieve this a slice was sawn from the largest intact piece of mortar, with this dried and impregnated with a blue dyed resin in preparation for the manufacture of thin sections.

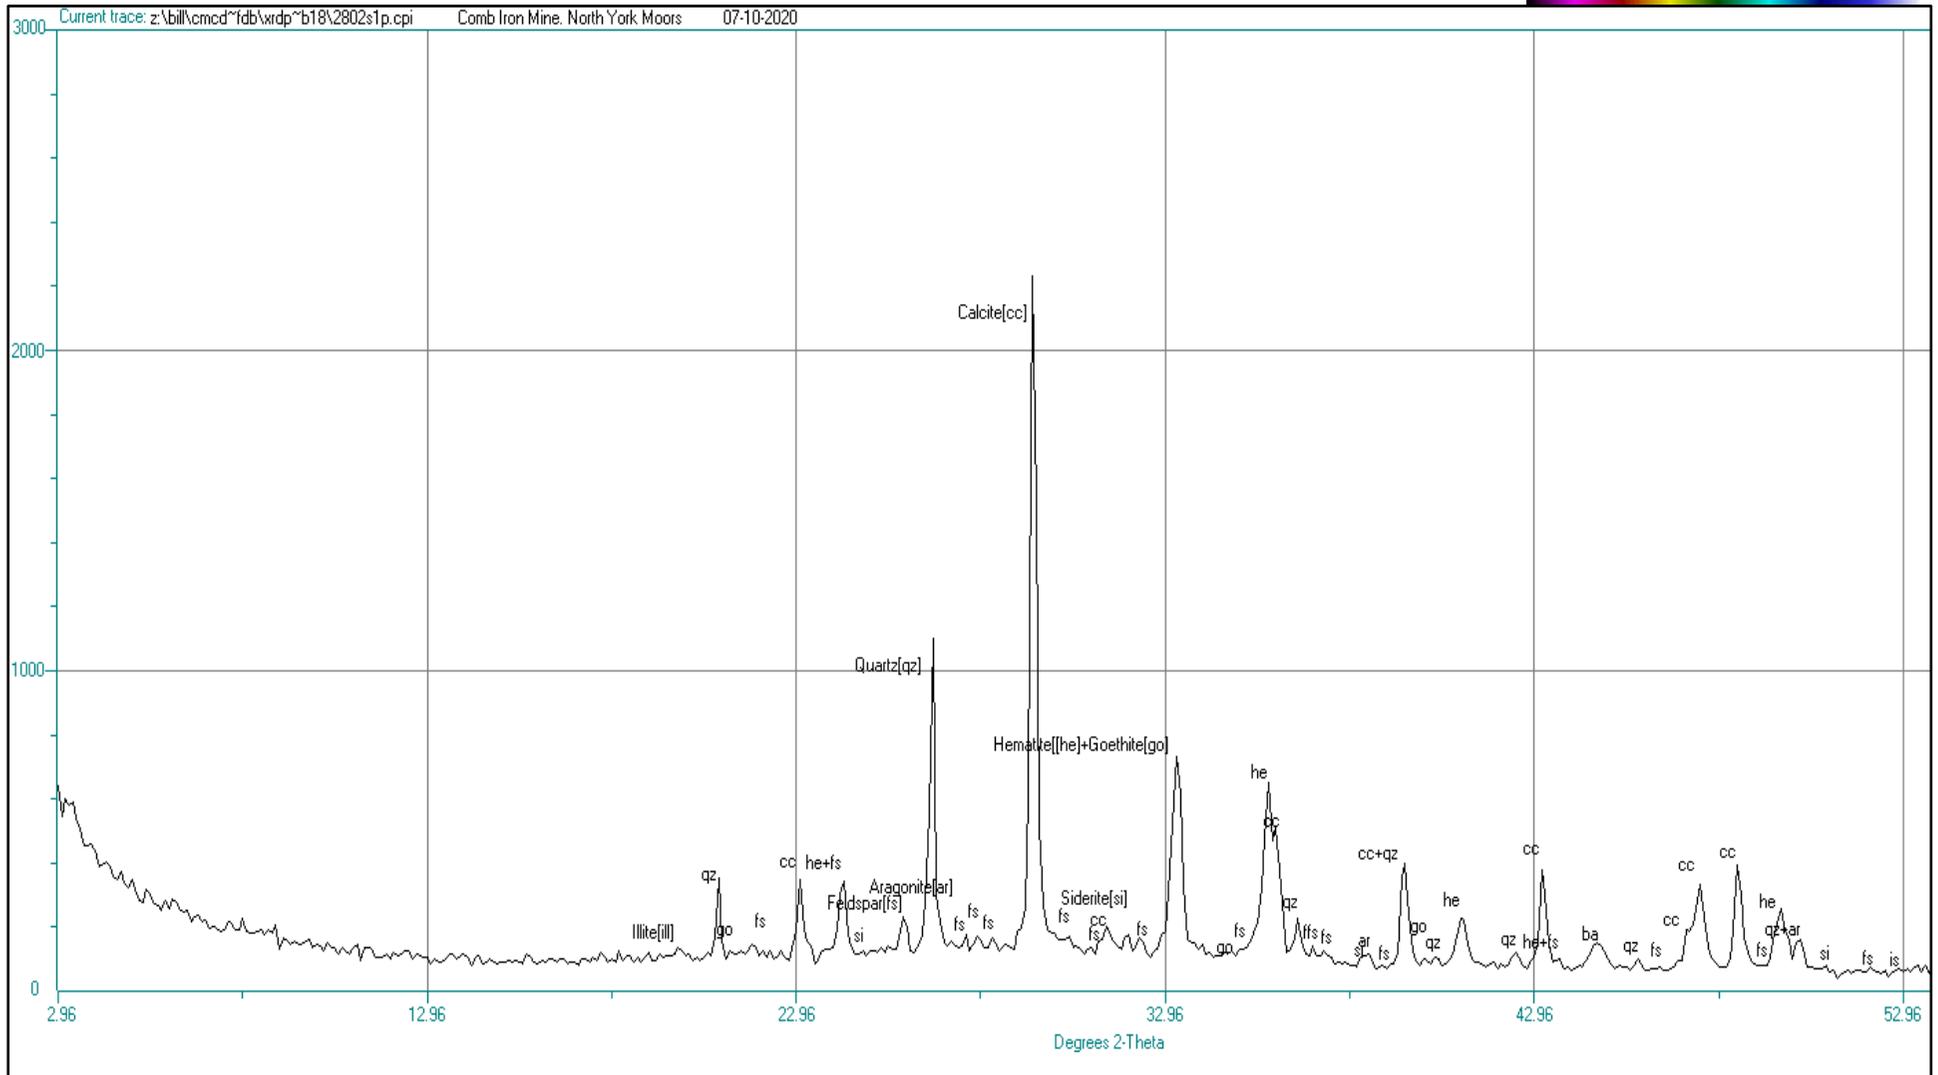
Figure No. 2: SR2802-S1 Bedding Mortar from Wheel-pit at Combs Wood Ironstone Mine.

The sample was analysed in a Diffractometer which was fitted with a single crystal monochromator, set to run over the range 3° to 60° 2θ in steps of 0.1° 2θ at a rate of 1° 2θ /minute using $CuK\alpha$ radiation. With the digital output analysed by a computer program, which matched the peak positions against the JCPDS International Standard Mineral Data-base sub files using a search window of 0.1° . The result obtained from the analysis is presented in the following attached Figure, in the form of a labelled X-ray Diffractogram:

The abbreviations used on the charts, to identify peak positions, are as follows:

- cc** = Calcite (CaCO_3) Calcium Carbonate, carbonated lime from lime binder and any limestone aggregate present in the mortar,
- ar** = Aragonite (CaCO_3) another crystalline form of Calcium Carbonate, from limestone, commonly associated with shell and found in some forms of redeposited leached lime binder,

- qz** = Quartz (SiO_2) Silicon Oxide, a component of the aggregate and also present with the ironstone,
- he** = Hematite (Fe_2O_3) Iron oxide, from the ironstone and any slag in the aggregate,

- go** = Goethite ($\text{FeO}(\text{OH})$) Iron oxide hydroxide, weathering product of iron ore,
- si** = Siderite (CaFeCO_4) Iron Carbonate, commonly found in hydrothermal veins and also a common diagenetic mineral in shales and sandstones,

- al** = Albite, feldspar mineral of the Plagioclase group and Sanidine, a high temperature form of alkali feldspar, present as common rock forming minerals,

- ill** = Illite, a common clay mineral, similar to mica, present as a rock forming mineral, from the alteration (weathering) of Micas and alkali Feldspars, present within the fines fraction.

From the XRD analysis, it is indicated that the mortar is a lime mortar, made with an air lime, a non-hydraulic lime. The strength noted in sample is considered to be due to the presence of a proportion of potentially pozzolanic components in the aggregate.

The high Hematite content confirms the presence of a high proportion of ironstone in the aggregate, this and the presence of Goethite and Illite suggesting the use of mine waste tailings as the aggregate in the mortar production.
