CERTIFICATE OF ANALYSIS OF MORTAR SAMPLES FOR DETERMINATION OF MIX COMPOSITION & BINDER TYPE

Project Reference	:	North Yorkshire Moors – This Exploited Land of Iron
Sample Location	:	Warren Moor Mine
Sample Description	:	WM1 – Chimney Brickwork Mortar WM2 – Chimney Stonework Mortar
Date Received	:	8 th January 2019
CMC Sample Ref	:	SR 2674 – S1 = WM1 – Brickwork Masonry SR 2674 – S2 = WM2 – Stonework Masonry
Date Analysed	:	17 th & 18 th September and 10 th & 11 th October 2018
Method of Test	:	Determination of binder type by X-Ray Diffraction analysis, with mix composition by acid digestion with grading analysis of recovered aggregate, and thin section examination.

North York Moors National Park Authority.
Warren Moor Mine
Examination and Analysis of Mortar samples
from Chimney Brick and Stone Masonry.

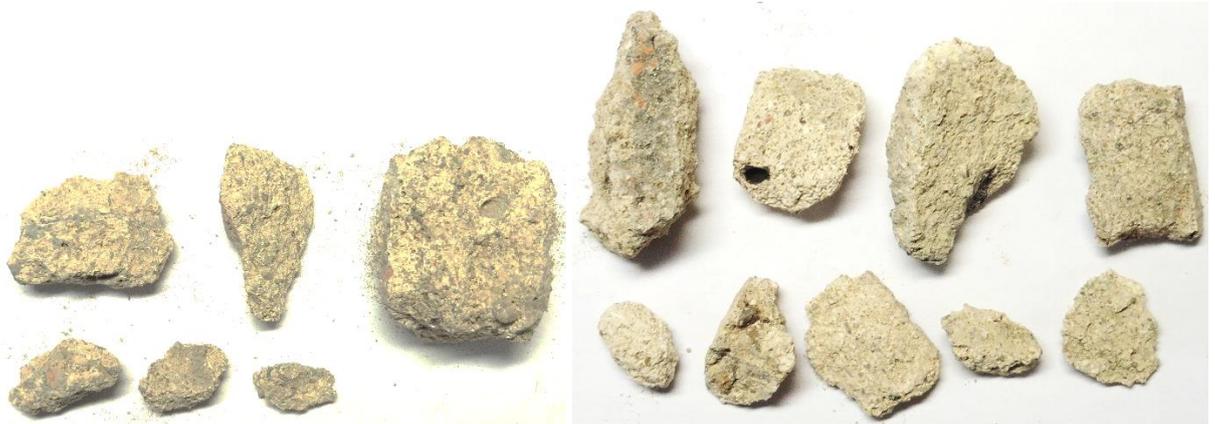
The mortar fragments were well compacted and were noted to contain an abundance of lime inclusions. The intact pieces could be broken under moderate finger pressure and once disrupted could be powdered under moderate to firm finger pressure.

Plates No. 1 & 2: The left plate shows the intact pieces of mortar in the sample from 12/10/18, as received, with the right plate showing the intact pieces extracted from the sample dated 27/12/18. The fragments in the latter sample were dustier than the earlier sample and some of the pieces retained brick fragments adhering to their bed faces. The largest piece in the sample dated 12/10/18 displayed localised leaching with one “outer” surface having been affected significantly by weathering.

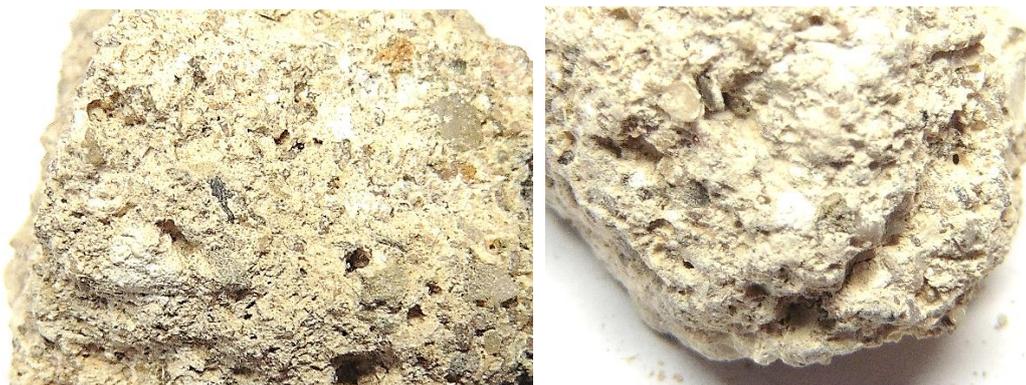
On examination it was noted that the mortar in both sub-samples displayed the characteristics of a lime mortar, with an abundance of lime inclusions apparent. The inclusions measured up to 2.4mm in size, with these being sub-angular to sub-rounded in shape.

The mortar was well compacted but variable in hardness and most of the pieces could be broken under moderate finger pressure, where the larger fragments broke with an audible “snap”, indicating a degree of brittleness. However, a few of the smaller fragments were noticeably softer and finger friable and could be powdered under light to moderate finger pressure.

Plates No. 3 & 4: The left plate shows an outer, weathered surface of one of the mortar pieces in the sample from 12/10/18, with the right plate showing a fractured surface on one of the fragments from sample taken on 27/12/18. Note, the presence of small lime inclusions distributed throughout the fabric in both fragments.

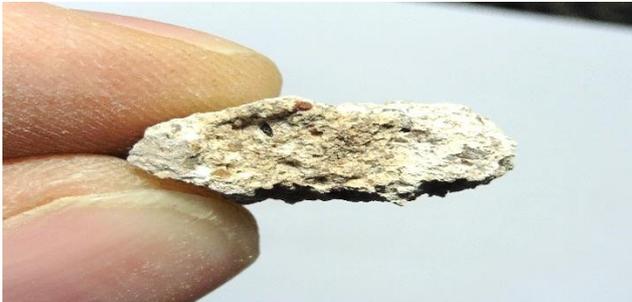
Plate No. 5:

The mortar was indicated from the Phenolphthalein indicator test, to be fully carbonated throughout the thickness of all pieces tested. Water droplets placed onto fractured surfaces were rapidly absorbed and diffused throughout the mortar to depth, indicating a well-connected pore structure within the mortar.

The plate opposite shows a magnified view of a freshly fractured surface through the thickness of a mortar fragment after the application of a Phenolphthalein indicator solution. The absence of a colour change indicating that the mortar was fully carbonated.

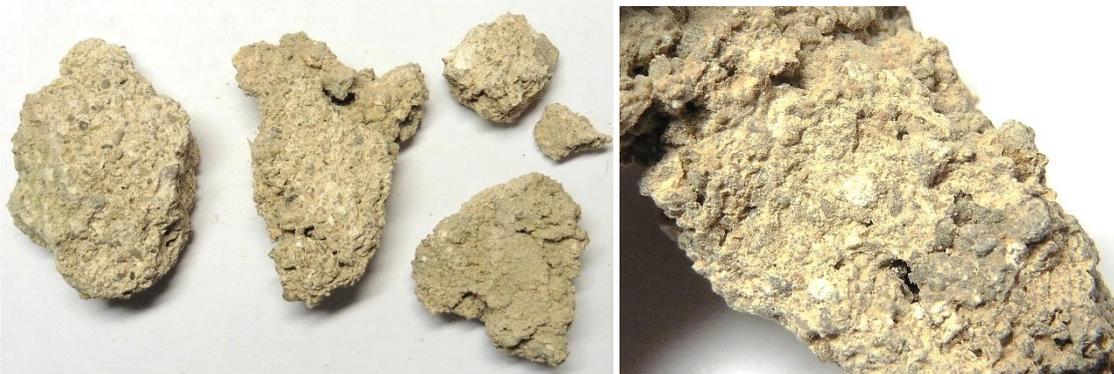
Plates No. 6 & 7: The left plate shows the intact pieces of mortar received. With the right plate showing a close-up of an outer surface where some surface leaching was apparent along with entrainment of soiling within redeposited lime. Small lime inclusions are also apparent on the surface.

The mortar fragments were well compacted, and all were noted to contain small lime inclusions distributed throughout. The inclusions were angular to sub-round and locally irregular in shape, with these measuring up to 1.2mm in size. The intact pieces could be broken under light to moderate finger pressure and once disrupted could be powdered under moderate finger pressure.

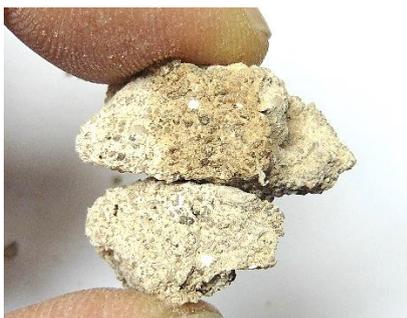
Plate No. 8:

The plate opposite shows a freshly fractured surface through the thickness of a mortar fragment after the application of a Phenolphthalein indicator solution to the upper part. The absence of a colour change indicating that the mortar was fully carbonated.

Note the compact condition of the mortar and the small lime inclusions(white) within the fabric.

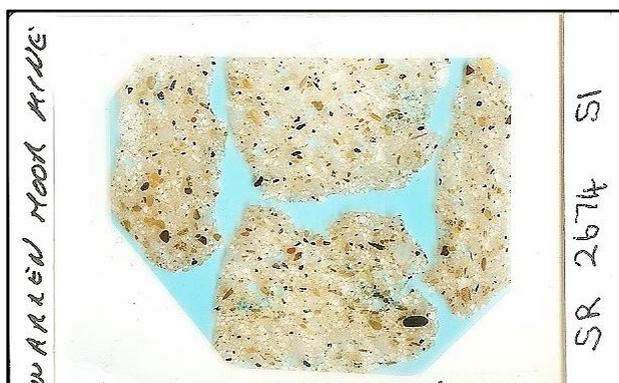
Plate No. 9:

Thin section prepared from four pieces of mortar from sample SR2674-S1 (WM1)

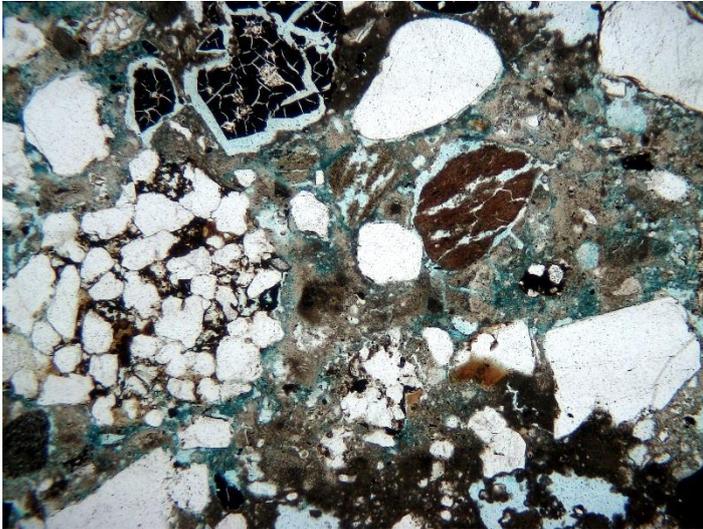
Plate No. 10:

A view in plane polarised light (ppl) showing a typical area of the mortar, with coal fragments displaying shrinkage and cracking apparent, upper left and right of centre.

The paste in view is fully carbonated. The aggregates are dominated by quartz, white in this view, with minor lithic grains and a large sandstone fragments, centre left, with minor igneous grains also apparent

Porosity is highlighted by the blue dyed resin. Field of view 2.4mm.

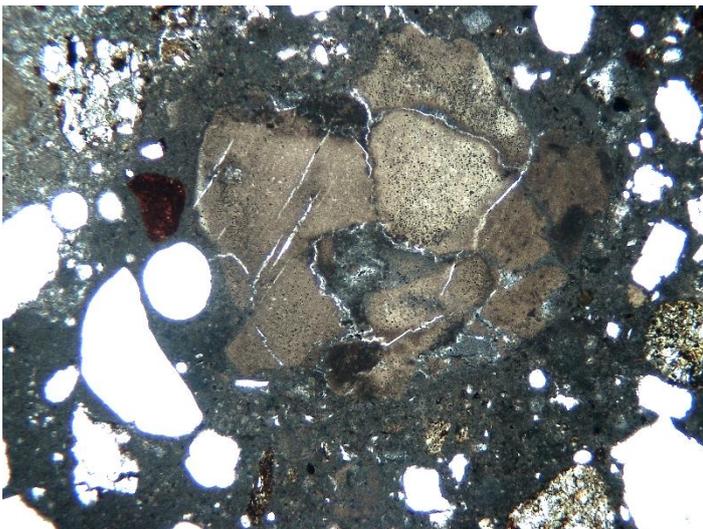
Plate No. 11:

A magnified view of a sub-round lime inclusion in the centre of the plate. This view is again in ppl.

The inclusion is of a partially over burnt limestone fragment, which has been partially slaked, with cracking throughout the fragment, note the patchy diffusion of slaked lime at its outer margin, upper left.

The encapsulating paste is dense and fully carbonated. Aggregates in view are mostly quartz, with minor lithic grains,

Porosity and voids are highlighted by the blue dyed resin. Field of view 1.2mm.

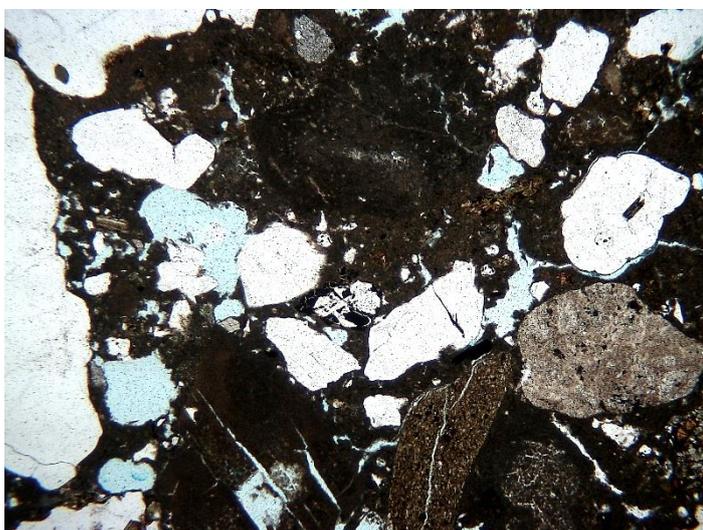
Plate No. 12:

Another view in plane polarised light (ppl), of an area containing an overburnt lime inclusion, upper centre. A limestone aggregate particle, showing a bioclastic fabric, lower right, above a partially burnt and partially slaked lime inclusion. A partially slaked limestone fragment, with linear cracks, can be seen lower left. Aggregates in view consist of quartz, siltstone, shale, igneous fragments, along with ironstone and small coal fragments.

Porosity and voids are highlighted by the blue dyed resin. Field of view 1.2mm.

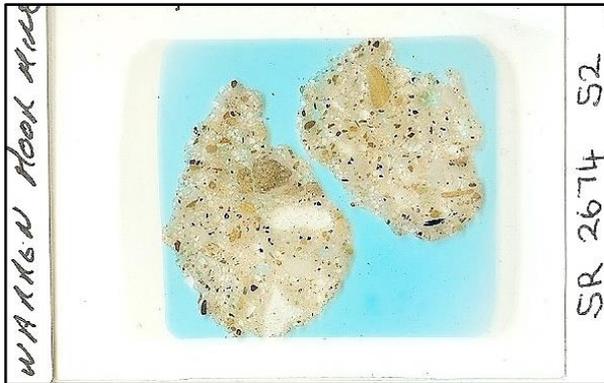
Plate No. 13:

Thin section prepared from the largest two intact pieces of mortar in sample SR2674-S2 (WM2)

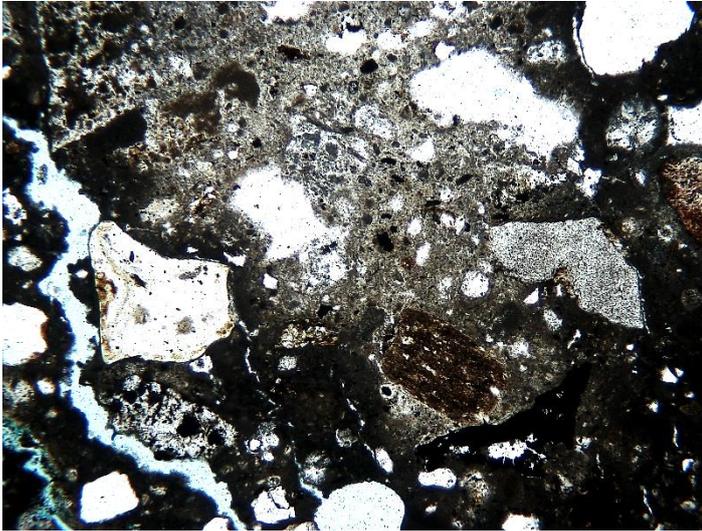
Plate No. 14:

A view in plane polarised light (ppl) showing a typical area of the mortar, with two abutting lime inclusions present. The upper left part is well slaked, and contains small sand grains included within it, whereas the lower right inclusion is poorly calcined and only partially slaked, upper left margin. The aggregates present include quartz, igneous particles, limestone (centre right), coal fragments and a proportion of ash. Note shrinkage crack in left side of plate, crack is free of secondary minerals.

Porosity is highlighted by the blue dyed resin. Field of view 2.4mm.

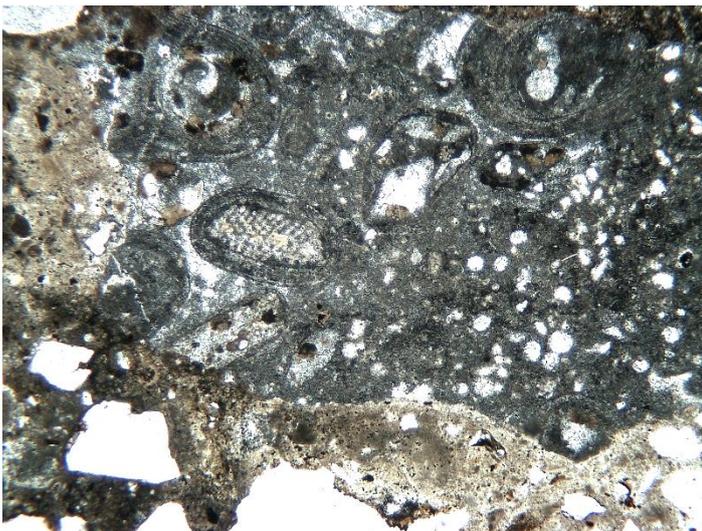
Plate No. 15:

A magnified view of a sub-angular limestone fragment in the centre of the plate. This view is again in ppl.

This is of a limestone fragment, with no evidence of having been calcined. The limestone retains all of its original fabric, i.e. that of a bioclastic limestone, note Oolith in upper right. The particle displays a sharp outer margin. The encapsulating paste is fully carbonated with fine quartz grains and locally, in lower left, some ash grains.

Porosity and voids are highlighted by the blue dyed resin. Field of view 1.2mm.

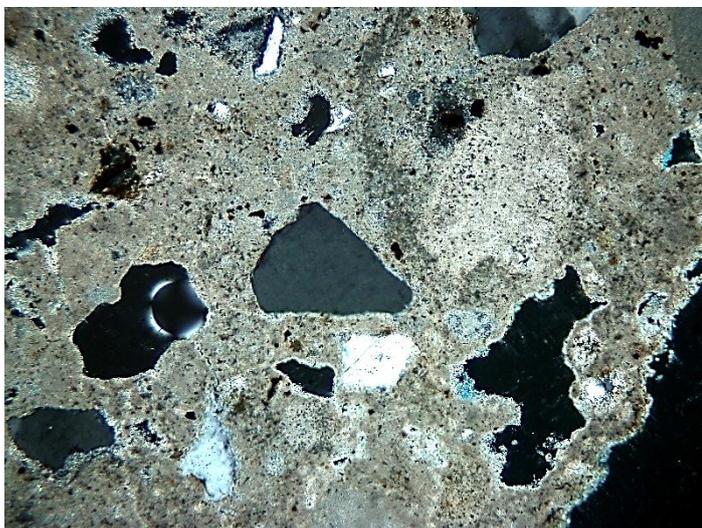
Plate No. 16:

A view in Cross Polarised Light (xpl), of an area containing a fully slaked small angular lime inclusion, upper right of centre. This is well encapsulated within the lime paste but did not diffuse into it. The paste is fully carbonated and the outer surface and void (black in image) are coated with a fine fringe of redeposited calcite and, locally, with sulphate minerals lower left. Aggregates in view are mostly of quartz.

Porosity, the blue impregnating resin and opaque minerals all appear black in xpl. Field of view 1.2mm.

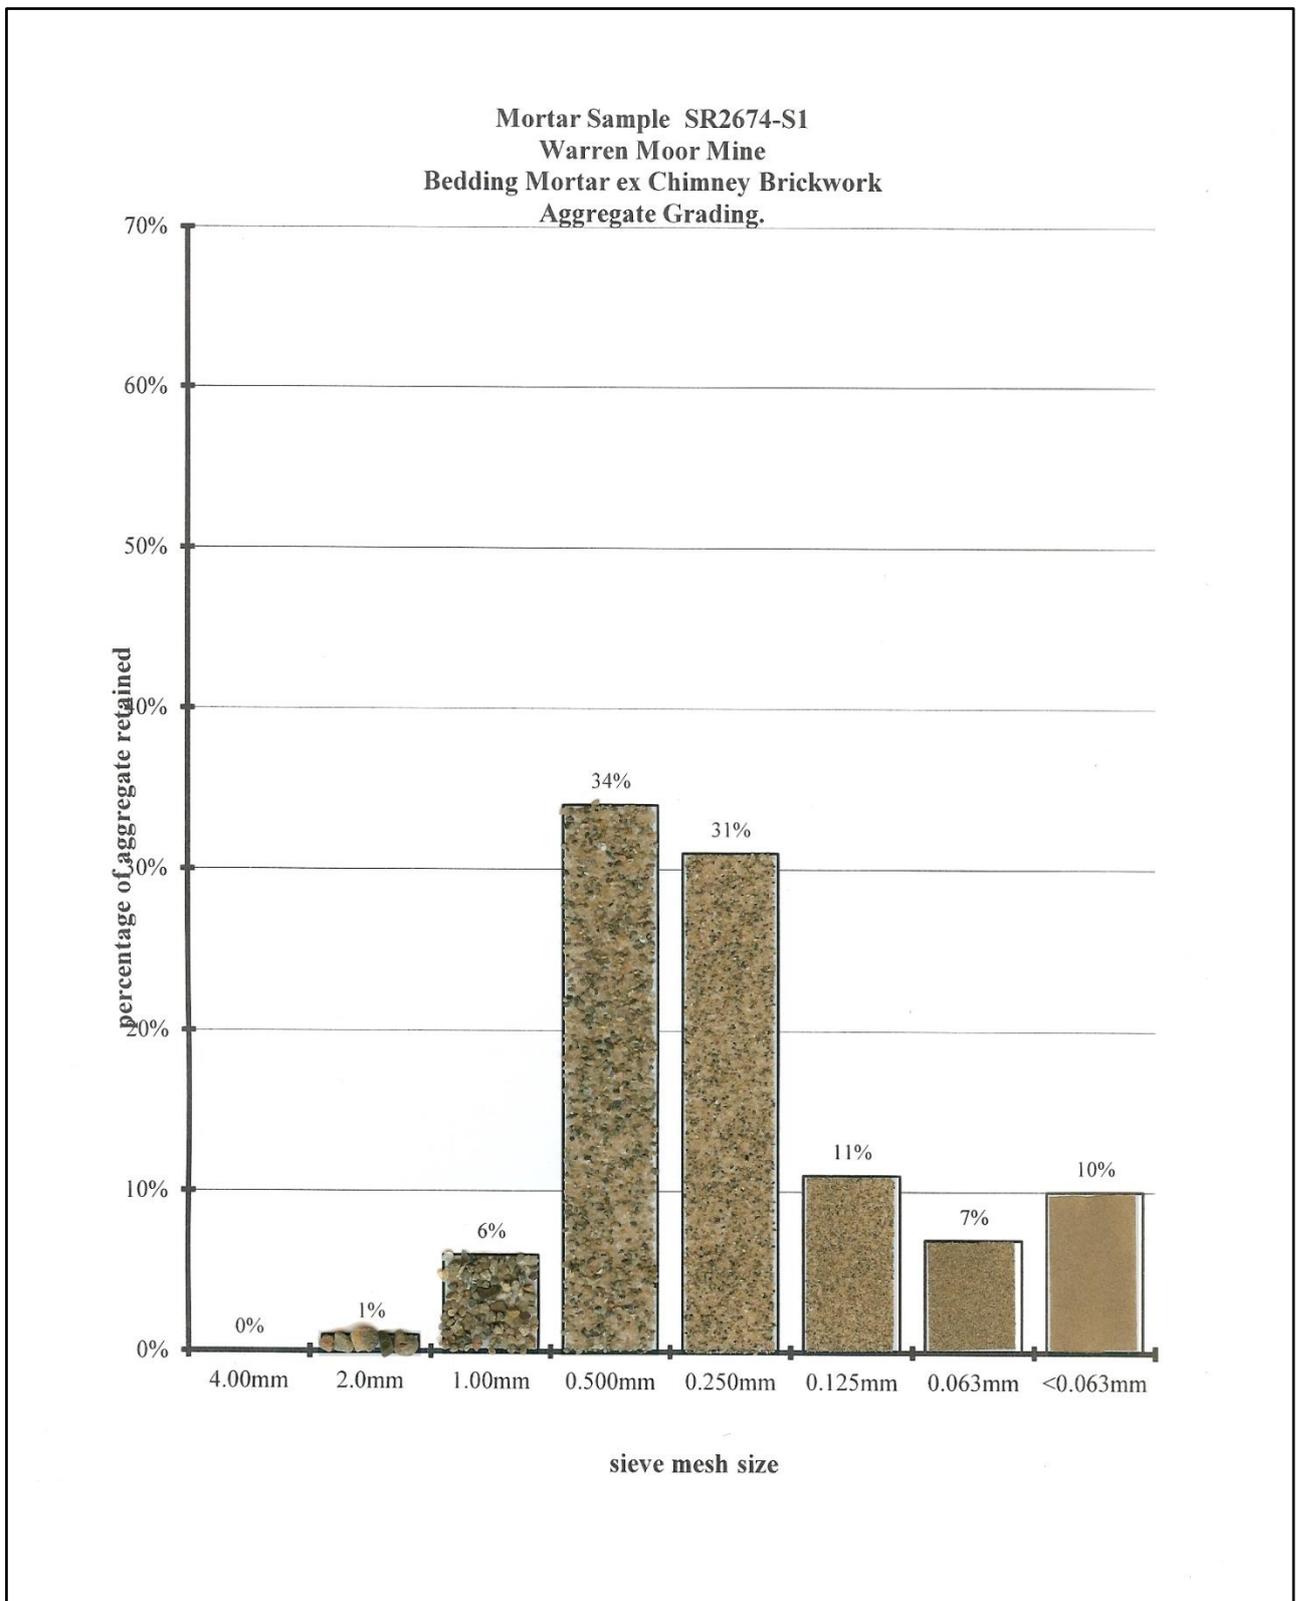
Figure No. 1: Aggregate Grading on Aggregate recovered from sample WM1.

The aggregates from the acid digestions were recovered and the particle size distribution determined, with the results obtained presented in table No. 1 below, and in the form of an aggregate filled histogram in Figure No. 1.

The aggregate in the mortar are dominated by quartz grains with minor chert, sandstone, silt and shale, along with other indeterminate lithic fragments, including a minor proportion of limestone. The grains are sub rounded with water worn surfaces, and they are likely to have been won from a local Glaciofluvial deposit. The high fines content, along with the clay minerals detected in the XRD analysis, would suggest that they had been used in the form of “as dug” aggregate, without washing.

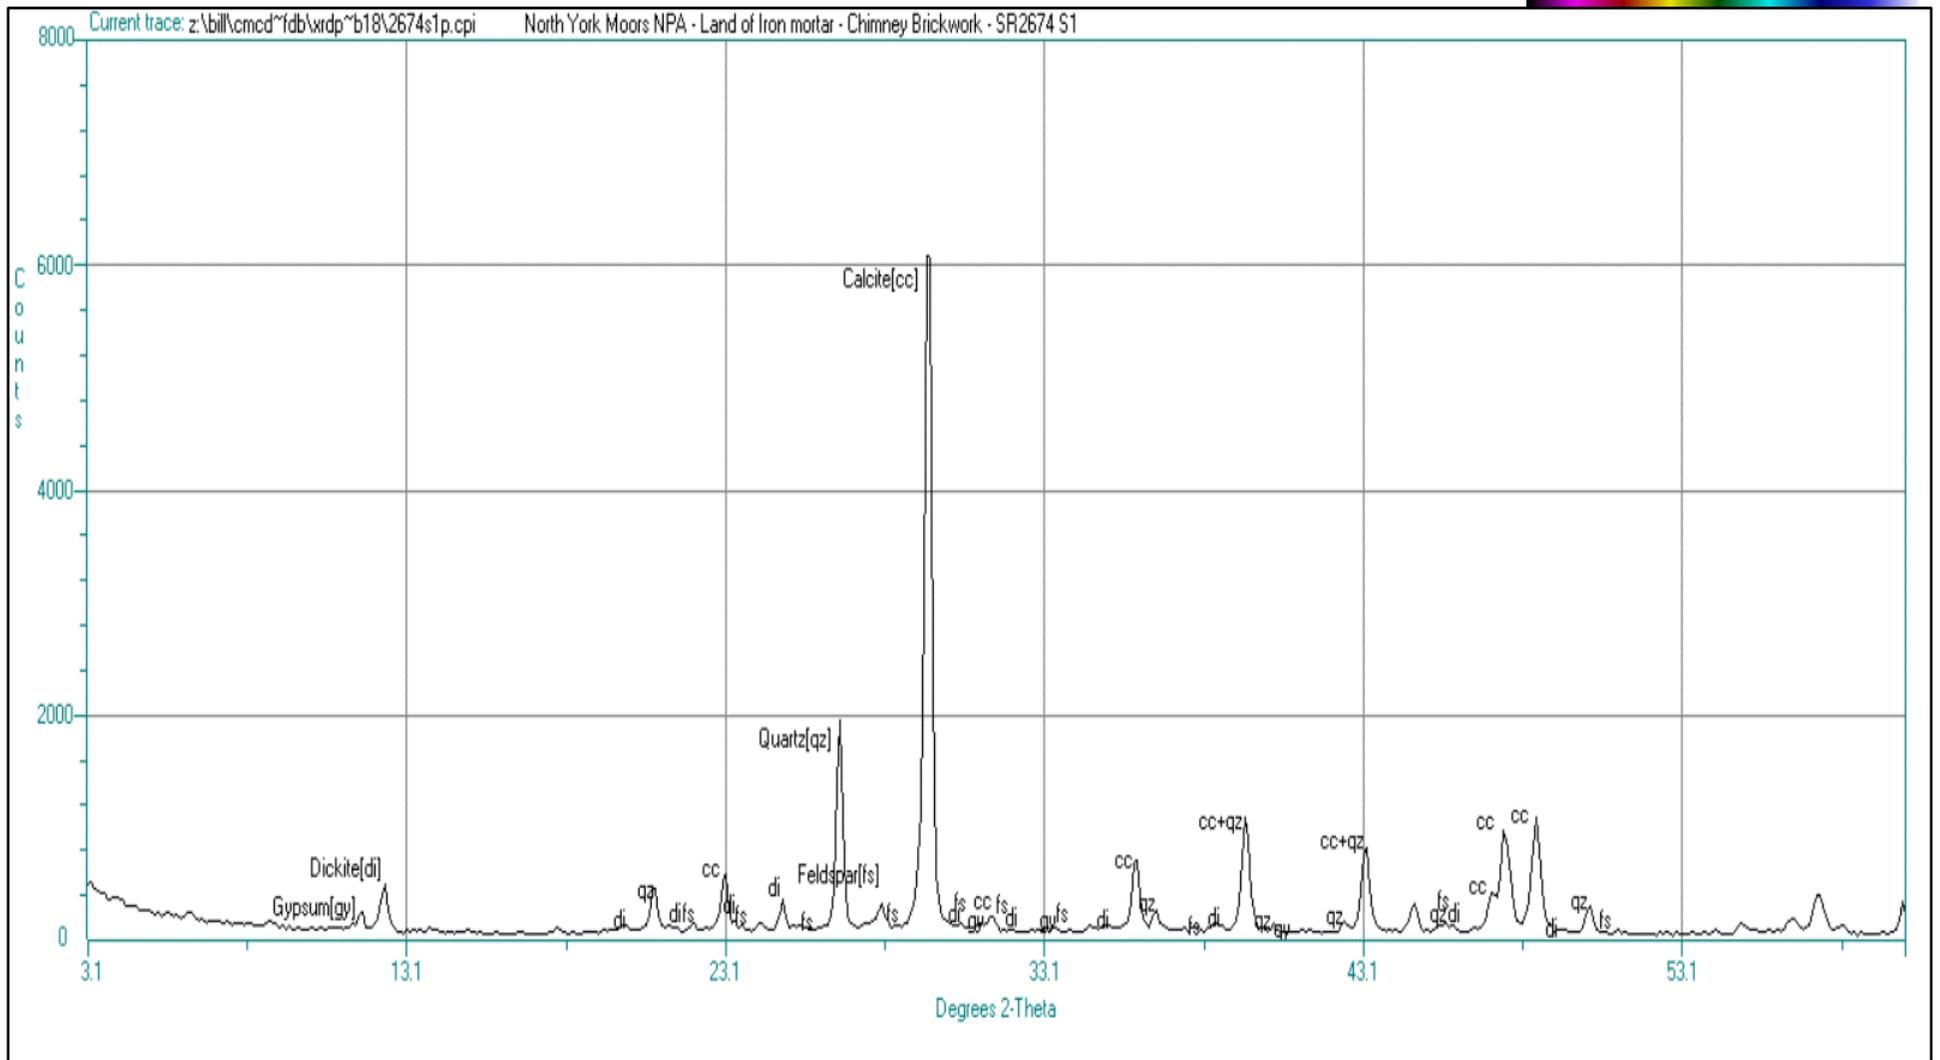
Figure No. 2: SR2674-S1 (WM1) Binder rich fines from mortar ex Chimney Brickwork Masonry,

- cc** = Calcite (CaCO₃) calcium carbonate, carbonated lime from lime binder and any limestone aggregate present in the mortar,
- qz** = Quartz (SiO₂) dominant component of the aggregate in the mortar.
- fs** = Feldspar, with Anorthite of the Plagioclase group being the dominant form detected, along with minor Sanidine, an Alkali Feldspar, also present in sample S2,
- mi** = Muscovite Mica, common layer lattice mineral, present as an aggregate component,
- di** = Dickite, Clay mineral of the Kaolinite group, present as an aggregate component, weathering product and soiling. Also, possibly a contaminant from associated masonry brickwork,
- gy** = Gypsum (CaSO₄2H₂O) Calcium Sulphate Hydrate, Sulphate reaction product, product from a reaction of environmental sulphates (Smoke, soot, acid rain, etc.) with lime in binder,

Based on the XRD analysis, and data it is indicated that the two samples were both made using a high Calcium air Lime with no hydraulic or pozzolanic components detected in the paste. The Quartz, Feldspar, Mica and Dickite are all present as aggregate components, albeit a proportion of the Dickite may be present as a contaminant, from the brick masonry, as a weathering product, or from accumulated soiling.
