Our Ref: M/1571/14/C1

## CERTIFICATE OF ANALYSIS AND EXAMINATION OF MASONRY SAND

Project Reference	:	York House
Sample Source	:	Plaster on Hard, from Stair
Sample Description	:	Clay/lime Plaster
Date Received	:	17 <sup>th</sup> December 2014
Sample Ref	:	SR2211 – S1
Date of Test	:	Various dates, 17 <sup>th</sup> December 2014 to March 2015.
Method of Test	:	Determination of mix composition by acid digestion, with further confirmation by modal analysis on a Petrographic thin section. XRD Analysis by an In-house procedure.

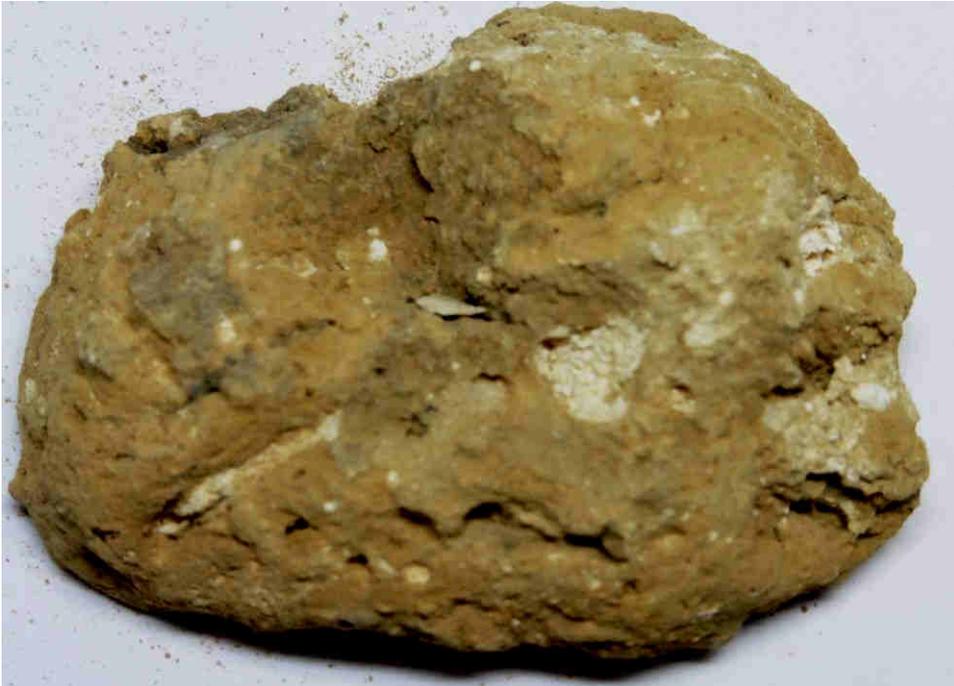
**Plate No. 1:** The above shows the outer surface of the sample as received, prior to drying. Note the high abundance of lime inclusions, the inclusions mostly have rounded margins and from the initial examination it is indicated that the lime was probably used in the form of a putty lime, width = 64mm.

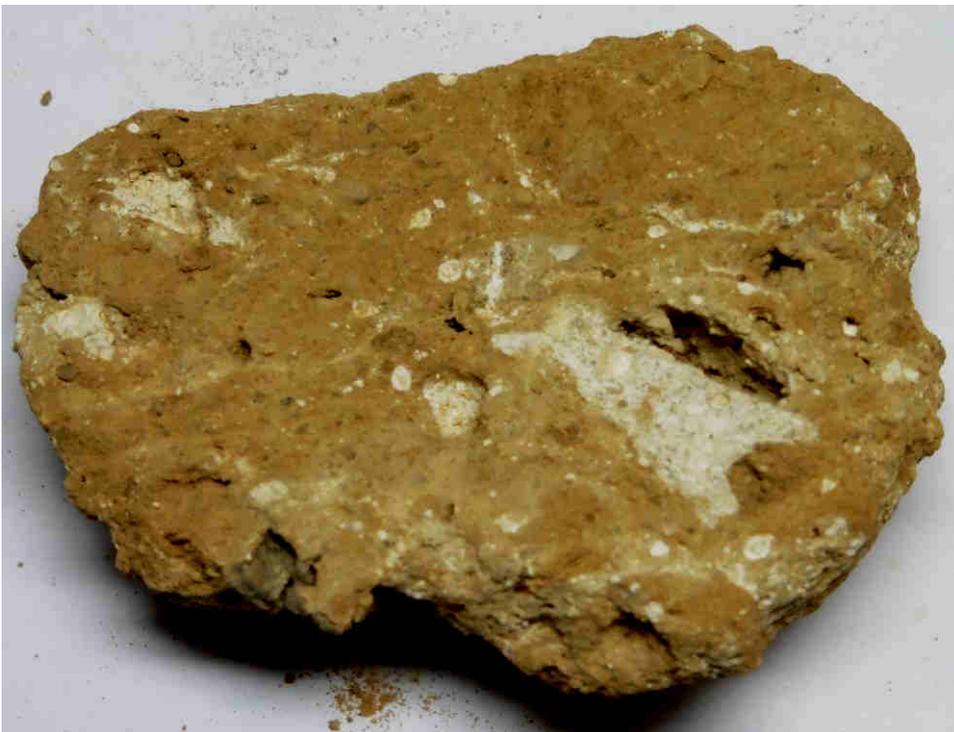
**Plate No. 2:** This shows the sawn surface through the plaster, from which a slice was removed for the preparation of a petrographic thin section. Note that the mortar is lime rich. Width of sample = 60mm.

The mortar is well compacted and firm, and required light to moderate finger pressure to break, but once disrupted the sample could be powdered with relative ease. The mortar was found to be fully carbonated and there was no evidence in the sample examined of the presence of any fibrous materials or other organic additives.

The mortar was composed mainly of clay with a proportion of sand grains dominated by quartz, along with feldspar, limestone and shell fragments. The binder used is lime and there was no evidence to suggest the presence of any other form of binder or pozzolana in the mix. The limestone fragments are from a bioclastic limestone, as was some of the limestone that was burnt to produce the lime used as the binder, see following plates. The bulk of the mix is dominated by clay minerals, which are below the resolution of the stereo-microscope.

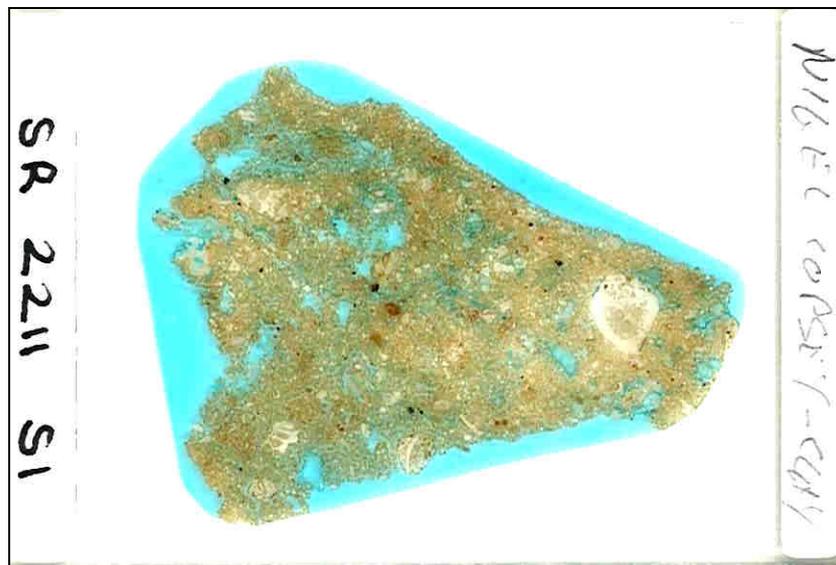
**Plate No. 3:** Image of thin section prepared from plaster sample. The blue colour is from the blue dye added to the impregnation resin in which the sample is embedded prior to cutting. The blue dye highlights the porosity in the mortar along with any voids, and cracks that may be present.

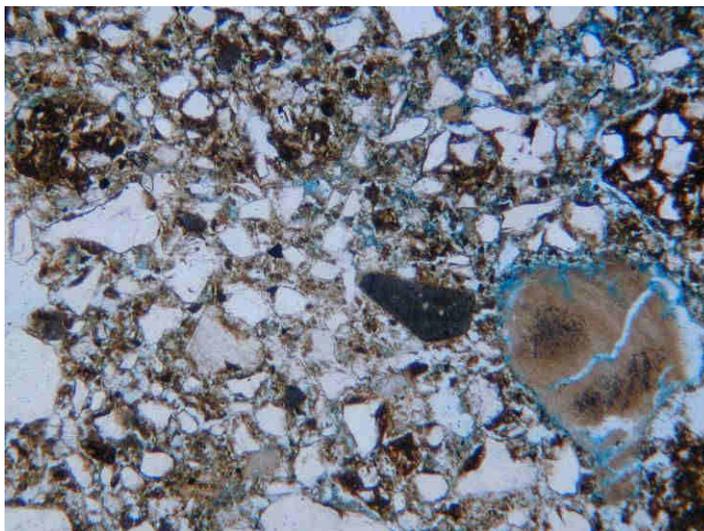
**Plate No. 4:**

Photomicrograph of the mortar fabric showing the general fabric.

The angular/sub-angular sand fragments are quartz grains. A partially hydrated lime inclusion can be seen on the right side of the plate, the inclusion is transacted by a crack.

The lower part of the plate is more porous and richer in lime than the upper part, which contains more clay and more dense.

Field of view 2.4mm in plane polarised light. Porosity is highlighted by blue dyed resin.

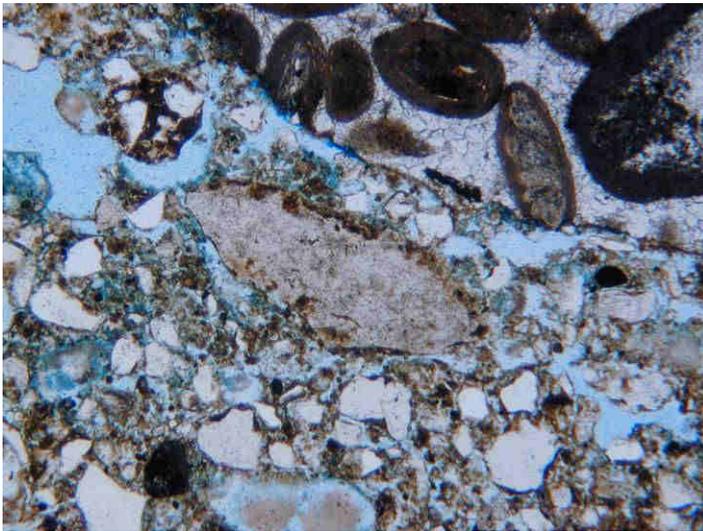
**Plate No. 5:**

In this view a bioclastic limestone fragment can be seen upper right, with a partially calcined limestone fragment in the centre and a fully hydrated lime putty inclusion at the lower edge, centre.

The mortar contains a large void in the upper left with an abundance of fine shrinkage cracks throughout the paste; this is contributing to the porosity in the mortar.

Field of view 2.4mm in plane polarised light. Porosity is highlighted by blue dyed resin.

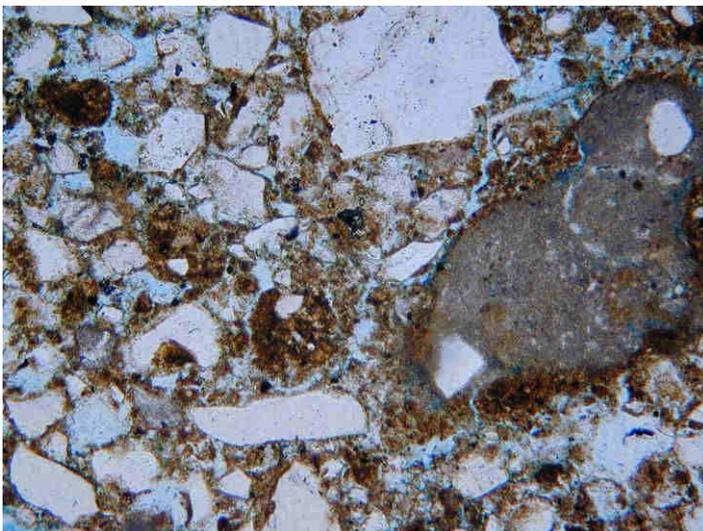
**Plate No. 6:**

The plate opposite shows another area within the mortar where a partially burnt limestone fragment can be seen in the right side of the plate, this retains the texture and structure of the original limestone.

Small clay nodules can be seen scattered throughout the mortar. Shrinkage cracks meandering through lime rich zones can also be seen, some have permitted fluid migration with leaching of binder, see centre of plate.

Field of view 1.6mm in plane polarised light. Porosity is highlighted by blue dyed resin.

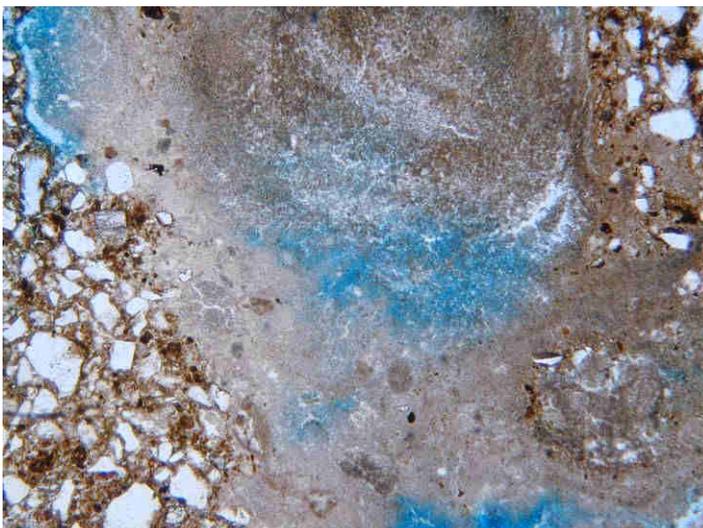
**Plate No. 7:**

This photomicrograph shows a large lime inclusion, where the lime has partially hydrated and is also diffusing into the body of the mortar, right side of plate.

The lower left is clay rich and contains an abundance of fine channel ways, some of which had transported lime rich fluids during mixing and placing.

Field of view 1.6mm in plane polarised light. Porosity is highlighted by blue dyed resin.

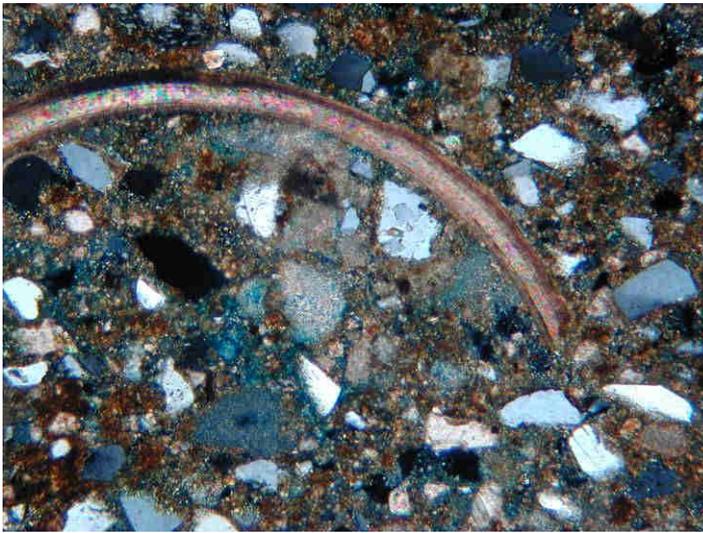
**Plate No. 8:**

This photomicrograph shows a shell fragment transecting the image, within a lime rich clay matrix, where the lime is finely diffused through the mortar.

The lime is fully carbonated and this is confirmed by the white speckling seen throughout the mortar in cross polarised light.

Field of view 2.4mm in cross polarised light.  
Porosity is highlighted by blue dyed resin.

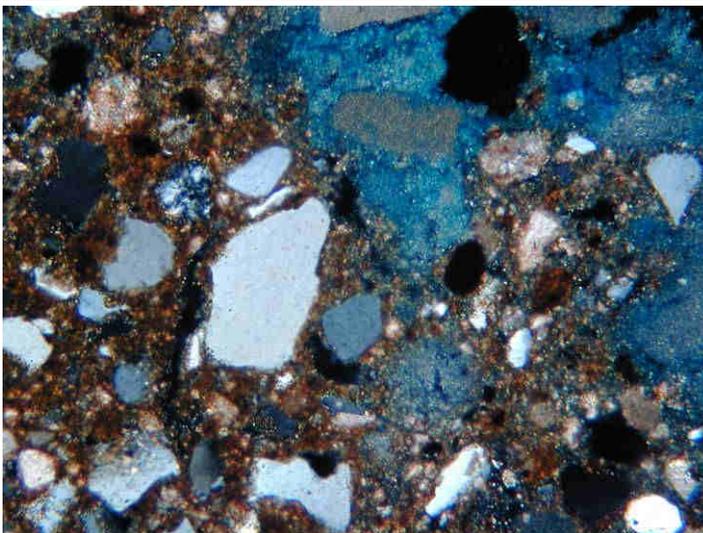
**Plate No. 9:**

A photomicrograph in cross polarised light of an area where a lime putty inclusion (right side of plate) is partially mixed into the adjacent clay rich fabric, left side of plate.

The majority of the sand grains in view (white and grey) are of quartz.

Field of view 1.6mm in cross polarised light.  
Porosity is highlighted by blue dyed resin.

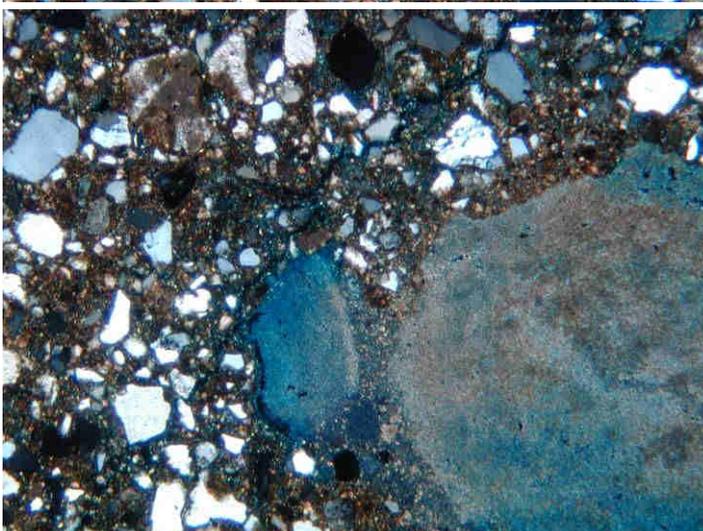
**Plate No. 10:**

A large intact lime inclusion can be seen in the lower right with a small separate inclusion in the lower centre.

The lime is carbonated and neither inclusion retains any rock fabric texture. The margins are distorted by the surrounding clay and sand grains, which in addition to their texture confirm that they were formed from putty rather than quicklime.

Field of view 2.4mm in cross polarised light.  
Porosity is highlighted by blue dyed resin.

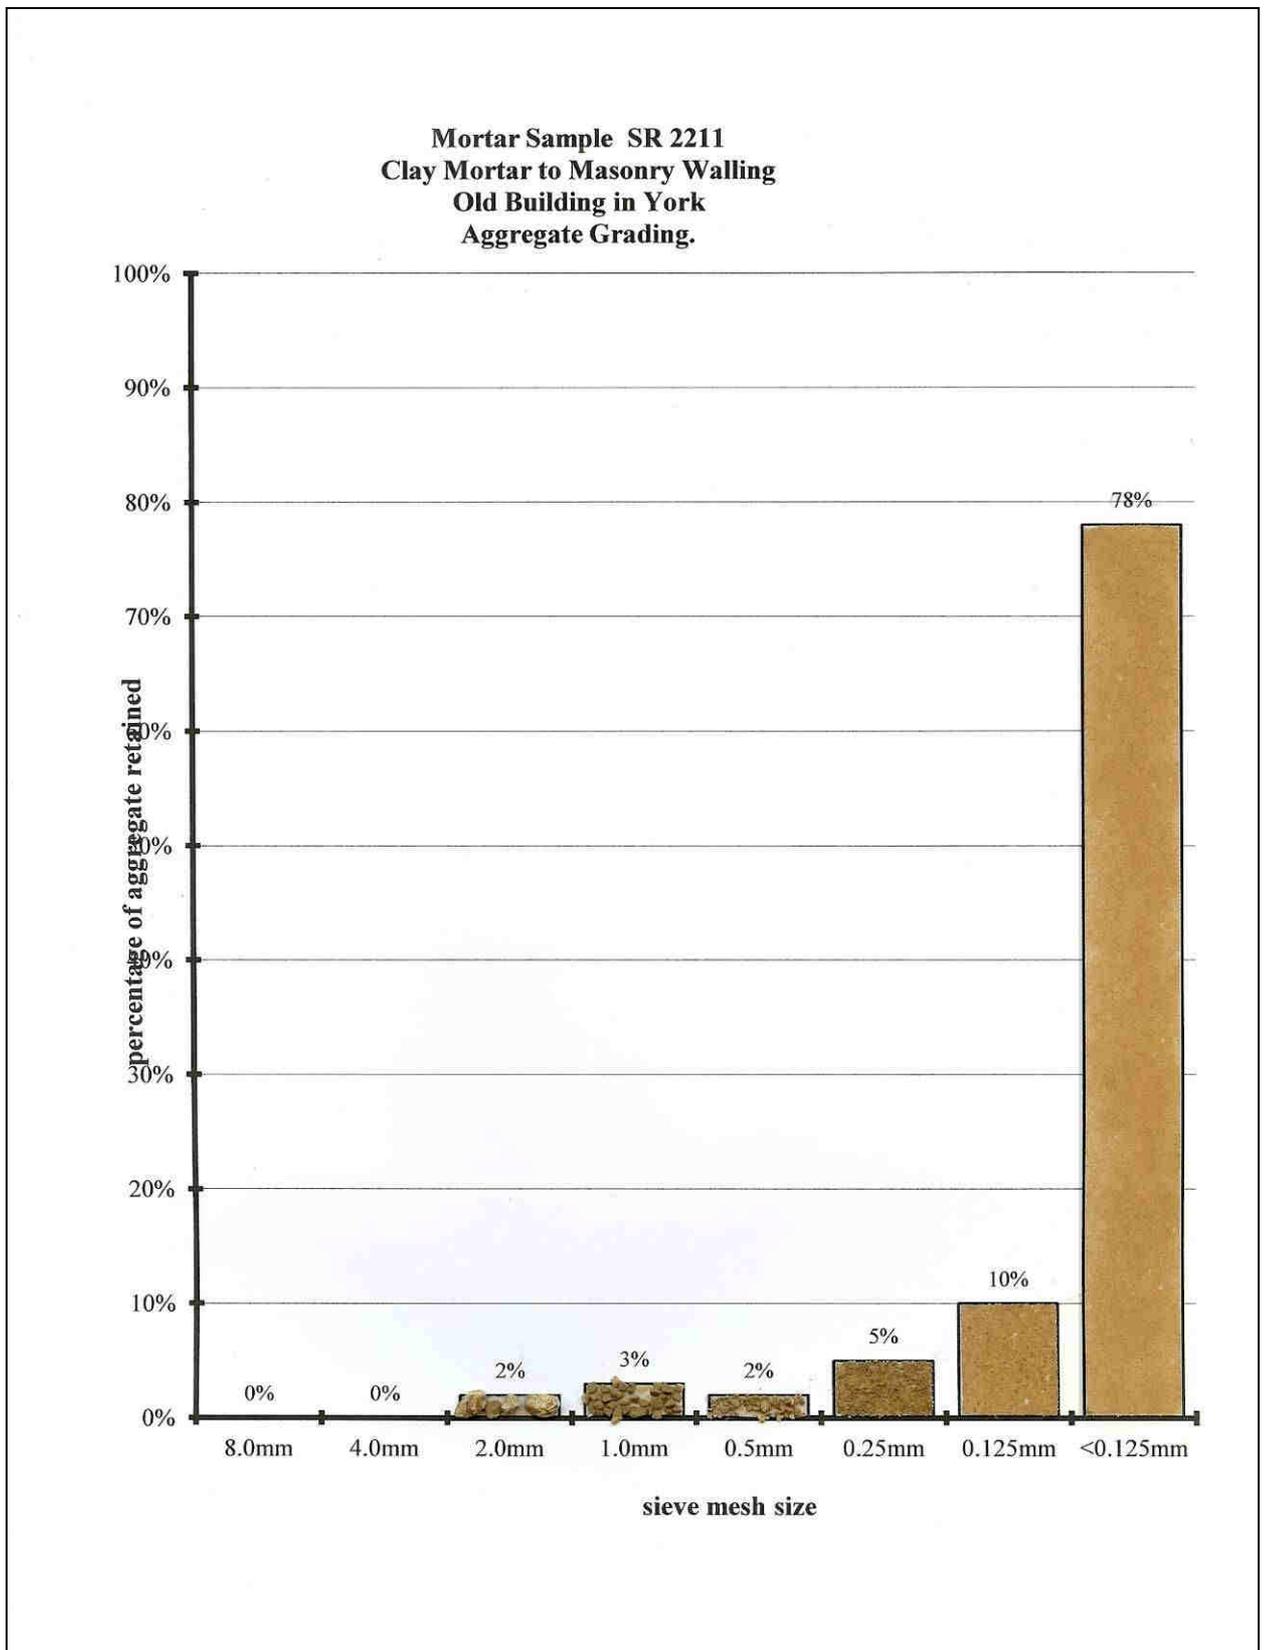
The aggregates recovered from the acid digestion were graded through a nest of British Standard sieves with the following particle size distribution obtained; see the table below and the aggregate filled histogram presented in Figure No. 1.

**Figure No. 1:** Grading of Aggregate & Clay recovered from Plaster sample.

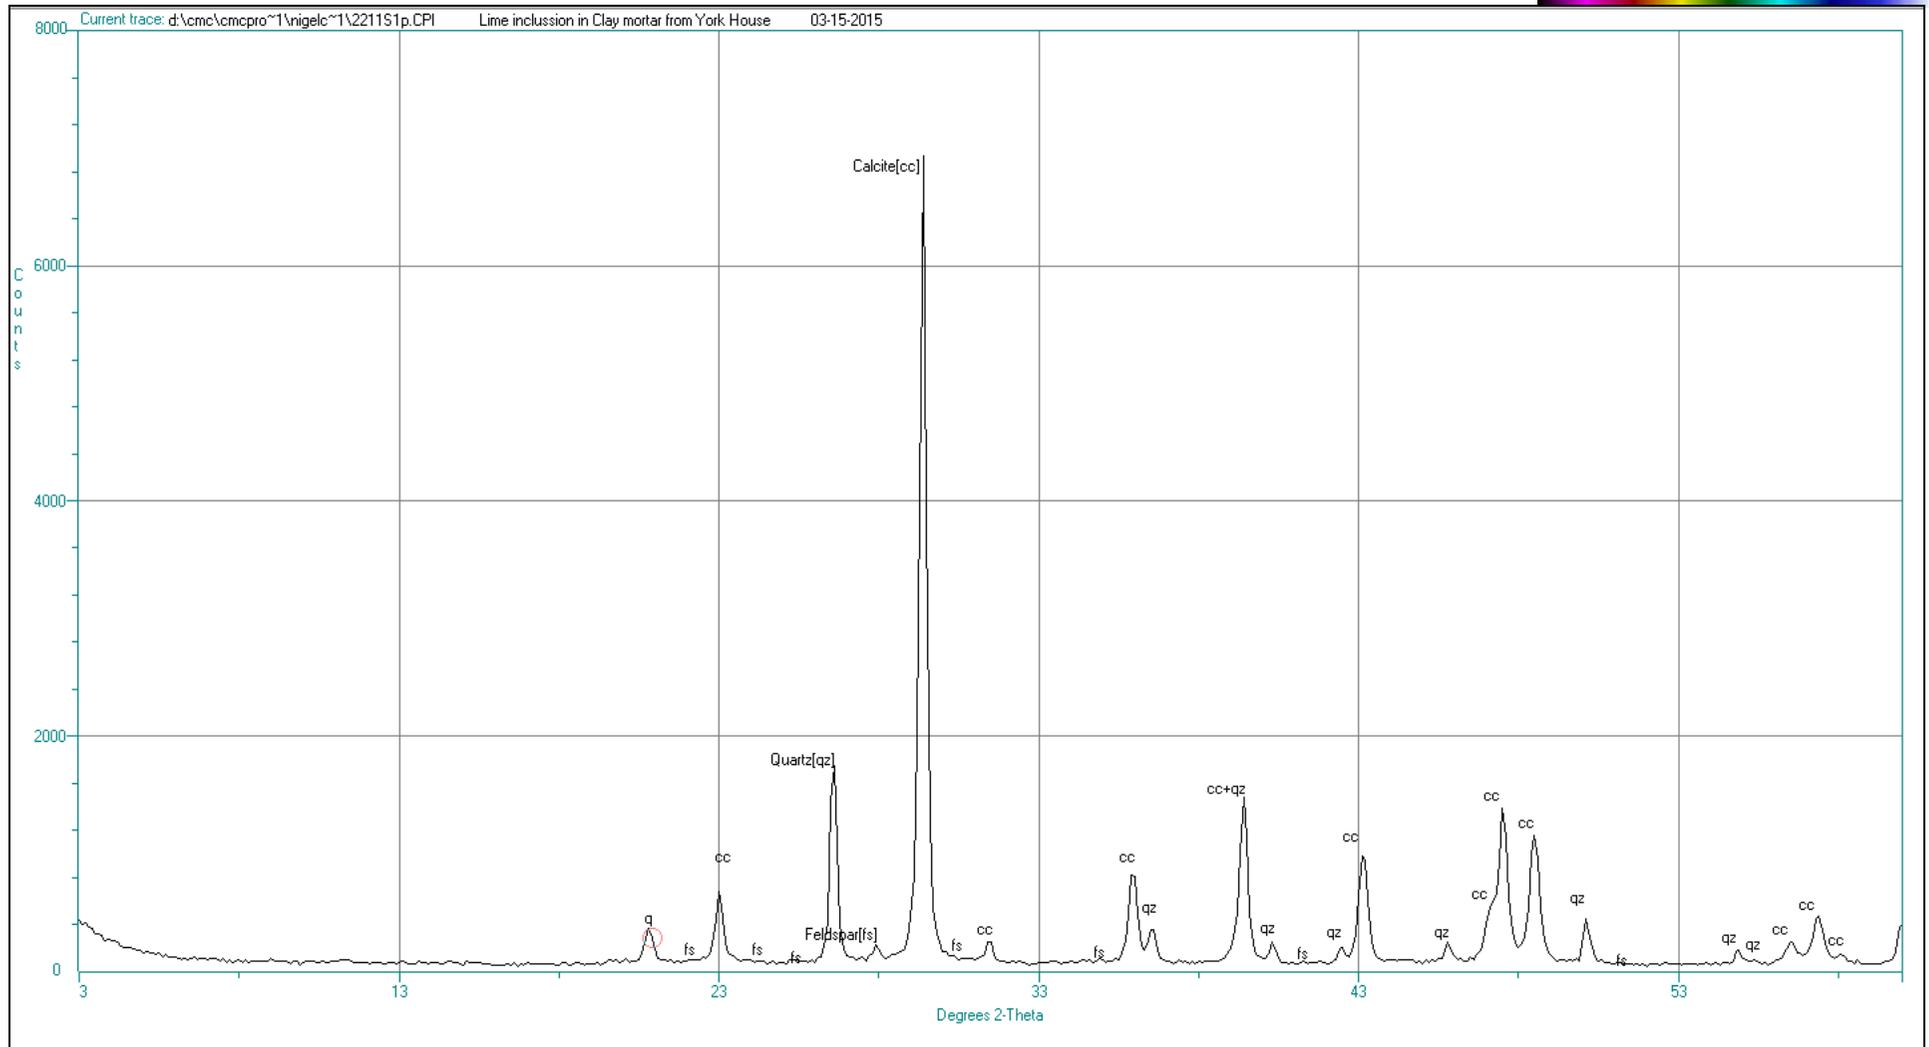
**Figure No. 2** – Sample SR2211 – Plaster on the Hard from the Stair at York House.

- cc** = Calcium carbonate (CaCO<sub>3</sub>), carbonated lime, major component of the lime binder,
- qz** = Quartz (SiO<sub>2</sub>), component of clay, possible contaminant from the mortar,
- fs** = Feldspar, various forms present but dominated by Albite and Anorthite, both of the Plagioclase group, natural mineral component commonly found in sands and clays.

On the basis of the XRD analysis it is indicated from the mineralogy of the lime, which is predominantly of calcium carbonate, that the lime was a non hydraulic high calcium lime at the point of use.
