## Construction Materials Consultants Ltd.

# Report on the Examination and Analysis of Samples from 15<sup>th</sup> & 19<sup>th</sup> Century Mortars

## *York Minster, York*

Our Ref: M/1894/18  
Your Ref: York Minster Mortars  
Doc. Ref: M189418R1-rev 1

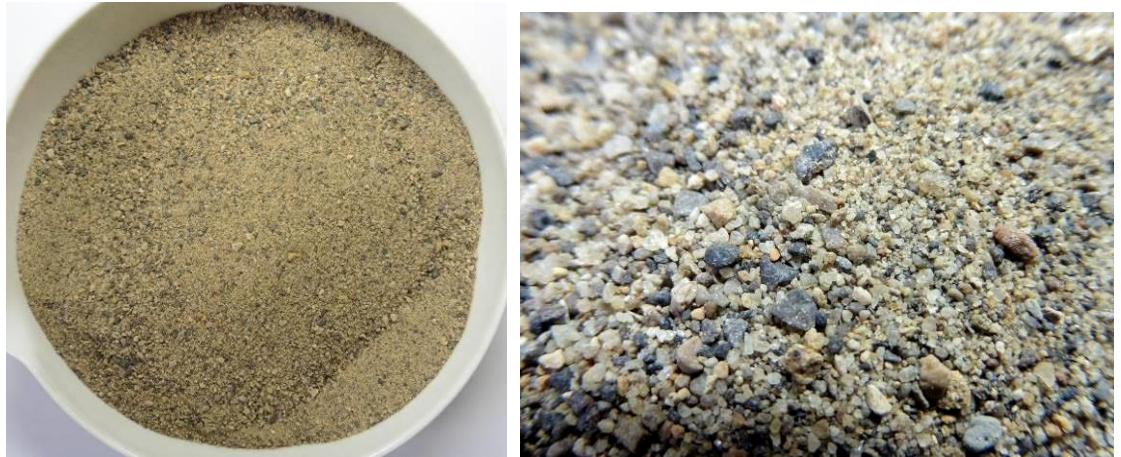
**Plates No. 1 & 2:** The above left plate shows the sample as received, with the right plate showing a close-up of the sand grains.

The aggregates are dominated by quartz and appear to have a maximum grain size of 3.4mm but mostly finer than 1.0mm and with a low fines content <0.063mm, suggesting a river or dredged source, or a washed sand. The sand contains a mixed suite of minerals dominated by quartz with lithic fragments, including limestone, quartzite and indeterminate igneous rock types. The colour<sup>1</sup> of the sand, was found to be close to 2.5Y 6/2 “Light Brownish Grey”.

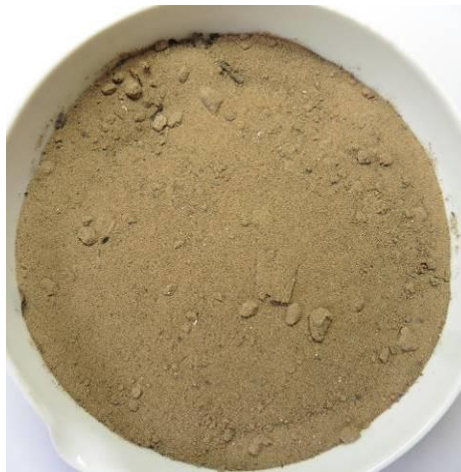
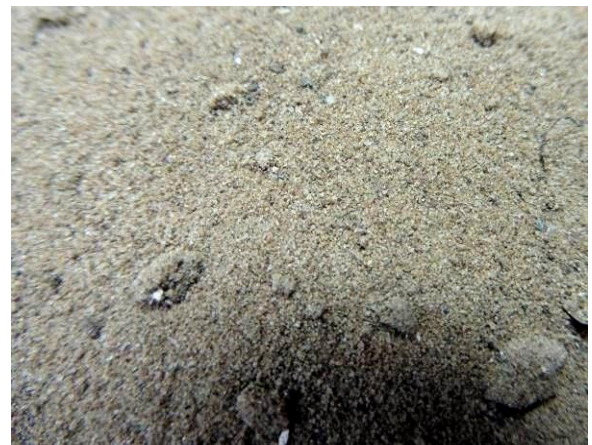
**Plates No. 3 & 4:** The left plate shows the sample as received, note the very fine grain size compared to sample S1. The right plate shows a close-up of the sand grains, same magnification as in plate No. 2 above.

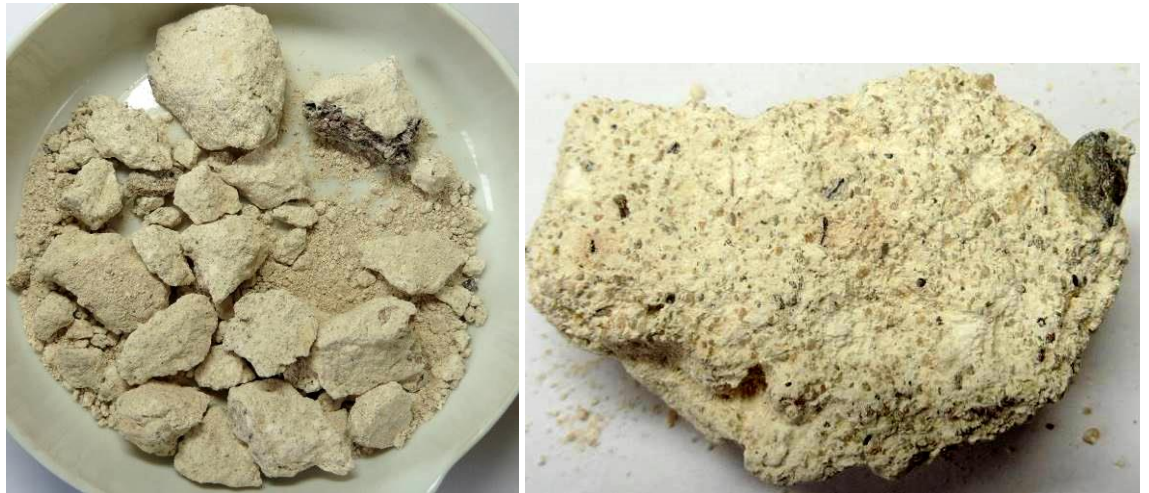
**Plates No. 5 & 6:** The left plate shows the condition of the sample as received, with the right plate showing an image of one of the larger fragments, in which it can be seen that there is an abundance of small lime inclusions distributed throughout the fabric

The sample pieces appear to be from a well compacted lime mortar containing an abundance of lime inclusions which on measurement were found to range up to 5.8mm in size. The inclusions are angular to sub-angular in shape and can be probed with a point pick suggesting that they are mostly from a well calcined limestone. The mortar is variable in hardness ranging from soft and finger friable to firm and hard requiring persistent firm finger pressure to break and powder.

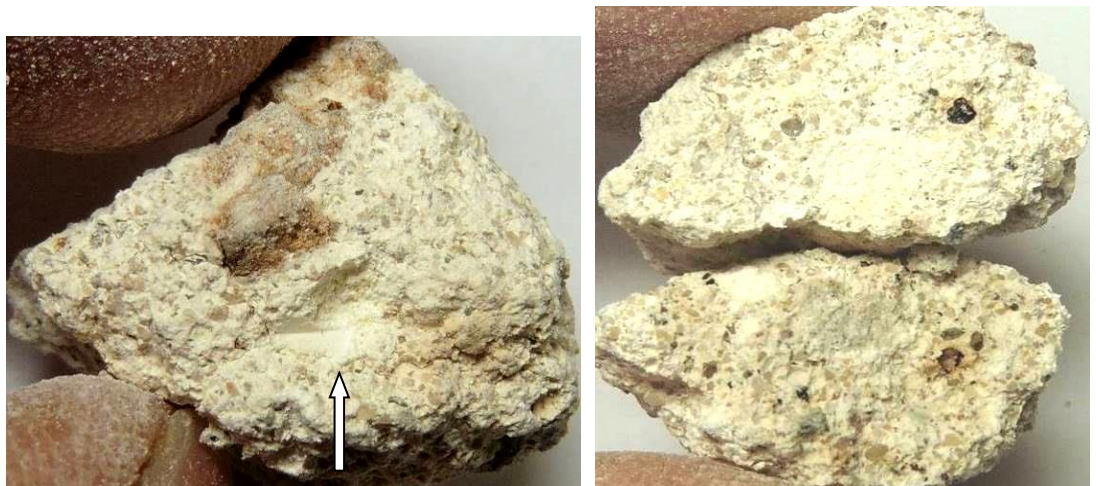
**Plates No. 7 & 8:** The left plate shows a magnified view of a freshly fractured surface through one fragment, where an angular lime inclusion can clearly be seen, arrowed in plate. The right plate shows another fractured fragment, after testing the lower piece with a phenolphthalein indicator solution. Where no colour change is observed, this is usually taken to confirm that the mortar is fully carbonated.

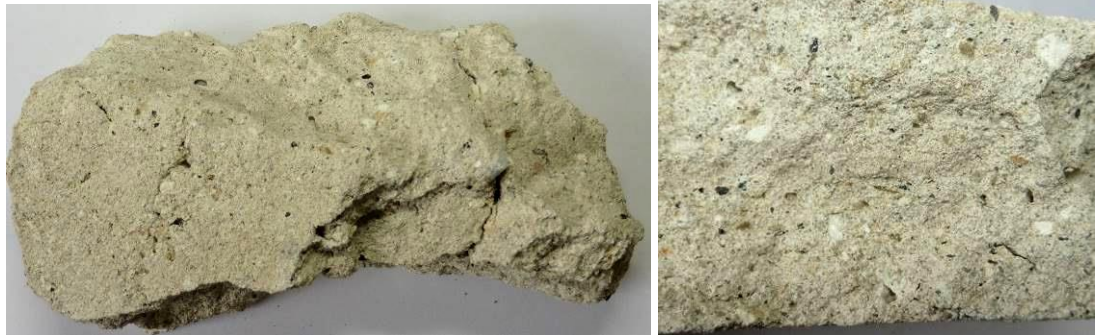
**Plates No. 9 & 10:** The left plate shows the intact piece forming the sample, as received. With the right plate showing a close-up of a freshly fractured surface through the mortar fragment. Note the abundance of small lime inclusions distributed throughout the area in view.

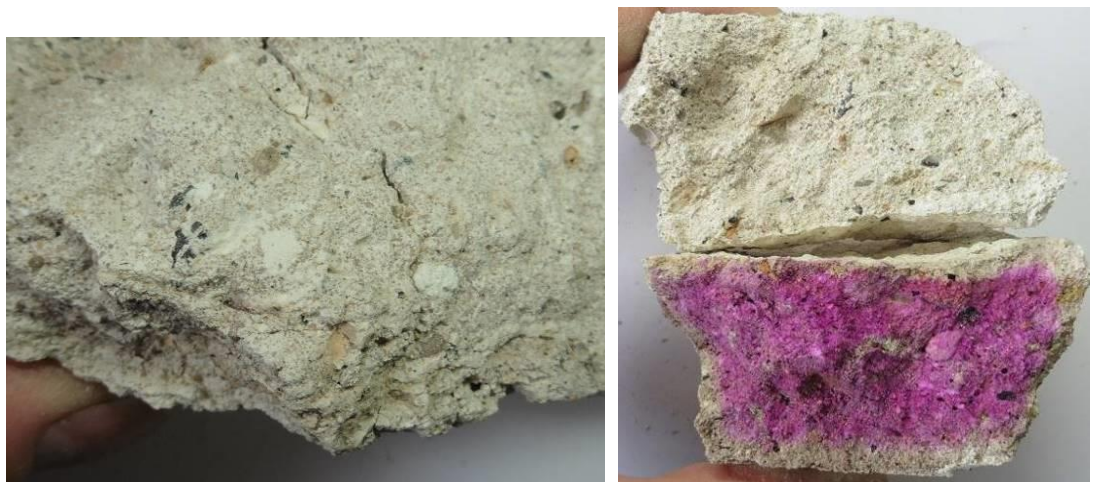
**Plates No. 11 & 12:** Small sub-round lime inclusions can be seen within the fabric of the mortar in the left plate. The right plate shows a freshly fractured surface on which a phenolphthalein indicator solution had been applied, lower piece. Note the deep fuchsia colour over most of the sample, inferring that the mortar had not carbonated, except at its outer surfaces.

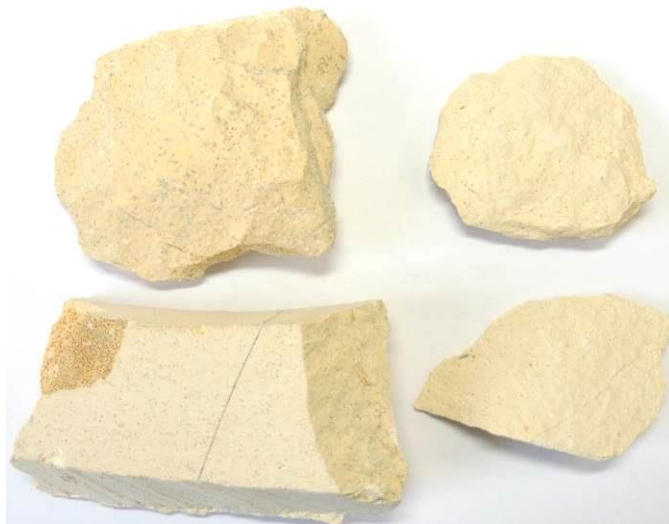
**Plate No. 13:**

The plate on the left shows the condition of the sample of Highmoor Limestone as received.

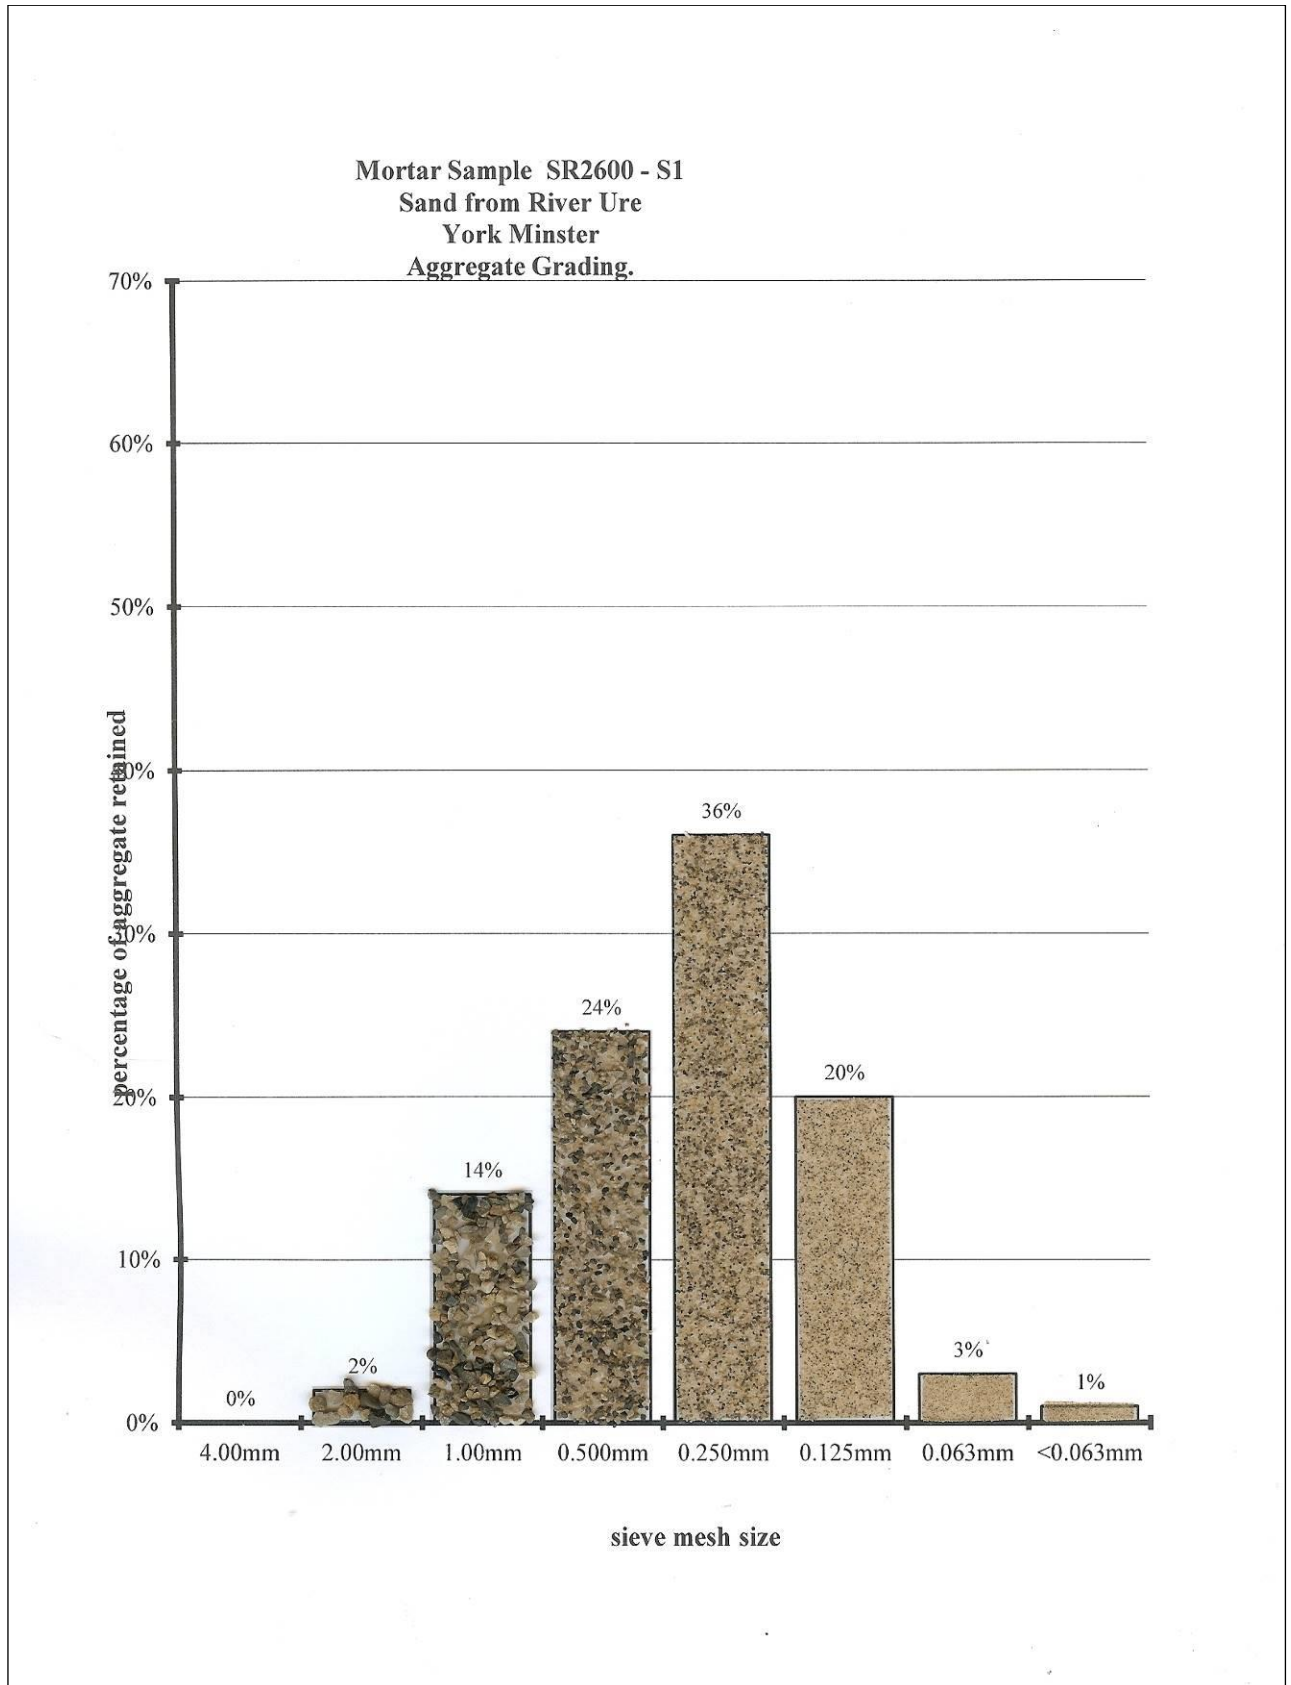
**Figure No. 1:** Grading of Aggregate from River Ure SR2600-S1

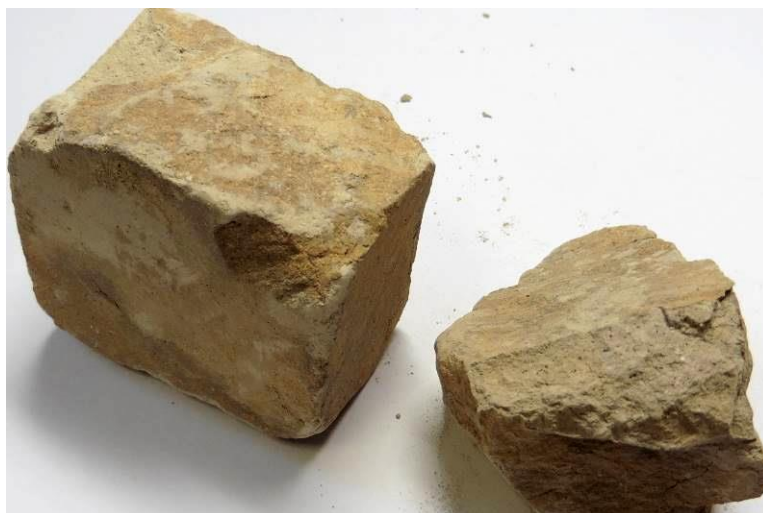
#### Plate No. A1:

This sample consisted of two pieces of a well burnt limestone.

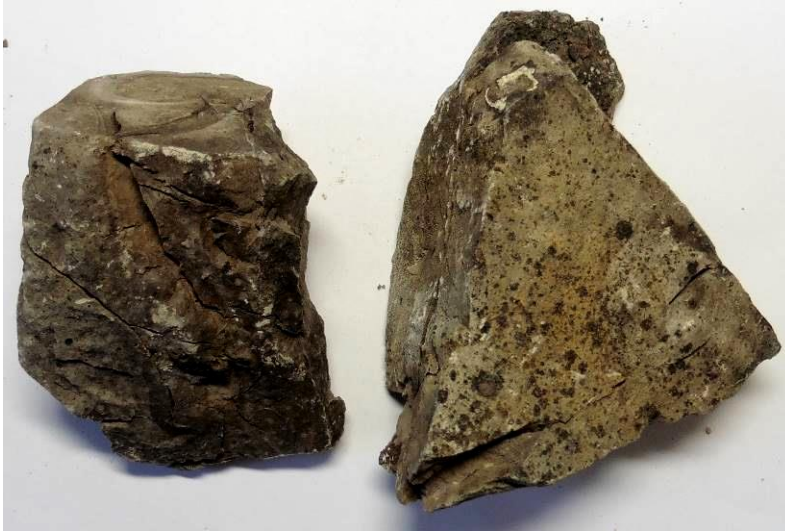
**Plate No. A2:**

This sample consisted of two pieces of an overburnt limestone.

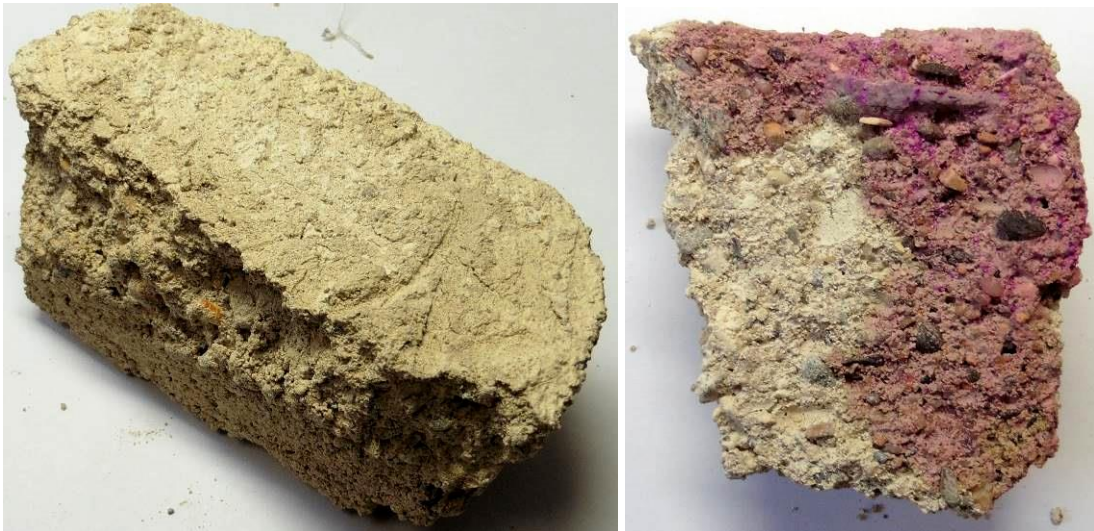
**Plates No. A3 & A4:** The left plate shows the sample as received, with the right plate a freshly fractured surface treated with a phenolphthalein indicator solution showing that the mortar was uncarbonated.

The mortar was well compacted and moderately firm requiring firm finger pressure to break and disaggregate a piece sawn from the lump. It was advised that the sample was approximately 50 days old at date of test (cast on or around the 17<sup>th</sup> May 2018).
