Mud Mortars in Masonry Construction – Malton, North Yorkshire

**Nigel Copsey, stonemason and building conservator , www.nigelcopsey.com
Ben Gourley, mud mason; researcher and field officer, University of York;
Richard Allen, research technician, University of York.**

This paper deals with the historic use of earth mortars in masonry construction and the appropriate conservation and repair of buildings in which these were common. It will examine their extensive use in Malton, North Yorkshire, where earth mortars were the material of choice for stonemasons and plasterers until the middle of the 18thC; as commonly in high status as lower status buildings. It will be demonstrated that earth mortars in masonry construction were very much more common and are much more widespread in the UK (and doubtless elsewhere) than has been generally understood or acknowledged and that this raises serious issues for the investigation and compatible, authentic conservation and repair of these buildings. The primary case study will be York House in Malton, a late C15 H-plan house of high status with subsequent significant alteration as a gentry house in both 1620 and 1694. This will be illustrated by

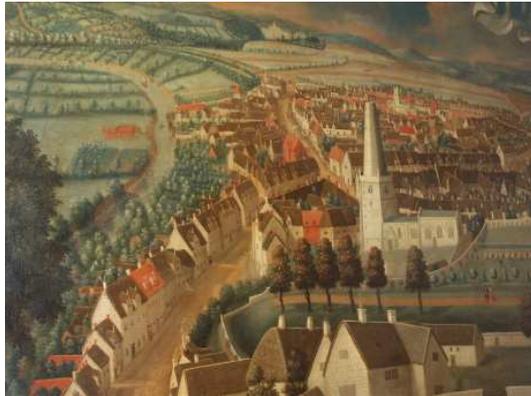
Figure 1: Malton in 1728. Almost all of the buildings shown will have been built using earth mortars. Most remain. All materials sourced or manufactured just without the boundaries of the town. Note thatched roofs, brick and tile works to left of picture. Vanbrugh and Hawksmoor's Castle Howard in distance.

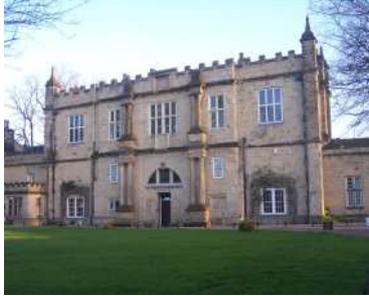
Figure 2: subsequently extended 1604 gatehouse of Eure mansion, Malton, constructed using calcareous sandstone, earth mortars and plasters

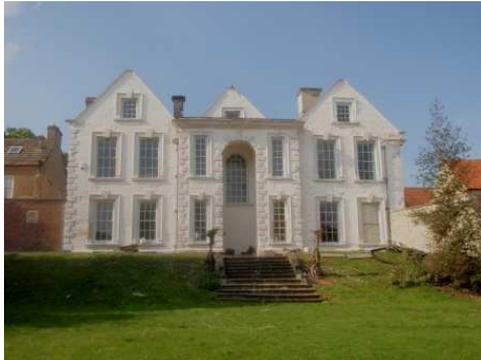
Figure 3: S elevation, York House, Malton. Central range and windows introduced around 1690, using earth and 5% quicklime mortars and hay-rich earth plasters with limestone dust, quicklime and oxhair finish coats over.

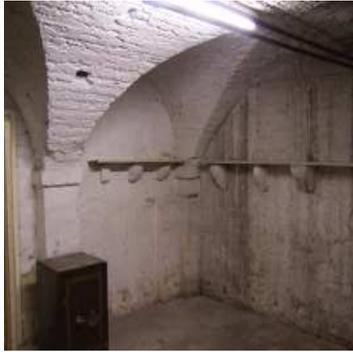
Figures 6 & 7: cross vault with earth mortared walls and lime mortared vault; 12thC ribbed vault with lime mortared ribs and earth mortared fill illustrating informed and deliberate mortar selections by stonemasons

from pits around the town or else during the excavation of the overburden on site. Within these undercrofts, the mortar of the walls is earth; that of the segmental vaults above, lime mortar the aggregate of which is limestone, with no added siliceous material.

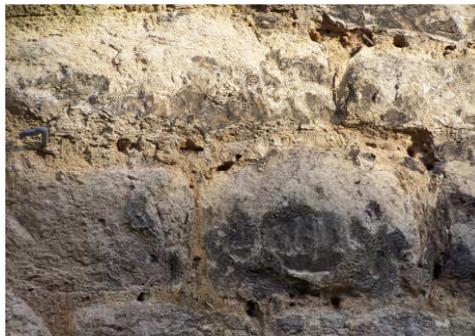
Figure 10 mud-mortared limestone, Malton

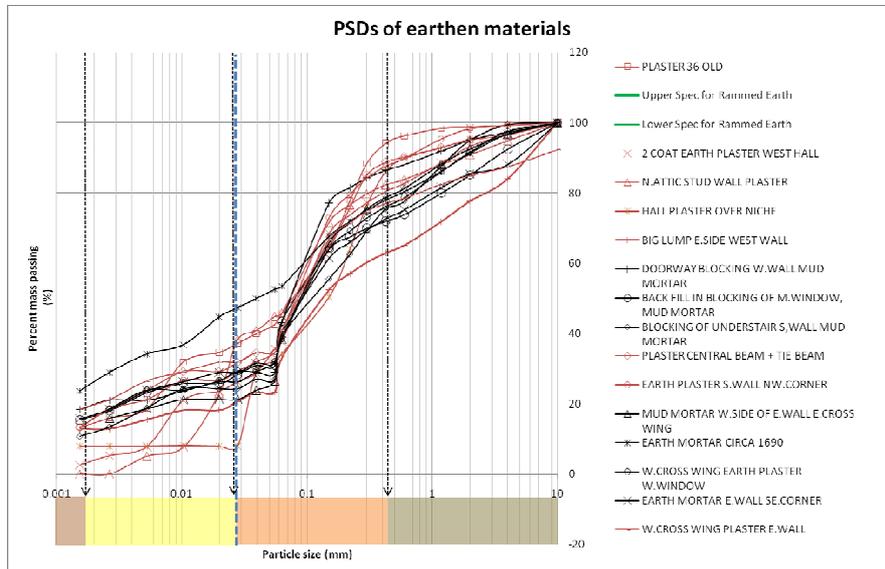
Figure 9 particle size distribution, sample mortars from York House and Malton. (Allen)

It is clear from the particle distributions in the 15 samples studied (see graph below), that there is considerable variation in aggregate size groupings and in geological make-up. In all 15 samples the largest proportion of aggregates falls within the 63 to 15 micron group. Therefore 'fines' predominate in all samples and proportionally decrease toward the larger end.

There are, however, two main categories which likely reflect mortars and plasters (correlation still to be confirmed). The two groups comprise 1) Samples with higher proportions of coarse aggregate of predominantly of limestone or chalk 2) Samples which tend toward the fine end of the spectrum, mostly of silicate or degraded lime fine sands. In both groups samples appear to reflect natural soils rather than intentionally modified building soils. We consider, therefore, that the two groups reflect two different broad sources. It seems likely, given the location of the building in an alluvial valley that cuts through glacial boulder clay (overlying calcareous jurassic hard geology), that building earths were sourced from river sediments, and from boulder clay upland from the river. Further analysis may confirm that the finer of the two groups was sourced in the river valley, while the coarser group represents boulder clay sourcing.

The samples are heavy in clays and silts. All 15 contain between 50 and 60 percent clays and silts, clay representing typically 20 percent. Notably, modern
