Report on the Examination and Analysis of a Selection of Mortar Samples

*Rudge Memorial Chapel, Lincoln
Nebraska, USA*

Our Ref: M/2014/19
Your Ref: Rudge Memorial Chapel
Doc. Ref: M201419R1-rev1

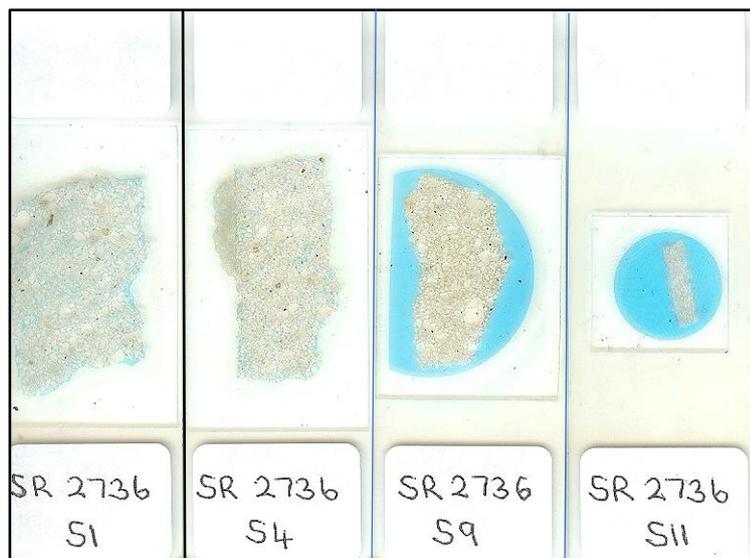
Plate No. 13: Thin sections prepared from mortar samples S1, S4, S9 and limestone fragment S11.

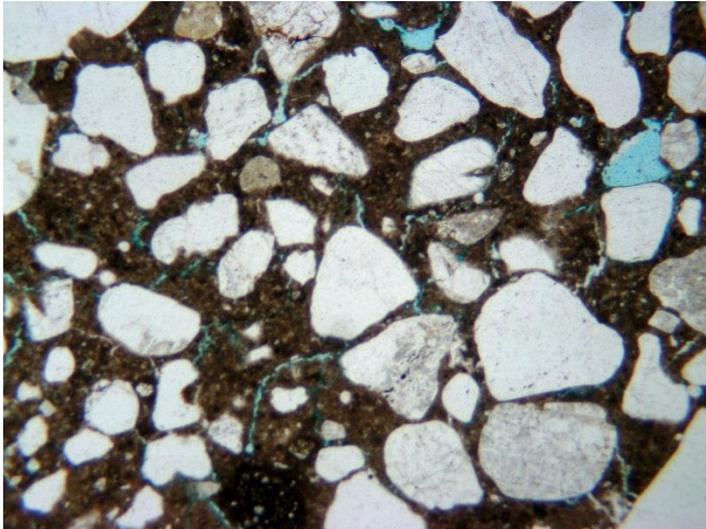
Plate No. 14:

A view in plane polarised light (ppl), of a typical area of the mortar where the fabric is consistent across the whole sample. It is well compacted and uniform throughout. Local entrapped air voids can be seen along with an abundance of fine shrinkage cracks, both highlighted by the blue impregnation resin. Most of the sand grains in view are quartz (white in section), with feldspar and minor igneous grains and also apparent.

Porosity is highlighted by the blue dyed resin.

Field of view 2.4mm.

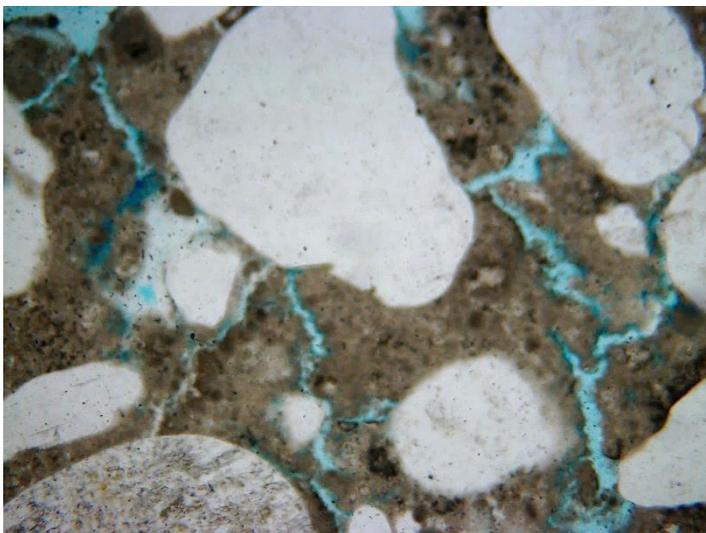
Plate No. 15:

Another view in ppl, of an area of paste containing small balled lime inclusions, centre right and lower centre left. These show a clotted or granular appearance, typical in hydrate mixes. The aggregates in view are again dominated by quartz, with minor feldspar. Cracks are abundant and those in the right side of the plate locally contain thin rims of redeposited calcite.

Porosity is highlighted by the blue dyed resin.

Field of view 1.2mm.

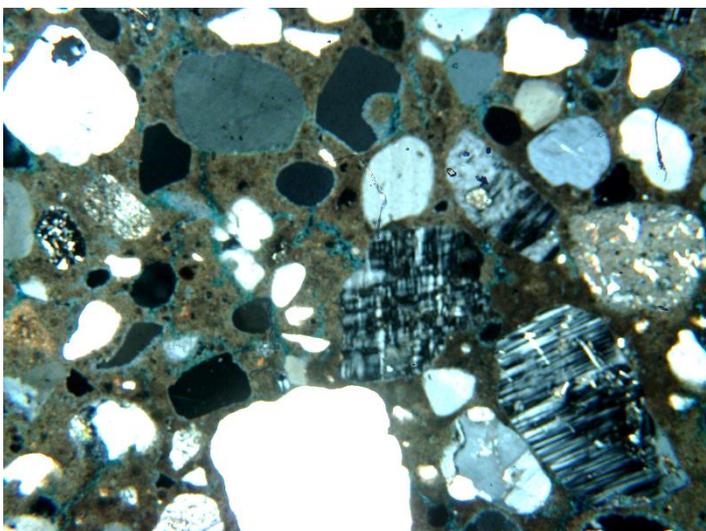
Plate No. 16:

A view in cross polarised light (xpl) of an area of the mortar. Although the paste is dense and well compacted there are a concentration of small voids in the upper centre, extending down to lower left, black in plate. Minor shrinkage cracks are also apparent. The paste is fully carbonated and most of the voids in view are rimmed with redeposited calcite (light fringes). Aggregate grains are again dominated by quartz, with an abundance of feldspar and minor igneous fragments present.

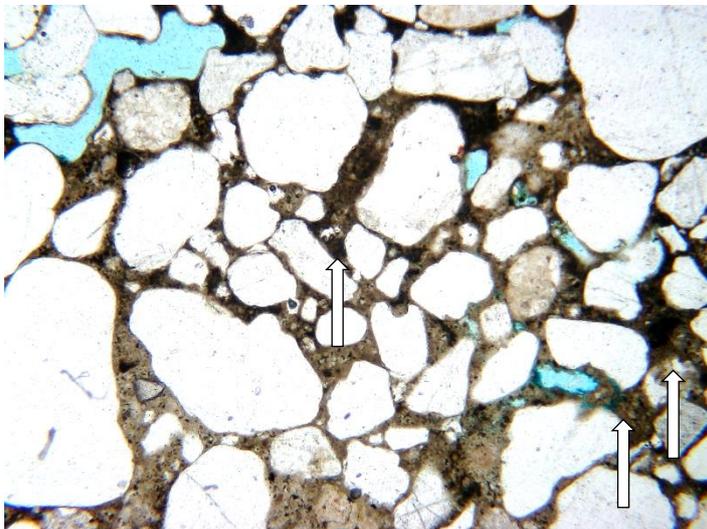
Plate No. 17:

A view in plane polarised light (ppl). This shows a typical area of the mortar, at a transition zone, with the paste in the lower half of the plate carbonated, whilst that in the upper part is not fully carbonated.

Porosity is highlighted by the blue dyed resin.

Field of view 2.4mm.

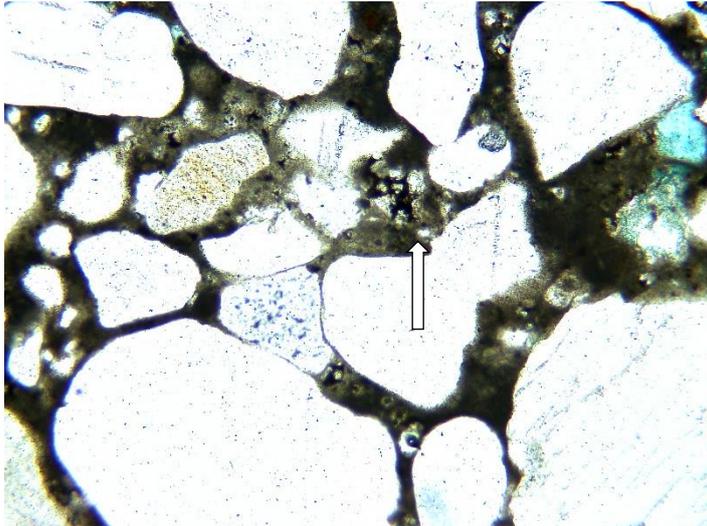
Plate No. 18:

A magnified view of a binder rich area of the mortar. Here the paste appears darker as it is predominantly uncarbonated, with invasive carbonation in the upper left. A coarse clinker particle can be seen in the centre of the plate, arrowed, this is composed of Alite and Belite, in a Ferrite groundmass. There are an abundance of smaller clinker grains and partially hydrated clinker in this view, indicating a relatively high binder content. Aggregates are again dominated by quartz grains, with feldspar

Porosity is highlighted by the blue dyed resin. Field of view 1.2mm

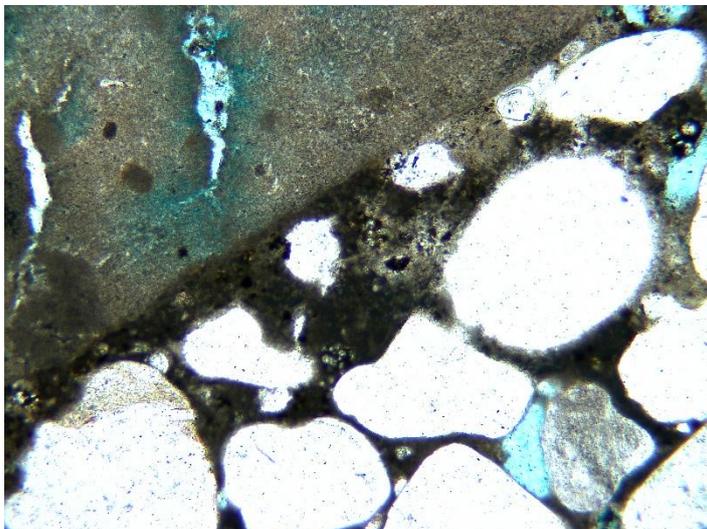
Plate No. 19:

A view in plane polarised light (ppl), of the interface between the pointing, lower part of plate, and the bedding mortar, upper left. The interface cuts diagonally across the field of view, with the bedding mortar dominated by the lime paste, showing typical shrinkage cracking.

The paste in the bedding is again clinker rich close to the interface but less so further away, not uncommon where the pointing had been applied to a dry bedding mortar. Aggregates are mostly of quartz in this view.

Porosity is highlighted by the blue dyed resin. Field of view 1.2mm.

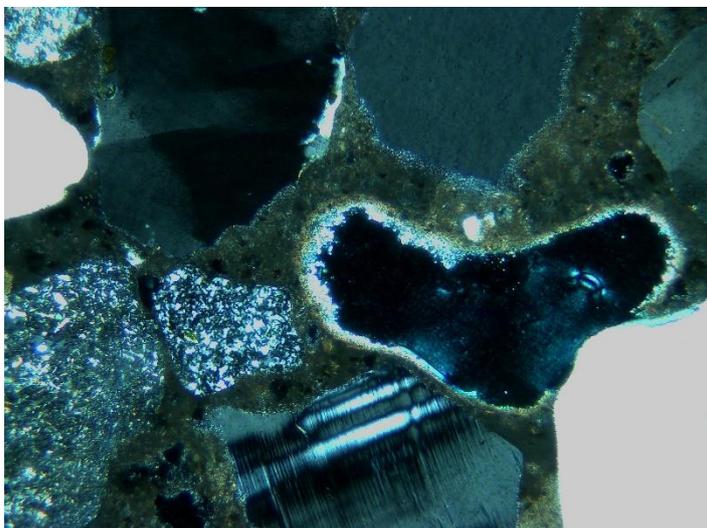
Plate No. 20:

A view in Cross polarised light (xpl), of an area of dense paste in which the void in the centre right is rimmed with coarse Portlandite crystals, mostly on the left side, with this having converted to Calcite at the mid-point of the void, with both Portlandite and calcite present at the right side. The surrounding paste is mostly uncarbonated with small pseudo morphs of partially hydrated clinker fragments distributed throughout. Aggregates are dominated by quartz, with feldspar, chert and an igneous fragment.

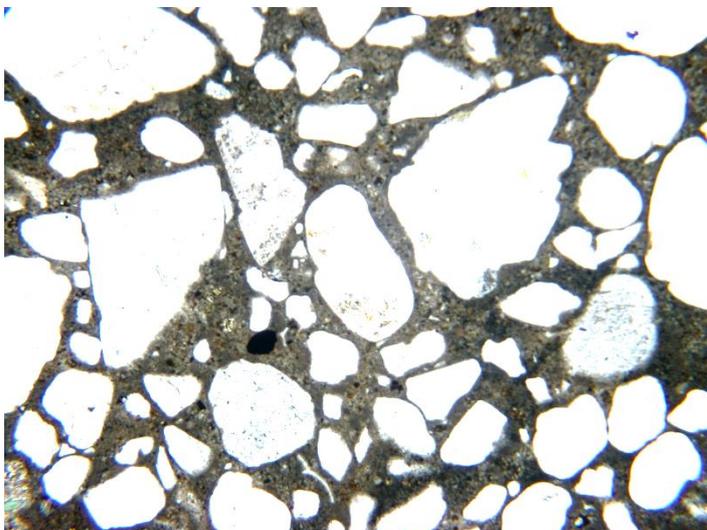
Plate No. 21:

A view in plane polarised light (ppl). This shows a typical area of the mortar. The paste in view is well compacted and relatively dense and mostly carbonated. There is an abundance of clinker apparent distributed throughout the paste, with this dominated by Belite with minor Gehlenite in the area in view. The aggregates are dominated by quartz in this view, with minor feldspar along with trace proportions of igneous rock fragments.

Porosity is highlighted by the blue dyed resin.

Field of view 2.4mm.

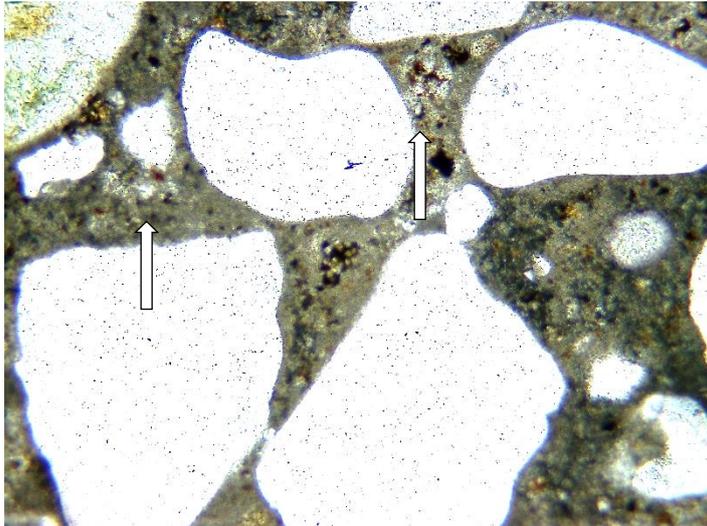
Plate No. 22:

Another view, at higher magnification, of a binder rich area of the mortar where an abundance of cement clinker can be seen, with Alite and Belite dominant along with trace proportions of Gehlenite. Belite clusters can be seen clearly within the paste, with Alite also present, upper centre, left upper quarter and centre right, examples are arrowed in plate, note the low Ferrite content in the cement clinker (normally dark brown/black). The aggregates in view are mostly of quartz.

Porosity is highlighted by the blue dyed resin.

Field of view 1.2mm

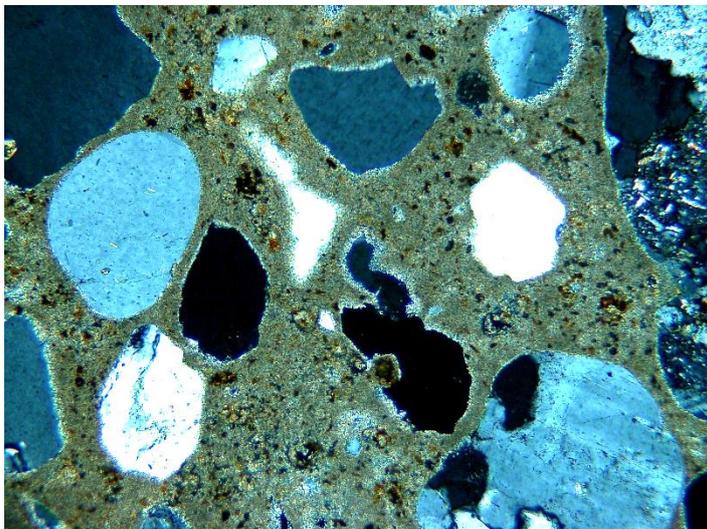
Plate No. 23:

A view in Cross polarised light (xpl), of an area containing fine clinker grains distributed throughout and with a void in the lower centre of plate. The void is rimmed with medium to coarse Portlandite crystals. The clinker in view is very fine and is dominated by Belite clusters many of which also show partial hydration. Aggregates are dominated by quartz, with feldspar and an altered igneous fragment, right side of plate.

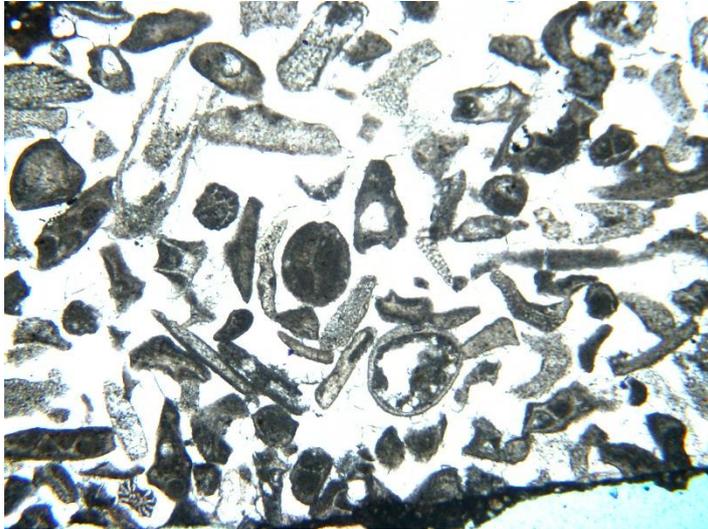
Plate No. 24:

A view in plane polarised light (ppl) showing a typical area of the limestone fabric.

Porosity is highlighted by the blue dyed resin.

Field of view 2.4mm.

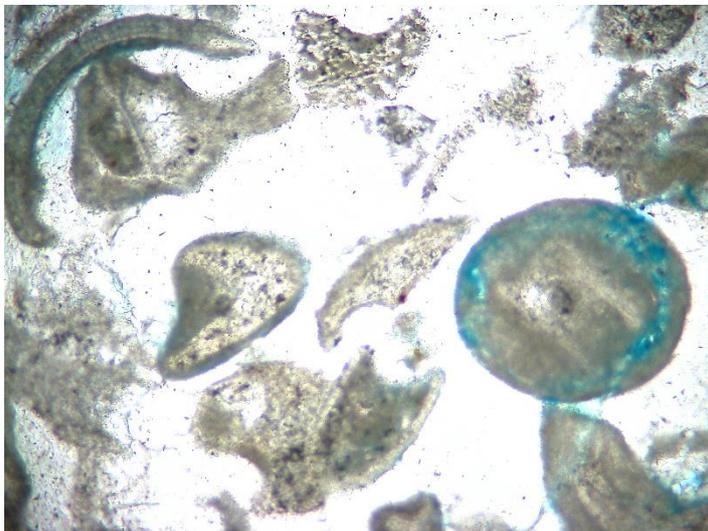
Plate No. 25:

A view in plane polarised light (ppl) at higher magnification to give clearer detail of the bioclastic debris from which the limestone is formed.

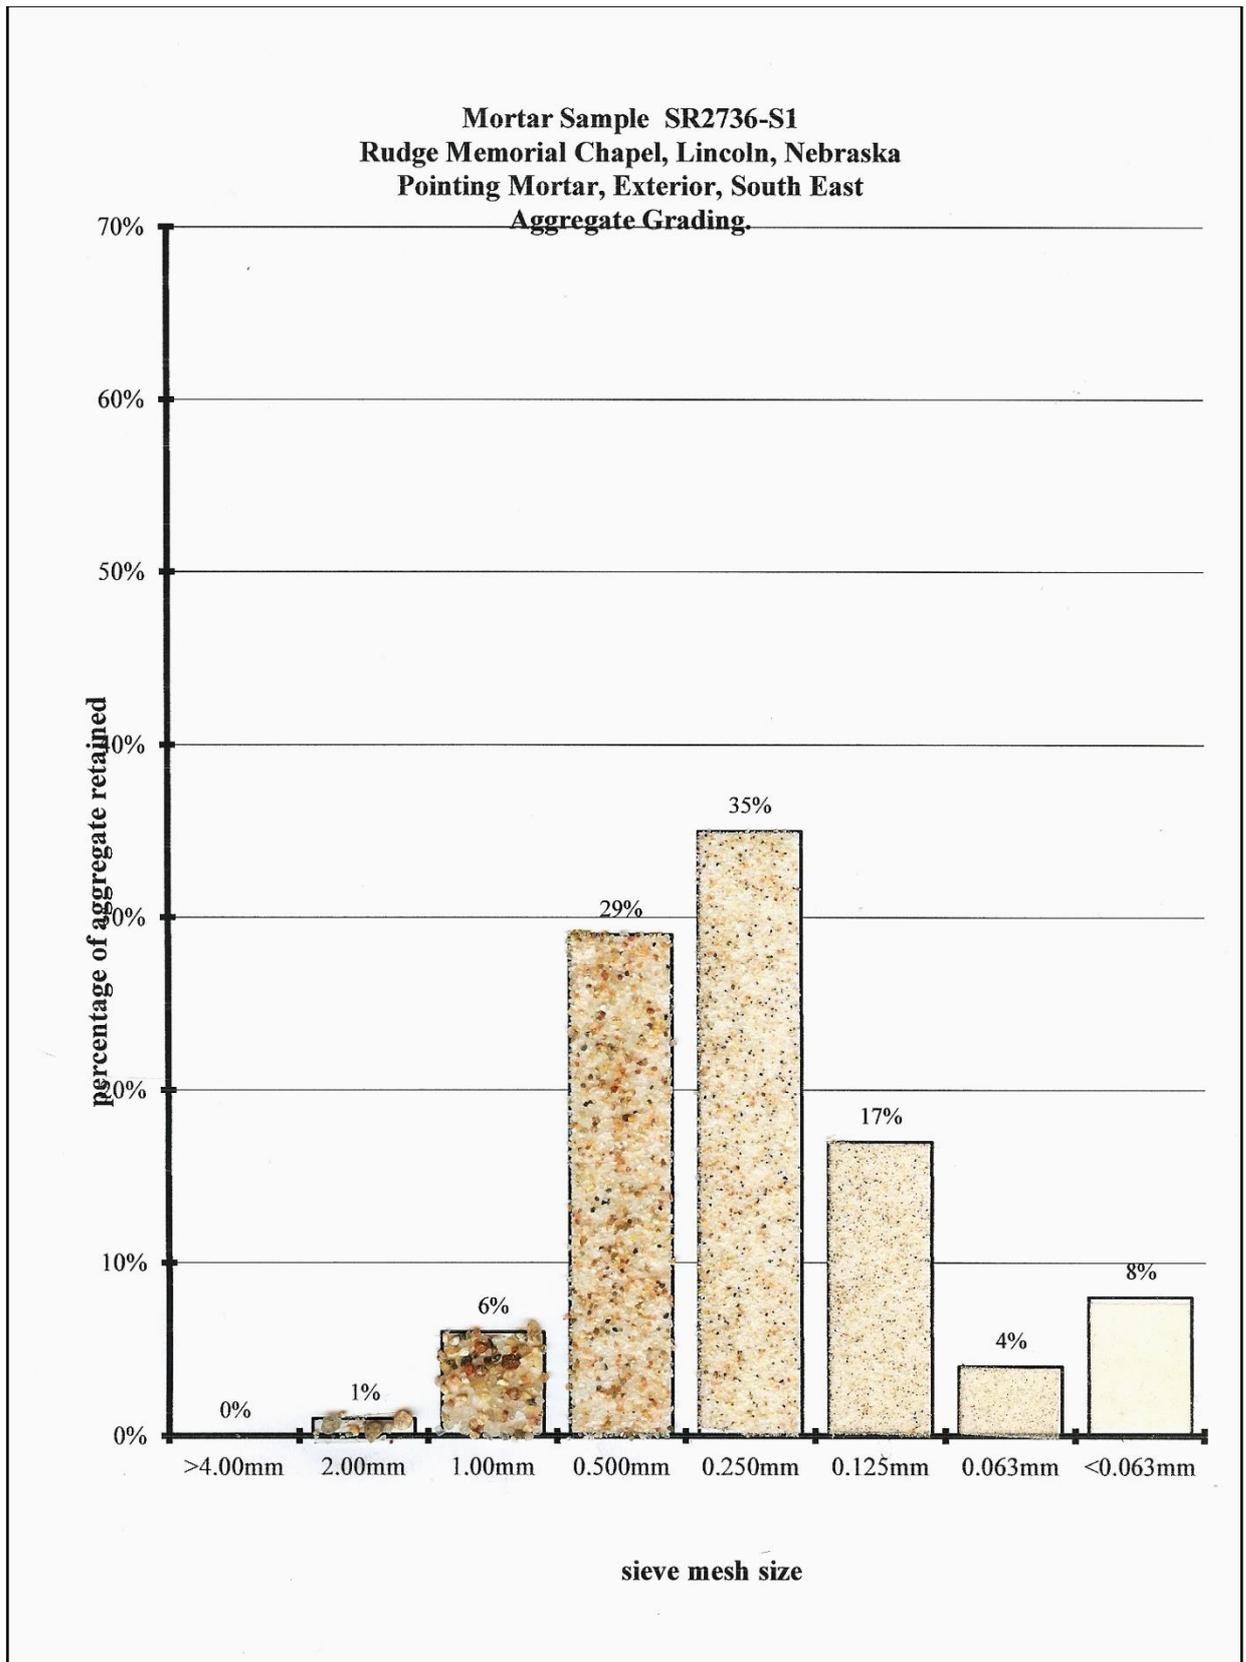
Figure No. 1: Grading of Aggregate from sample SR2736-S1

All have a moderate to relatively high fines content, which may suggest that the sand was used as dug, or if processed, it contained a proportion of aggregate dust arising from the processing procedure. The fines, passing the 63µm sieve were analysed by XRD and found to be dominated by quartz with feldspar minerals, no clay minerals were detected.

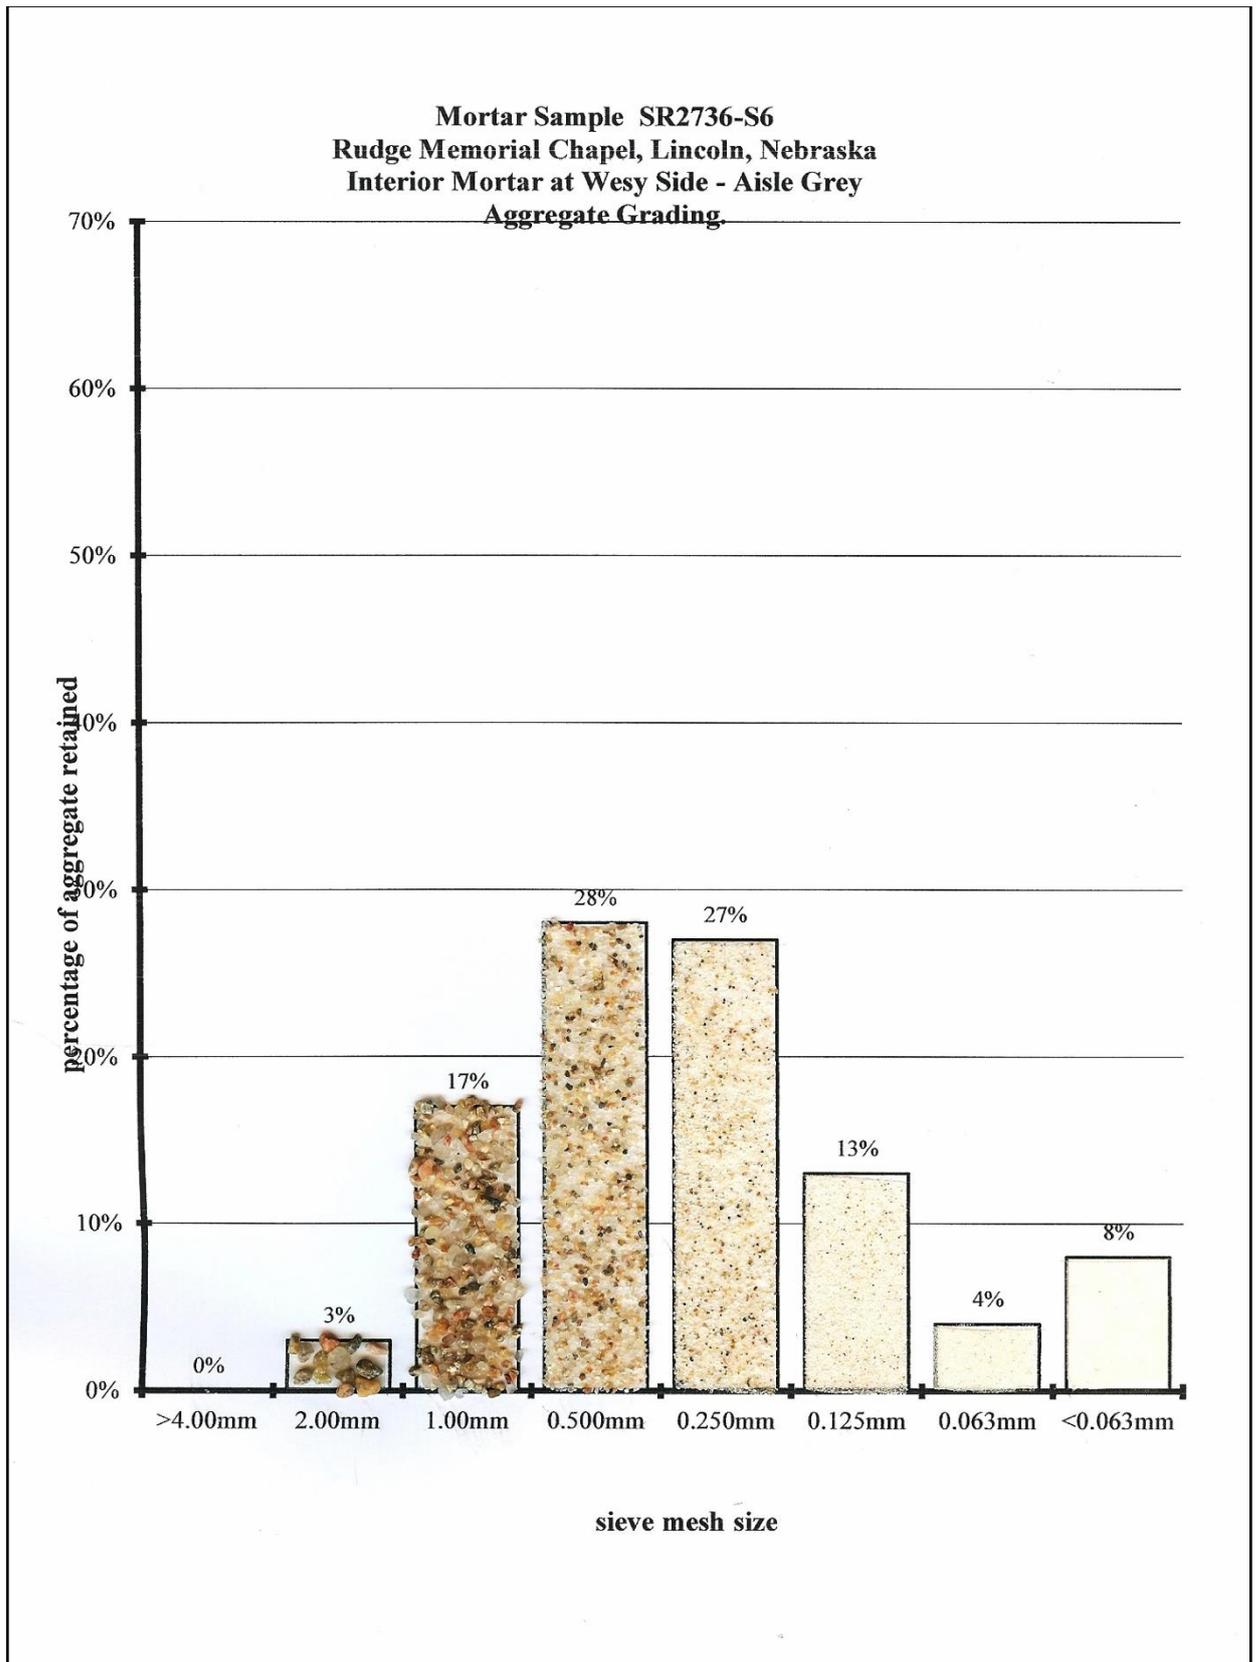
Figure No. 2: Grading of Aggregate from sample SR2736-S6

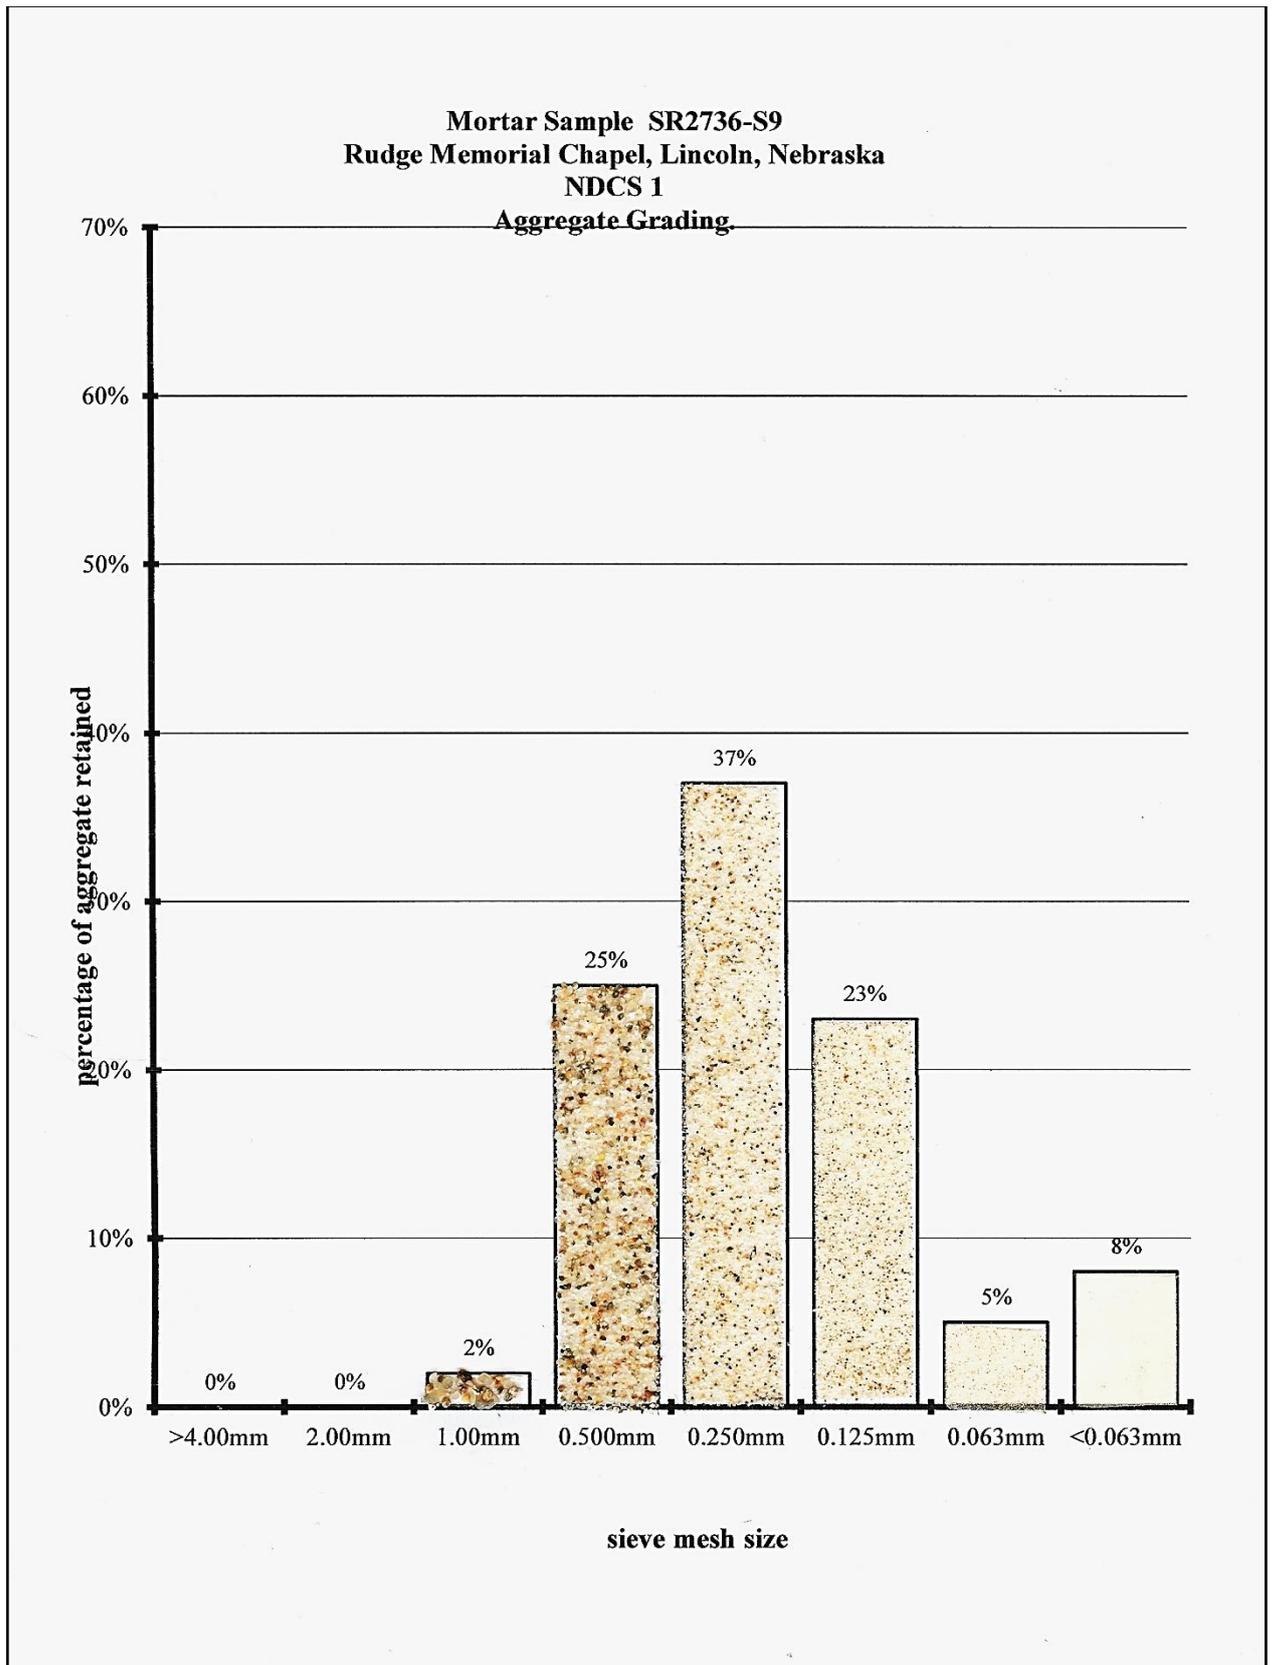
Figure No. 3: Grading of Aggregate from sample SR2736-S9

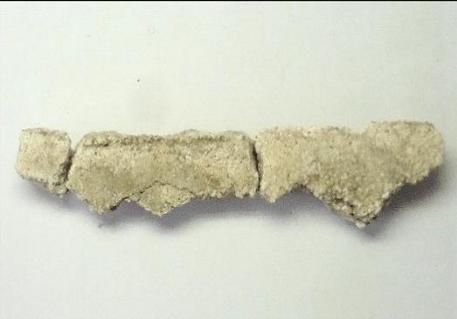
Sample Ref.	As Received weight (g)	Dimensions of largest piece of mortar (mm)	Photo	Colour Munsell Soil Colour Charts	Comments
S1	65.6	59.8 x 24.6 x 21.2

“White”	Exterior S.E. #1 – Pointing Mortar The sample consisted of three pieces of a hard well bound mortar. The mortar pieces resisted breaking under firm finger pressure and required an impact to disrupt. On testing a freshly fractured surface with a phenolphthalein indicator solution the mortar was found to be fully carbonated throughout its thickness. No lime inclusions were observed. Aggregates are from a natural quartz rich sand, having a maximum grain size of 2.9mm, and all display water worn surfaces.
S2	36.8	48.0 x 16.2 x 11.0

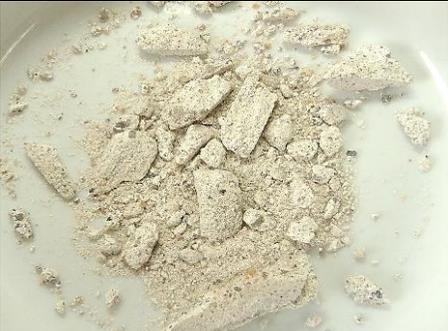
“White”	Exterior S.E. #2 – Pointing/Bedding Mortar A sample comprising small intact fragments of mortar and a quantity of fines. The mortar appears visually to be very similar to that in sample S1 above. The largest intact piece could be broken under firm finger pressure and on testing the freshly fractured surface it was again found to be fully carbonated. Aggregates are again from a water transported natural quartz rich sand with a maximum grain size of 3.1mm. No lime inclusions were observed in this sample.

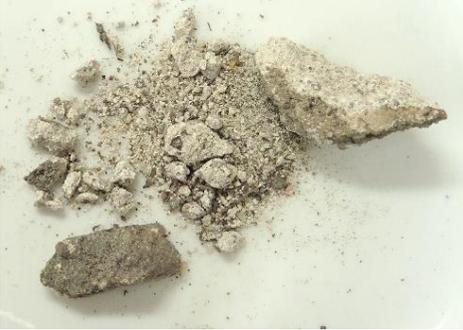
S3	13.4	38.7 x 17.9 x 12.3

2.5Y 8/1 “White”	Exterior N.W. FDN #3 – Pointing Mortar Again, this sample was composed of small fragments and fines. The largest intact fragment was hard, as in sample S1. The outer surface of the intact fragments was coated in a grey coloured granular soiling, with indications of long-term water percolation through the mortar/stone interface. The mortar is soft to moderately hard, with small angular lime inclusions apparent. The mortar is also carbonated and the aggregates are again from a natural sand, similar to samples S1 & 2.

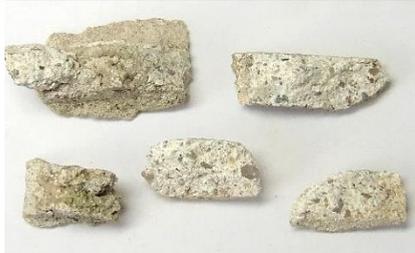
Sample Ref.	As Received weight (g)	Dimensions of largest piece (mm)	Photo	Colour Munsell Soil Colour Charts	Comments
S4	22.9	37.7 x 20.8 x 17.8

“White to Greyish White”	Exterior N.W. Wall #4 – Pointing Mortar This sample consists of five intact fragments and a quantity of fines. There are two different mortars in this sample with most being from a hard-repointing mortar, which is only partially carbonated and may be from a white cement pointing, or hydraulic lime. Small pieces of a soft to moderately hard white internal mortar adheres to the harder fragments. Aggregates are again similar to that in sample S1.
S5	42.5	33.4 x 18.4 x 8.0

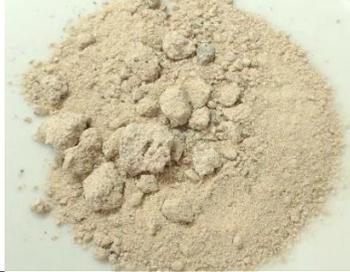
7.5 YR 8/1 “White”	Basement Mortar – In Tile Another sample which is composed mostly of fines with a few small fragments of intact well bound mortar. The intact pieces are variable with respect to hardness and the colour of the fines is greyer than those in samples S5 & 6 and may be weathered/altered. The sample is fully carbonated and the fragments do not display any water repellent properties. Aggregates are, however, similar to those in the other samples examined.

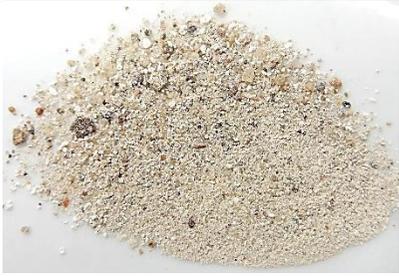
Sample Ref.	As Received weight (g)	Dimensions of largest piece (mm)	Photo	Colour Munsell Soil Colour Charts	Comments
S8	2.2	Fines only

5Y 8/1 "White" Sand grains	Salt – Mortar – Basement Sample is composed essentially of aggregate grains, which are from a natural quartz rich sand having a maximum grain size of 2.7mm. Small fragments of binder are present, with the largest piece measuring 1.4mm, but mostly finer than 0.25mm. the binder may be a lime as the fragments are relatively soft to moderately hard, but they could be powdered with ease. The sample was identified as "Salt - Mortar" Analysis would be required to confirm salts.
S9	11.01	34.7 x 16.5 x 13.4

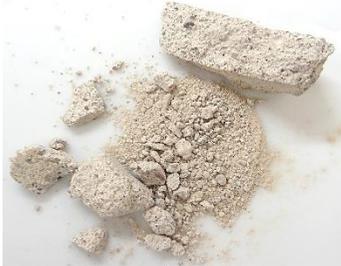
10YR 8/1 "White"	NDCS 1 The mortar in this sample is similar to the outer pointing mortar in sample S4. The mortar is hard and well compacted. On testing the mortar, it was found to be fully carbonated and it was noted from water droplet tests that the mortar had a low porosity with the droplets slowly absorbed. Aggregates are again from a quartz rich natural sand, with the grains displayed water worn surfaces, and is similar to that in other samples examined.

Samples SR2736-S3, S5 and S9: all appear to be based on a Portland cement type binder, with, possibly a proportion of lime hydrate added to the mix, in samples S3 and S5. Sample S9 having the higher Aluminate content (Gehlenite) may have contained a white cement as the binder, and this may be from a newer repair mortar.

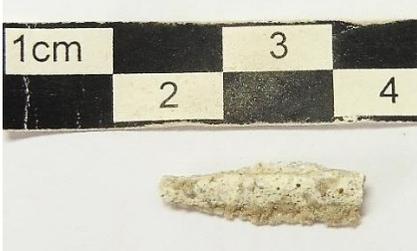
"White"	Limestone Chip with Adhering Mortar This sample consisted of a single small fragment of a crystalline limestone, with a thin coating of mortar along one edge.
