***Hair Reinforcement used  
in Lime Plaster and  
Render***

***Decay Mechanisms and  
contributing factors***

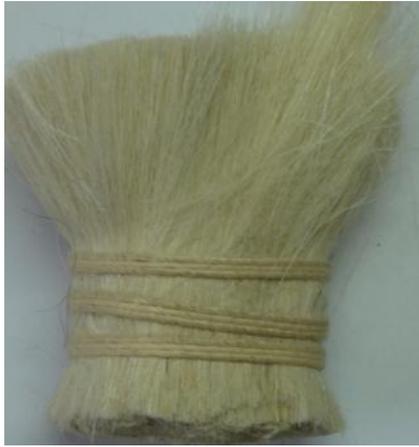
Goat Hair

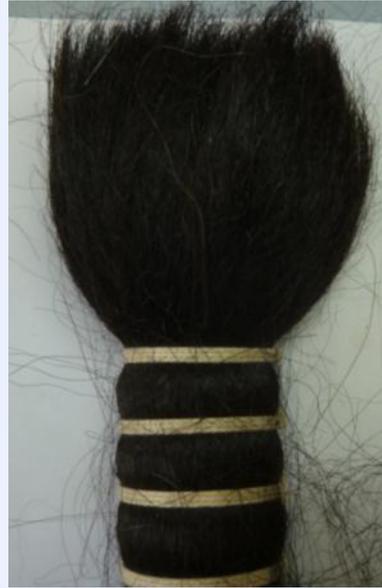
Yak Hair

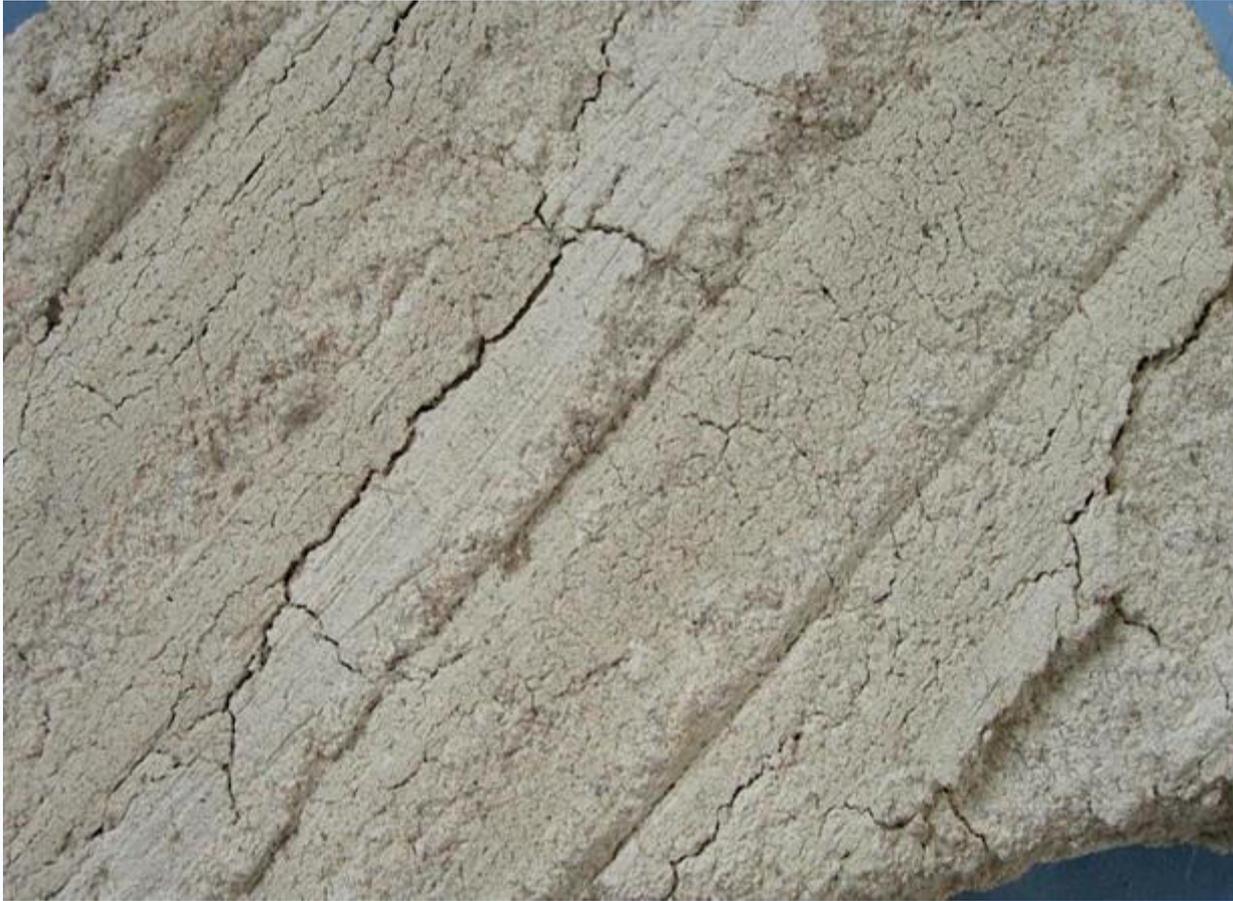
Failure of plaster due to shearing of rivets, in response to shrinkage, hair apparent along rivet roots

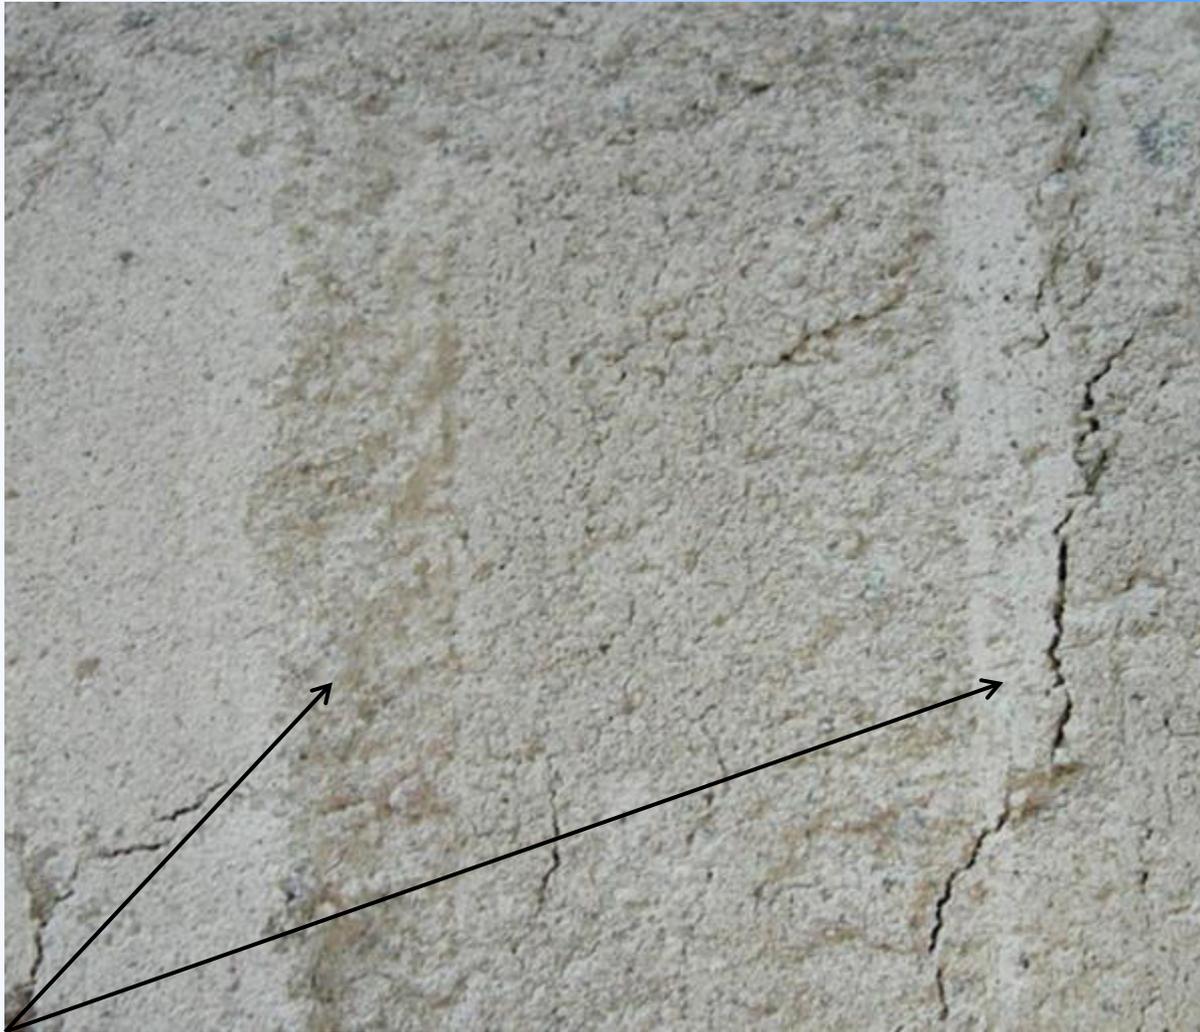
Narrow rivet roots either side of a lath imprint, some hair, failure due to “nipping” of the rivet as lath expanded when wetted

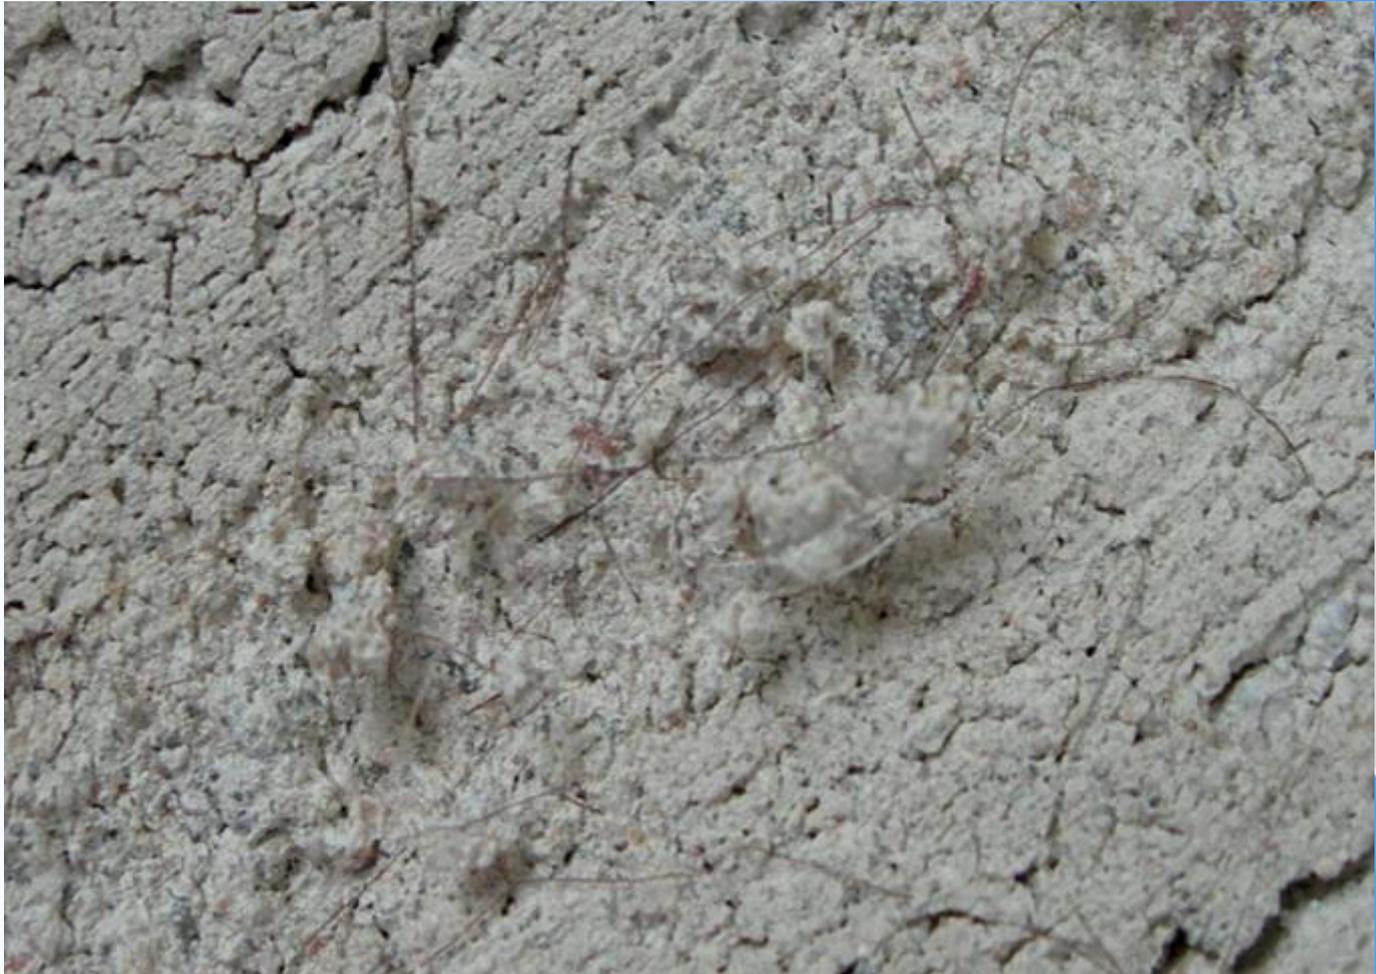
Hair concentrated along a disrupted rivet root, confirming hair was added, but here it brittle

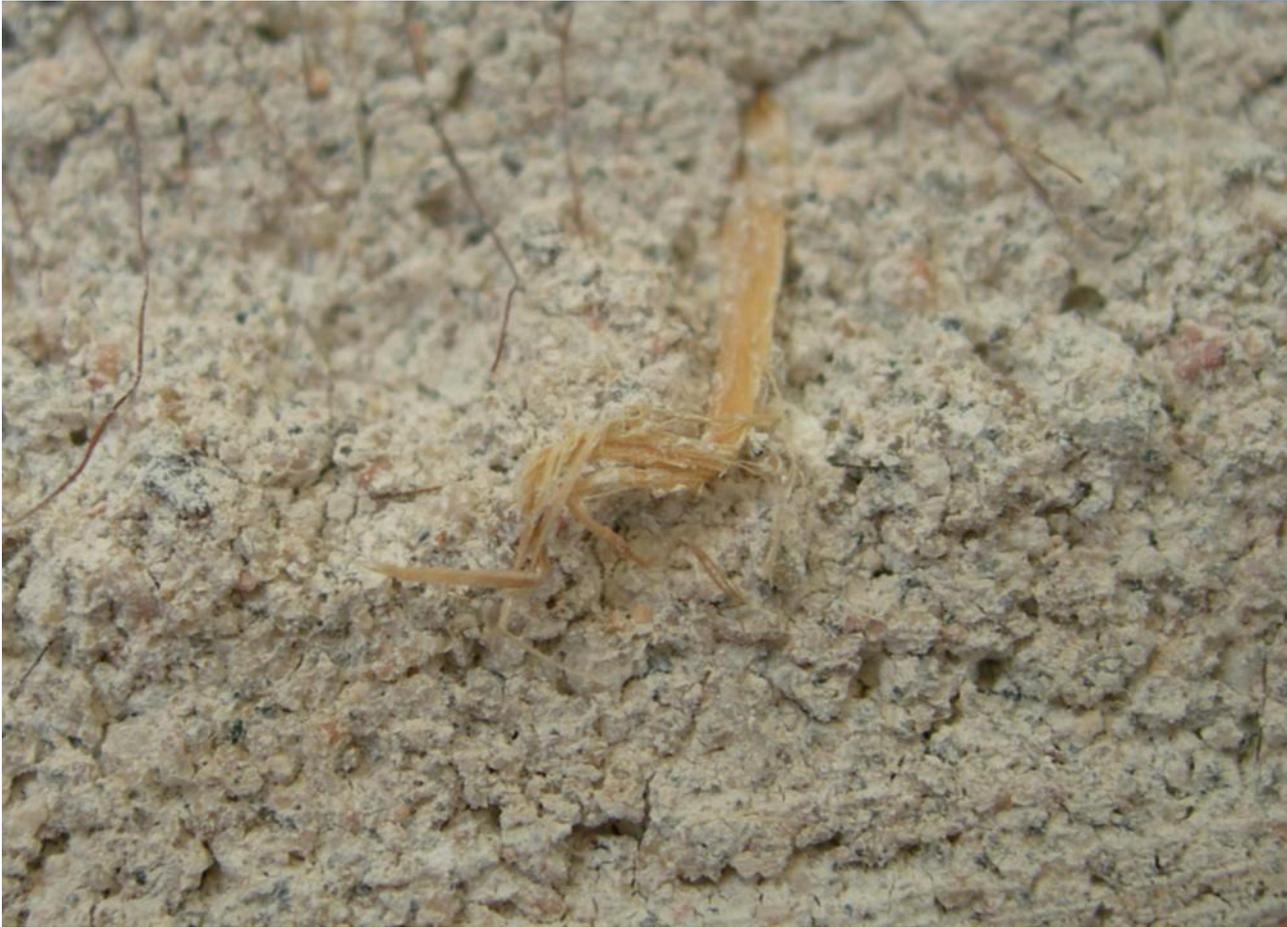
Hair randomly protruding from contact surface of plaster, with entrapment of wood fibre from split lath. This is one of the benefits of using split lath, as the fibres “lift” when the wood is moistened and the fibres become entrapped in the plaster applied.

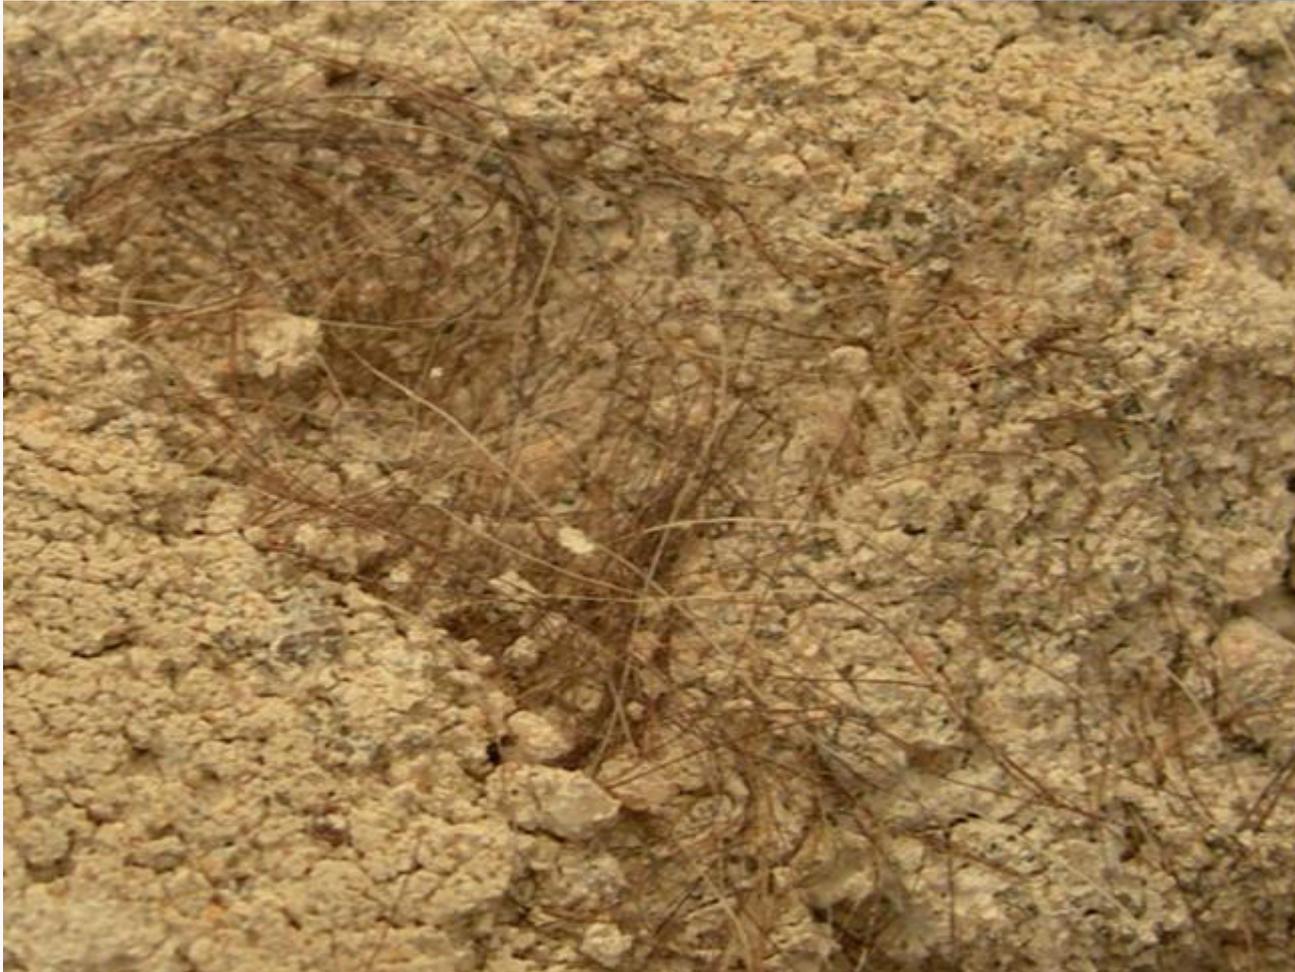
Hair clumped together found within a void adjacent to a rivet

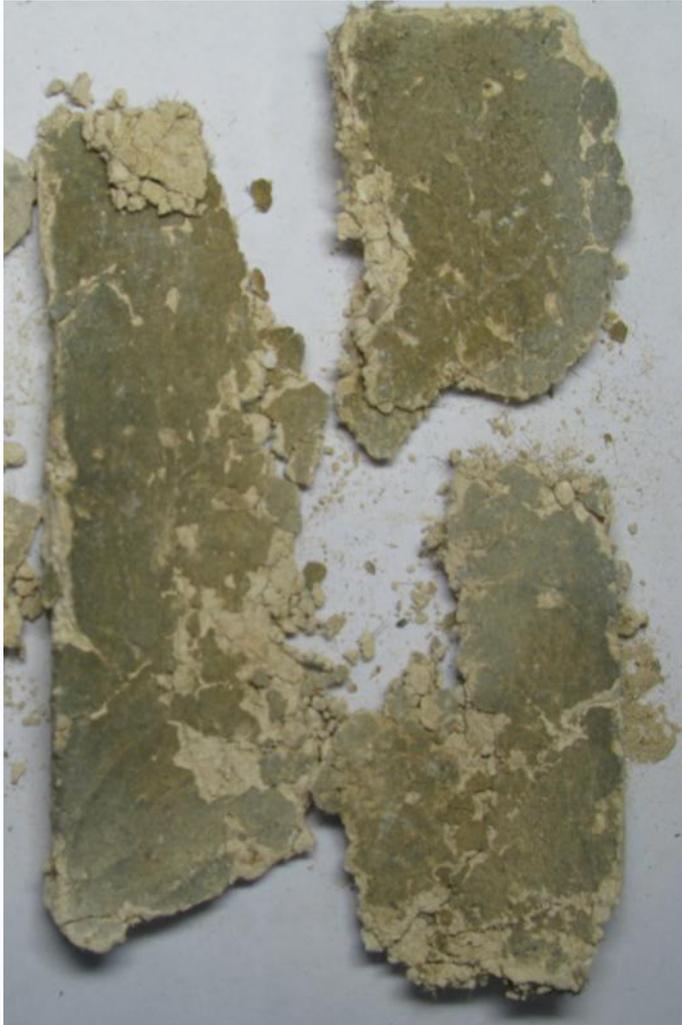
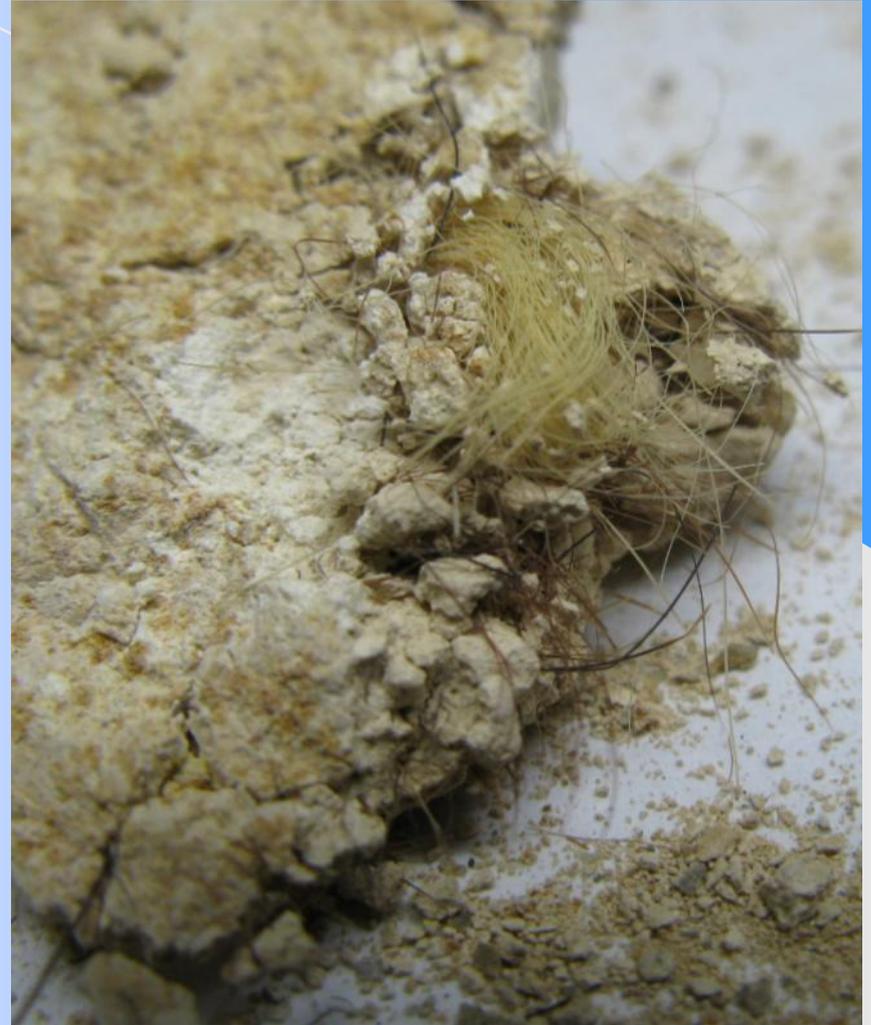
200 year old chalk lime mortar. Hair found to be in as fresh a condition as the day the mortar was mixed

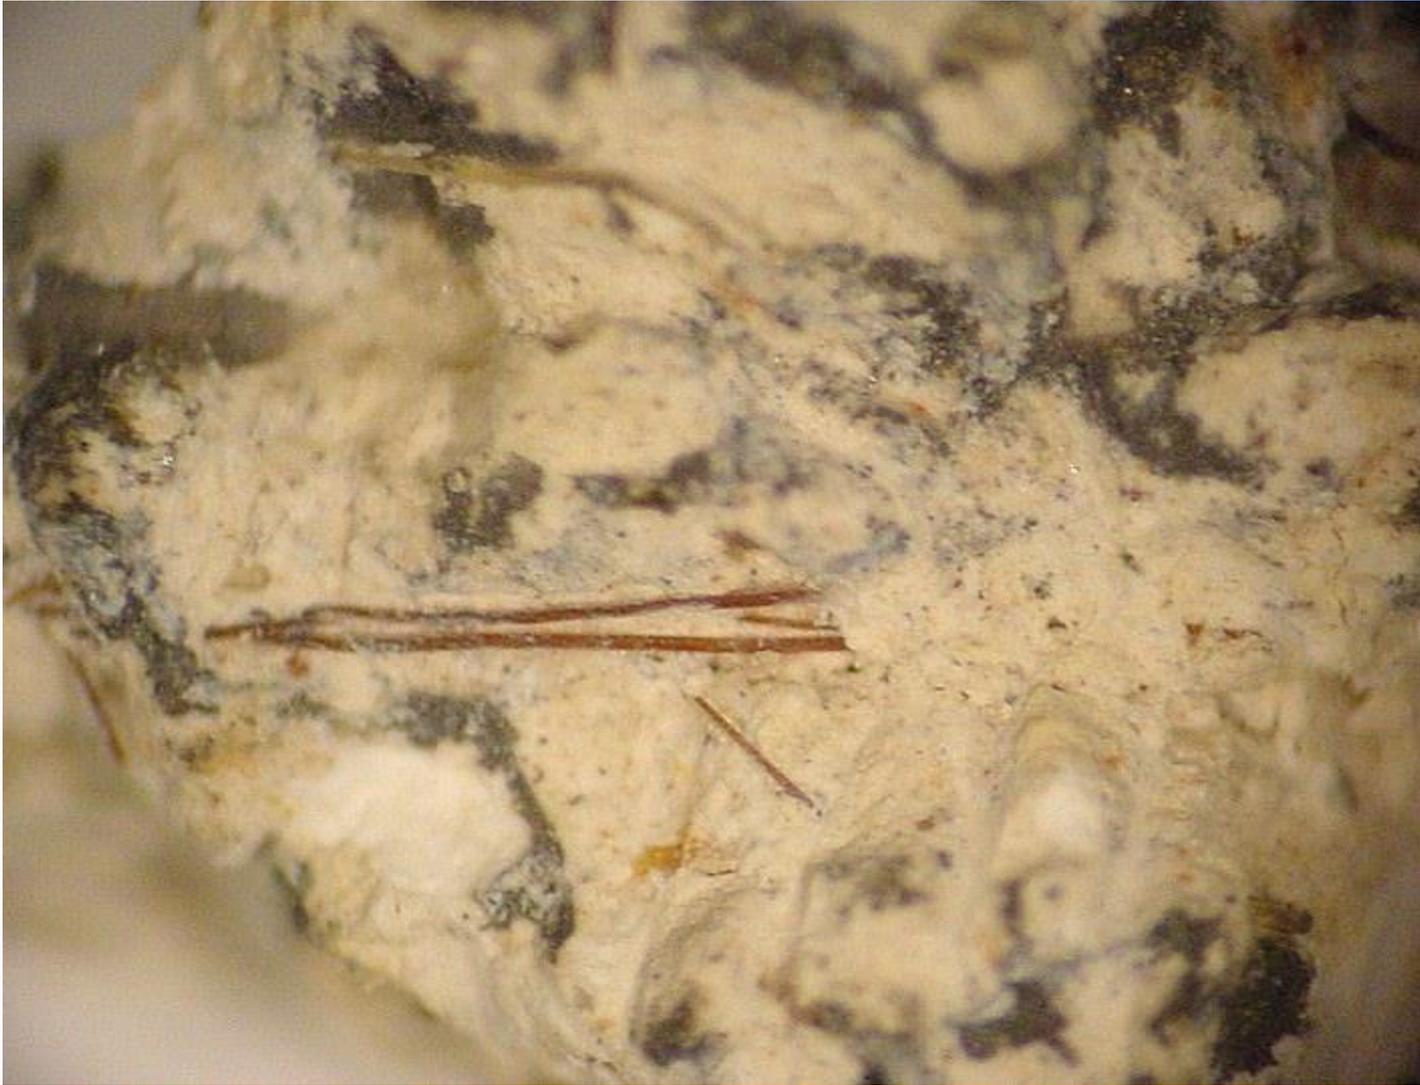
400 year old plaster from Perth with some of the hair in very good condition

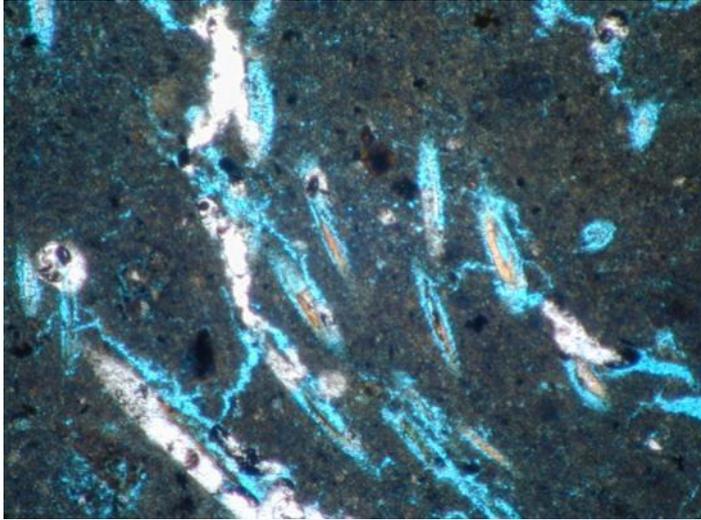
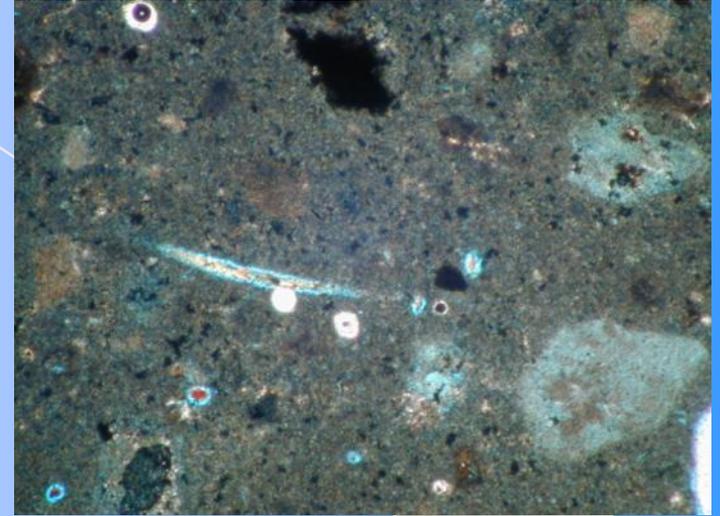
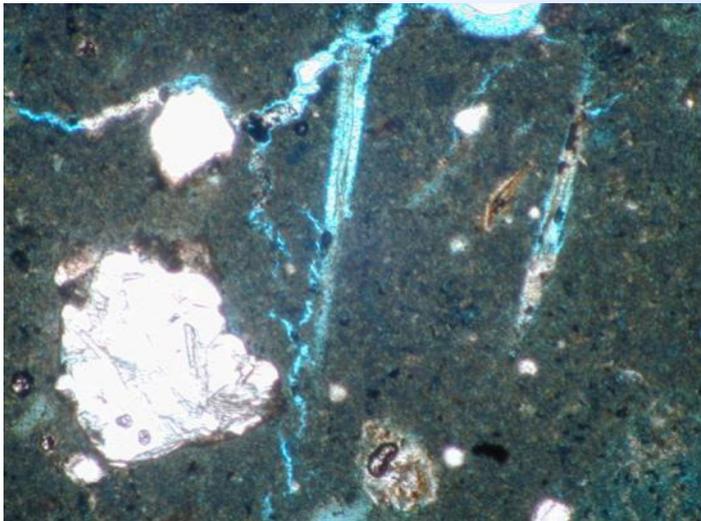
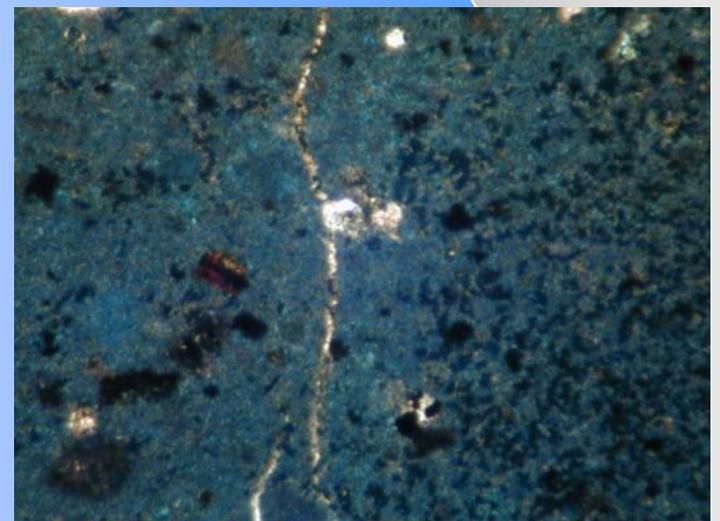
Thin sections of a Fat lime Plaster with Hair

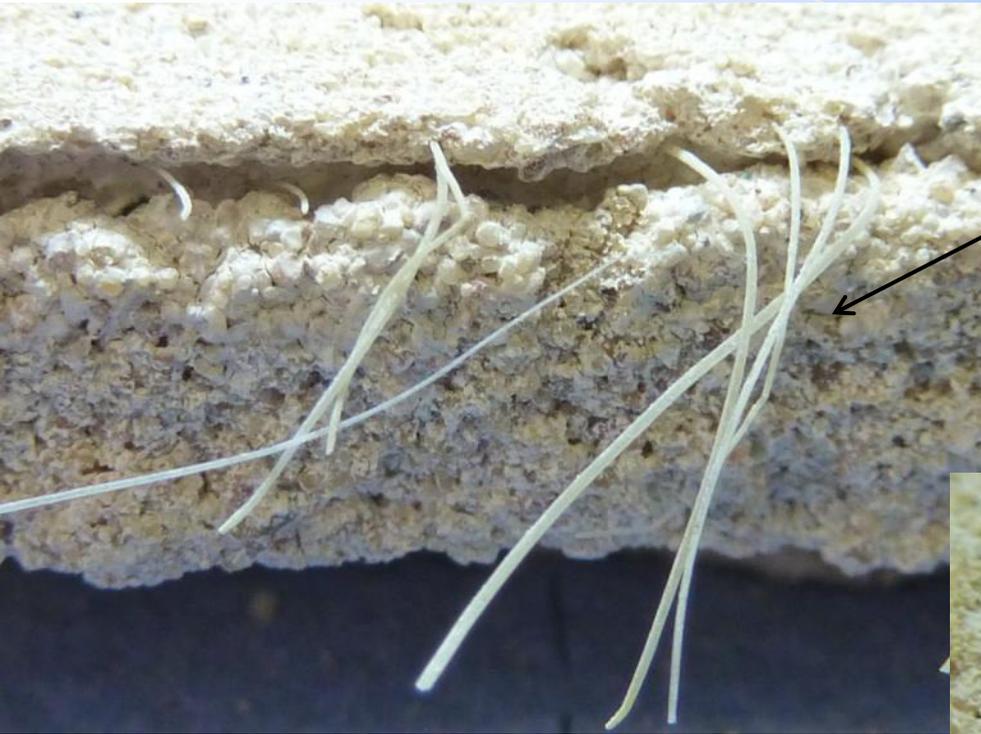
Aligned stiff fibres, in failed plaster, the stiffness perhaps inhibited penetration into the rivet, but hair found to be very brittle.

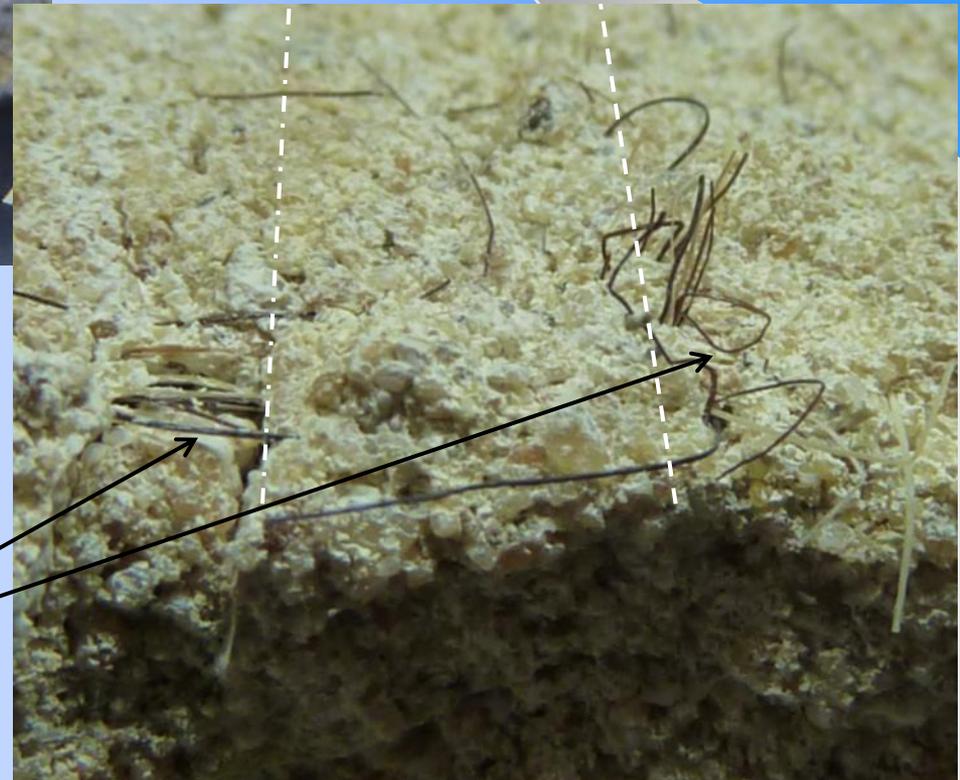
Hair fibre concentrated along the edge of a rivet, hair found to be brittle and broke when teased out of the plaster.

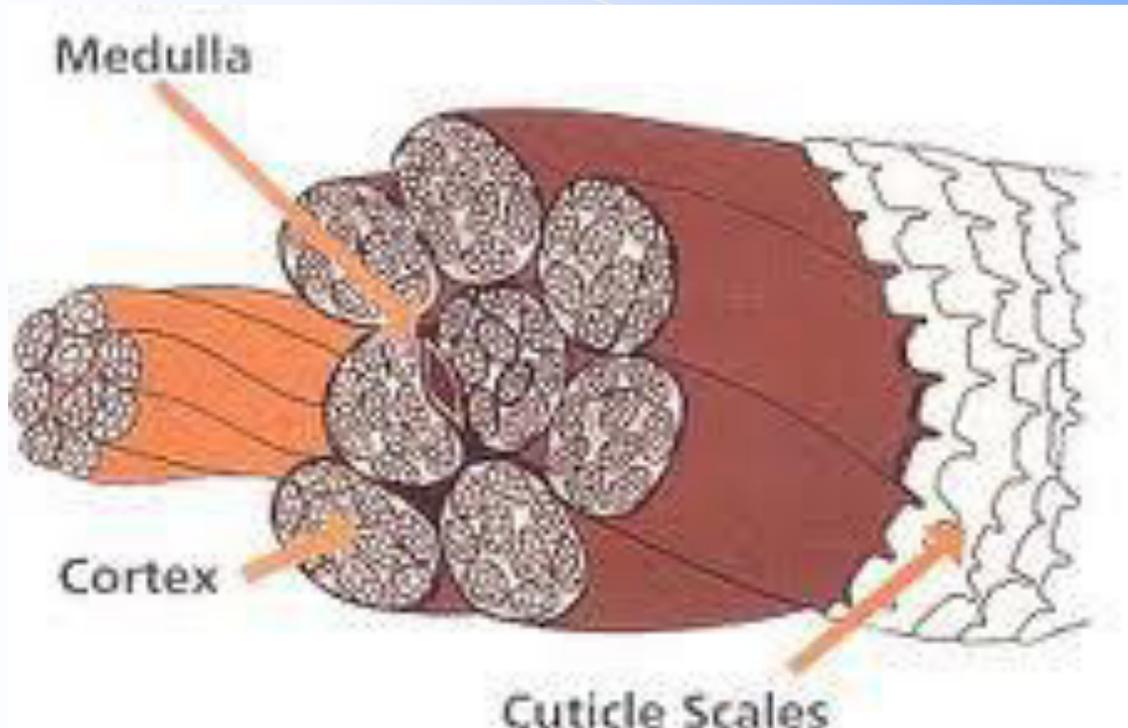
The hair shaft is formed by three layers. The innermost layer of the hair shaft is named the medulla. It is seen only in large and thick hairs. The middle layer of the hair shaft is called the cortex, made of keratin fibres. The strength, colour and texture of a hair fibre are provided by the cortex layer. The outermost layer of the hair shaft is the cuticle. This thin and colourless layer made up of between six to ten overlapping layers of long cell remnants, serves as a protection to the cortex

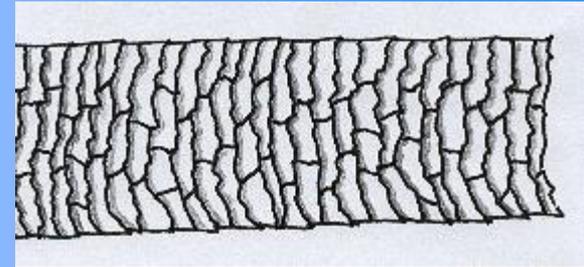
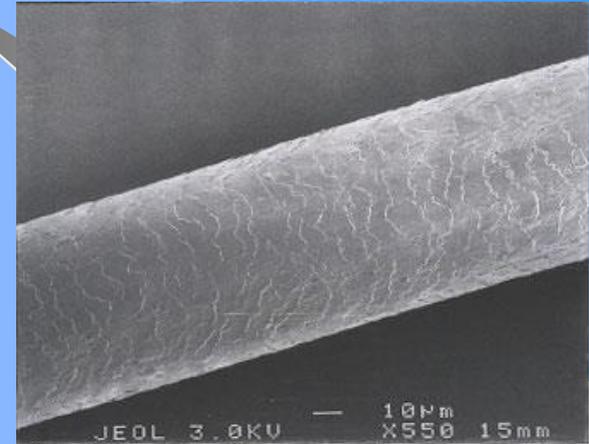
Imbricate Scale

Cuticle types, there are three types Coronal, Spinous (mostly in Fur hairs) and Imbricate. The latter are those most common in animal hair found in plaster.

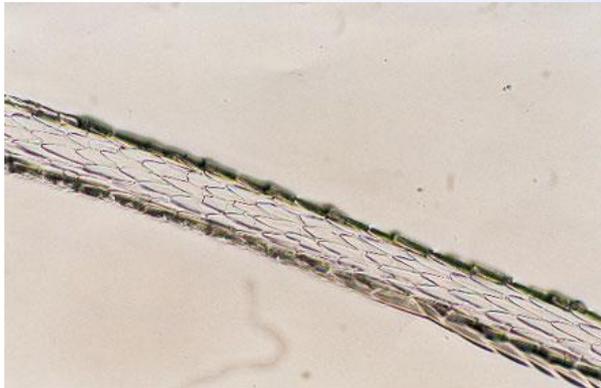
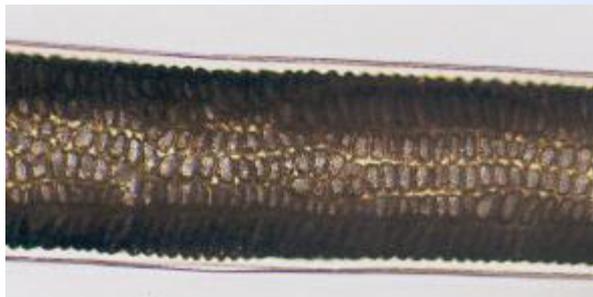
Medulla  
Common forms observed in animal hair,  
multiserial ladder medulla.

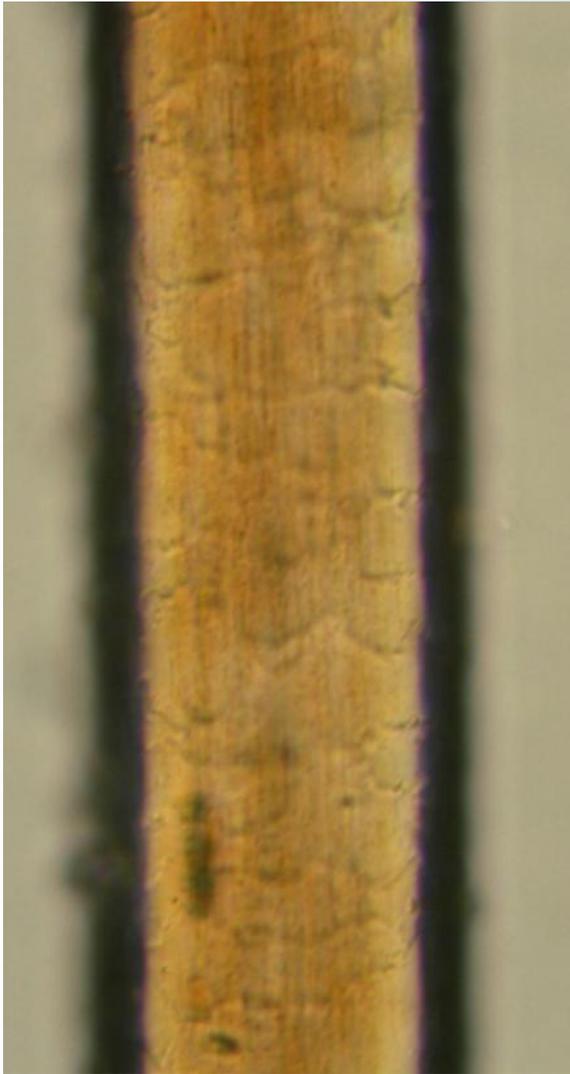
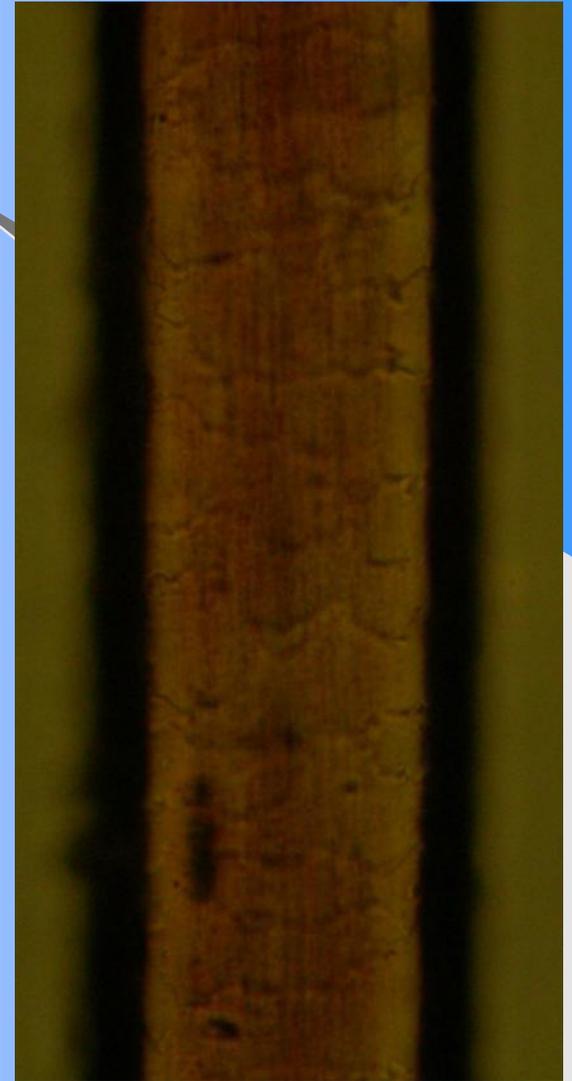
Bovine Hair  
viewed through a  
McCrone Oil  
Dispersion Lens,  
under two  
different annular  
conditions  
Hair is in good  
condition

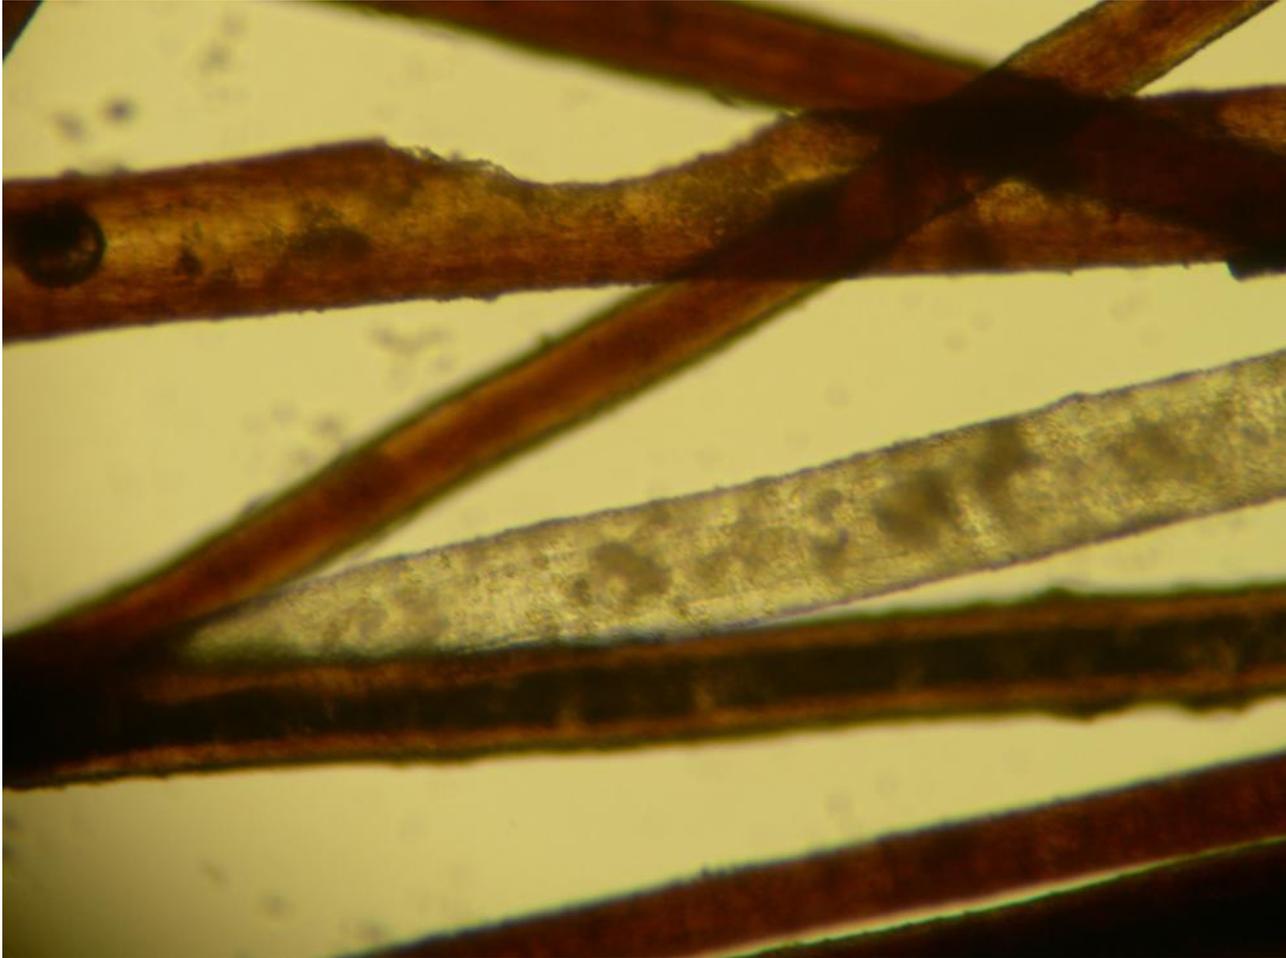
Hair recovered from a failed plaster, in which the hair has de-natured, becoming brittle and is slowly being dissolved in the alkaline (non-carbonated) environment within the plaster

The lime, as in lime putty, has not materially changed, and it is still extremely alkaline and will digest organic matter, in time, as it always has. Instances have been encountered where pre-mixed haired lime plasters have been employed in traditional work, where the pre-mixed materials had been stored, for varying periods, prior to use. It was not, therefore, unexpected when investigating the failure of some of these materials to find little or no hair remaining in the plaster, with those observed being short and noticeably brittle.

Examination of the hair confirmed that they were denatured with their structure disrupted. This, however, is not a new phenomenon, with it recorded in several texts on plaster, e.g. in William Miller's "Plastering - Plain & Decorative" in which he states that "hair should never be mixed with hot lime, and with no mortars, until nearly ready for using, because wet or hot lime weakens the hair, more especially if dry (the hair at time of addition)".

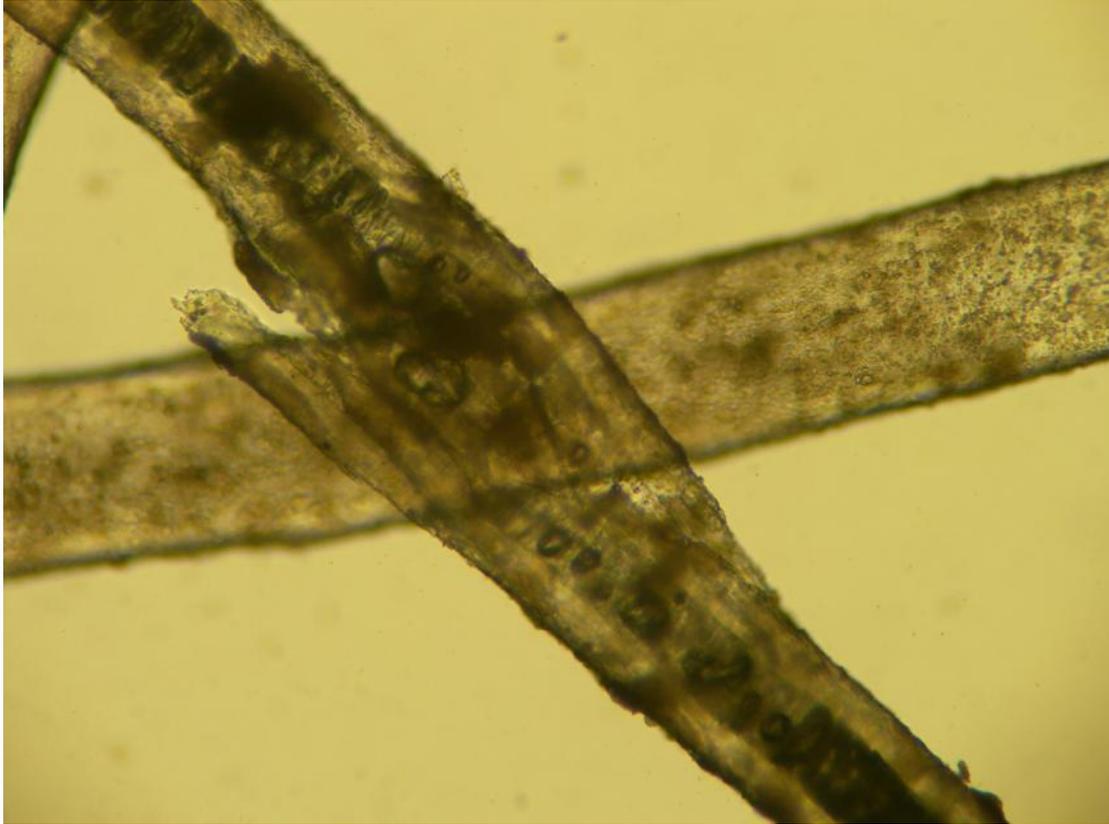
Mechanical damage to hair, possibly induced during mixing, along with evidence of denaturing

Both of these practices will be an anathema to an experienced plaster, and will make perfect sense, however, examples of both have been encountered in recent conservation works, with instances of loss of hair, due to digestion, and shortening and damage of hair fibres due to over mixing. With shortening also encountered due to cutting, with the argument that the hair mixes easier when cut short (<25mm)!

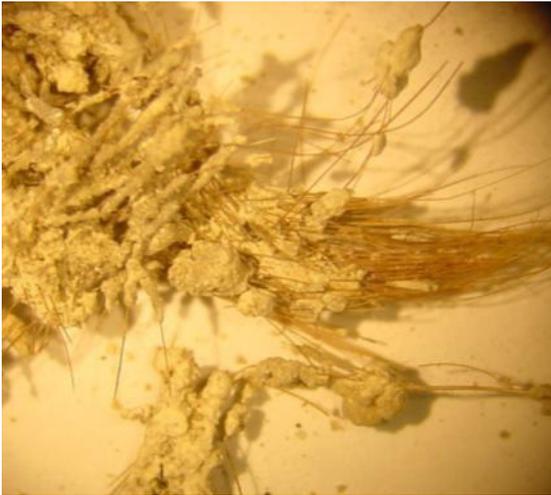
Mixed hair fibre  
from a Castle ruin  
circa 1450

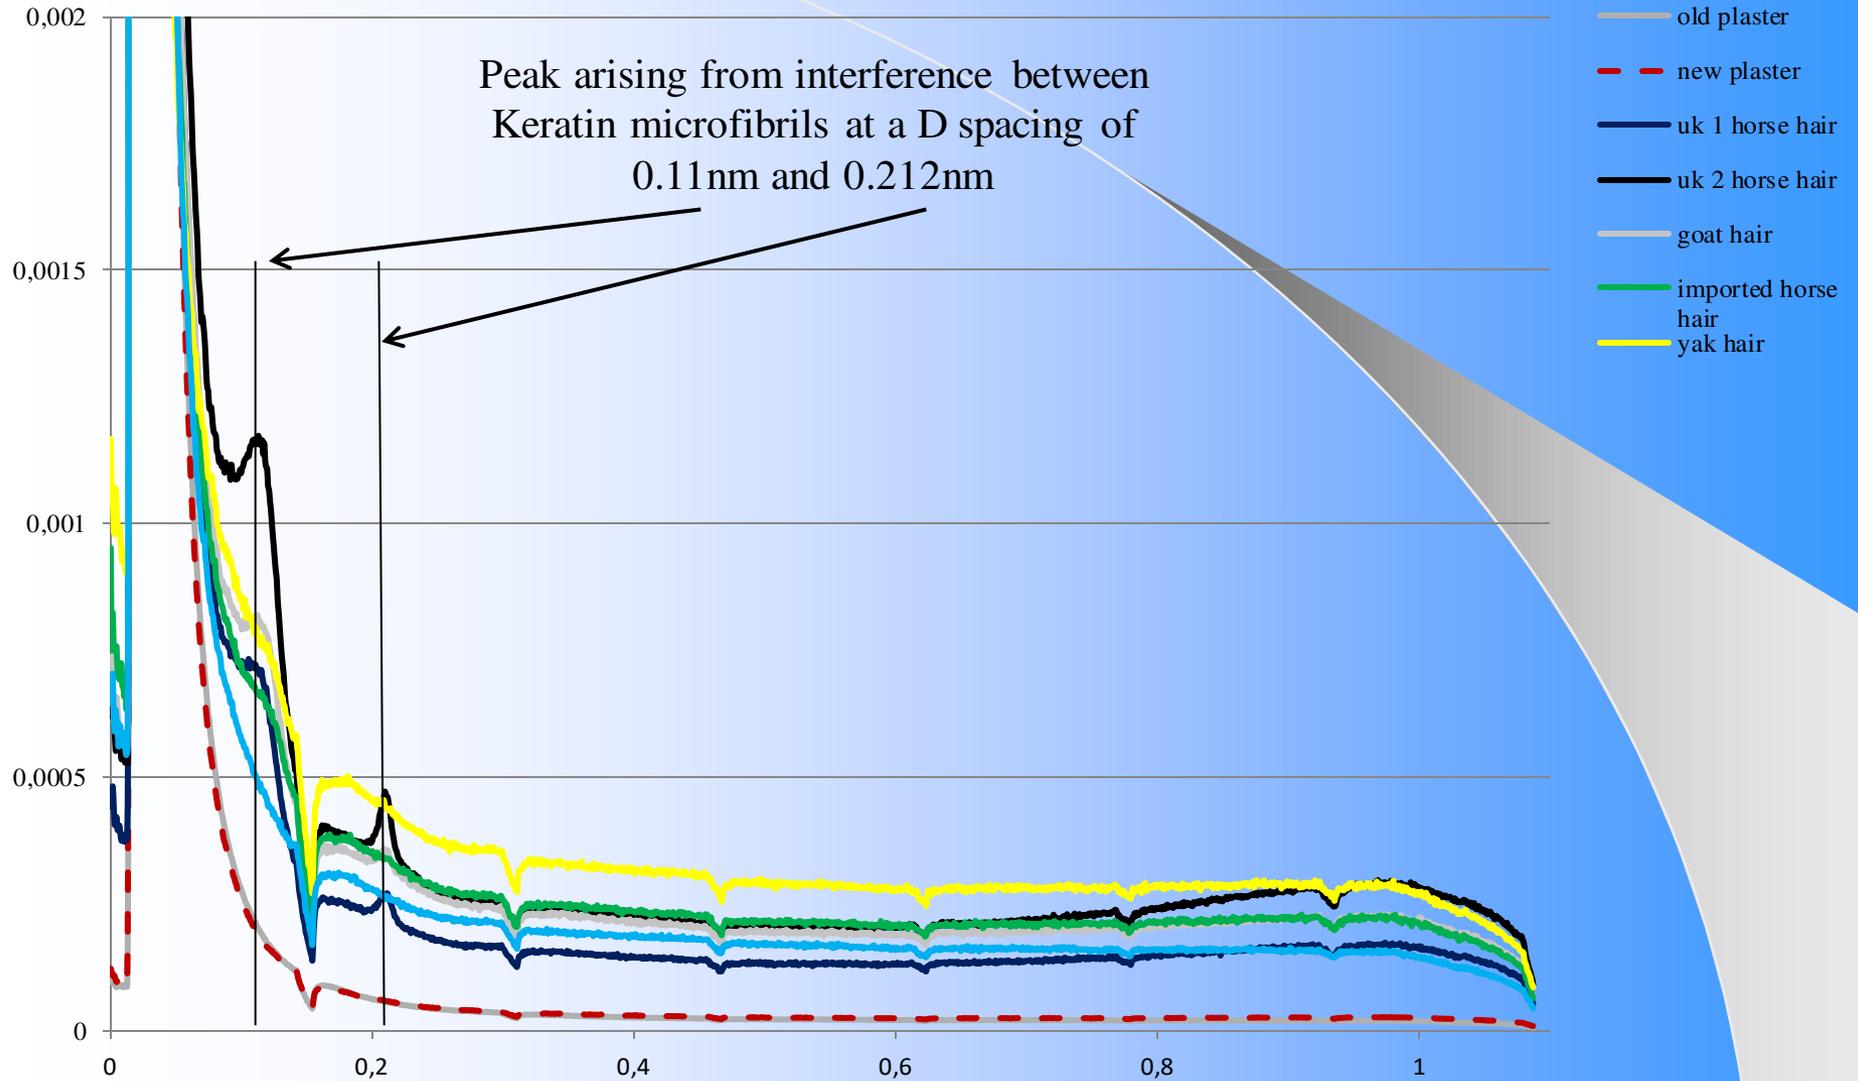
The two plaster samples show no indication of hair in the XRD profiles. There is no keratin peak or lipid peak, which are the two main features commonly seen.

UK Horse Hair 1 & 2 are very similar to each other. Both show a broad lipid peak as well as peaks arising from the interference between keratin microfibrils (~9nm in real space, 0.11 nm<sup>-1</sup> in D on the graphs and 4.7 nm, 0.212nm<sup>-1</sup> on the graphs). These are expected peaks from keratin. The Goat hair also shows these peaks.

The imported horse hair doesn't show the 4.7 nm peak and only a very weak 9 nm peak, suggesting that the keratin there has somehow been disrupted (steam cleaned or otherwise pre-treated?). Yak hair and the mixed imported hair shows neither of the expected keratin peaks, again suggesting that they have been altered by some form of aggressive treatment.

Strong keratin signals from UK horse hair 1, UK horse hair 2 and goat hair.

Weak keratin peak(s) from imported horse hair. No keratin peak from yak hair or mixed imported cow hair, or in either of the plaster samples, made with imported hair.

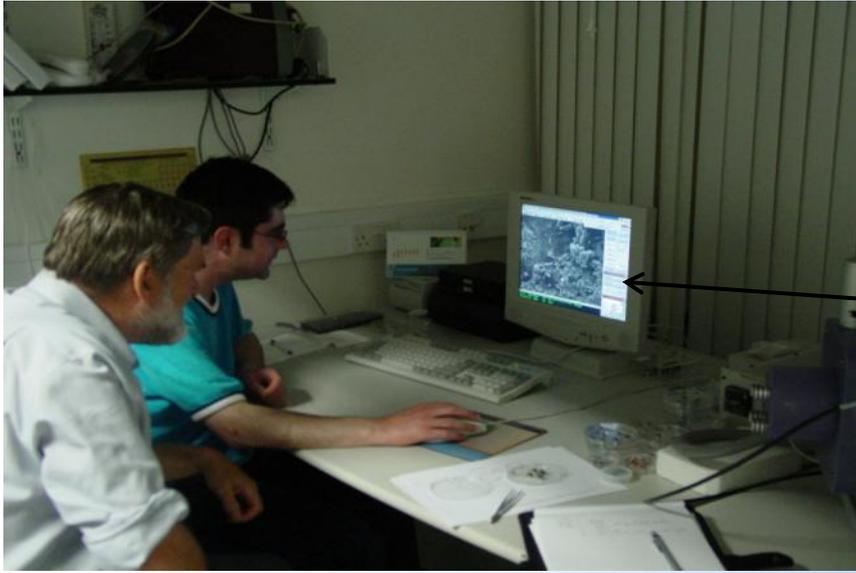
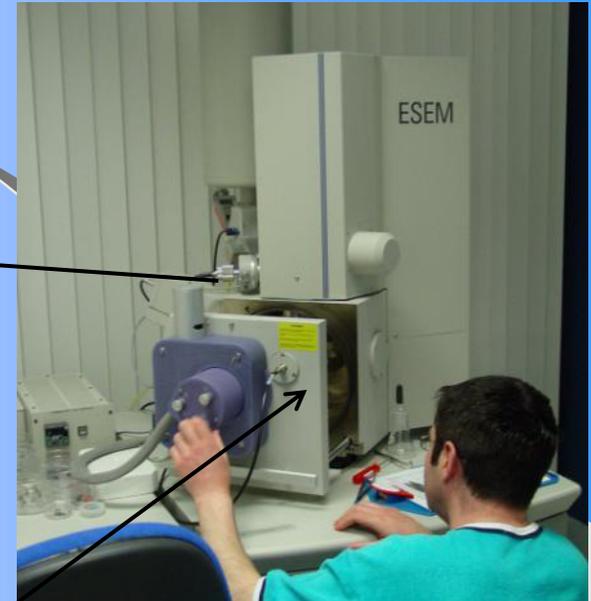
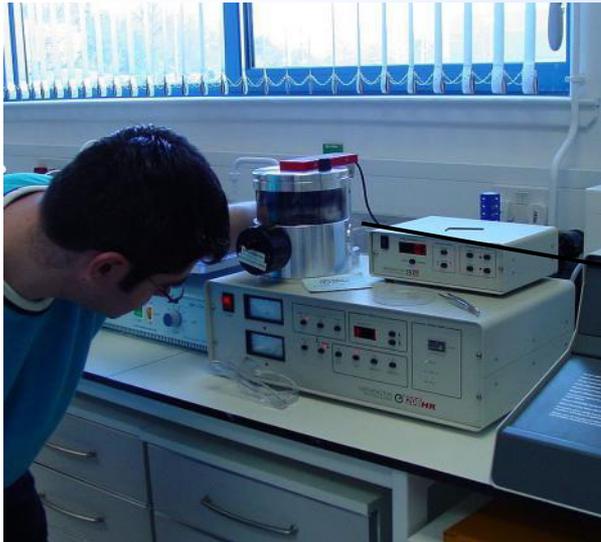
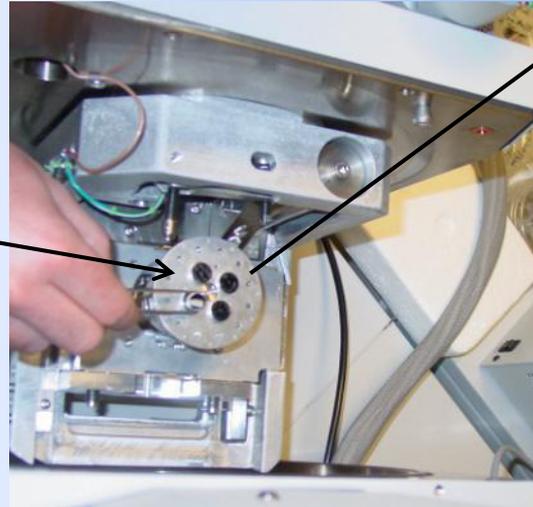
Environmental Scanning Electron Microscope (ESEM) with EDAX Capability, with four samples mounted for examination.
