***Hair Reinforcement used  
in Lime Plaster and  
Render***

***Decay Mechanisms and  
contributing factors***

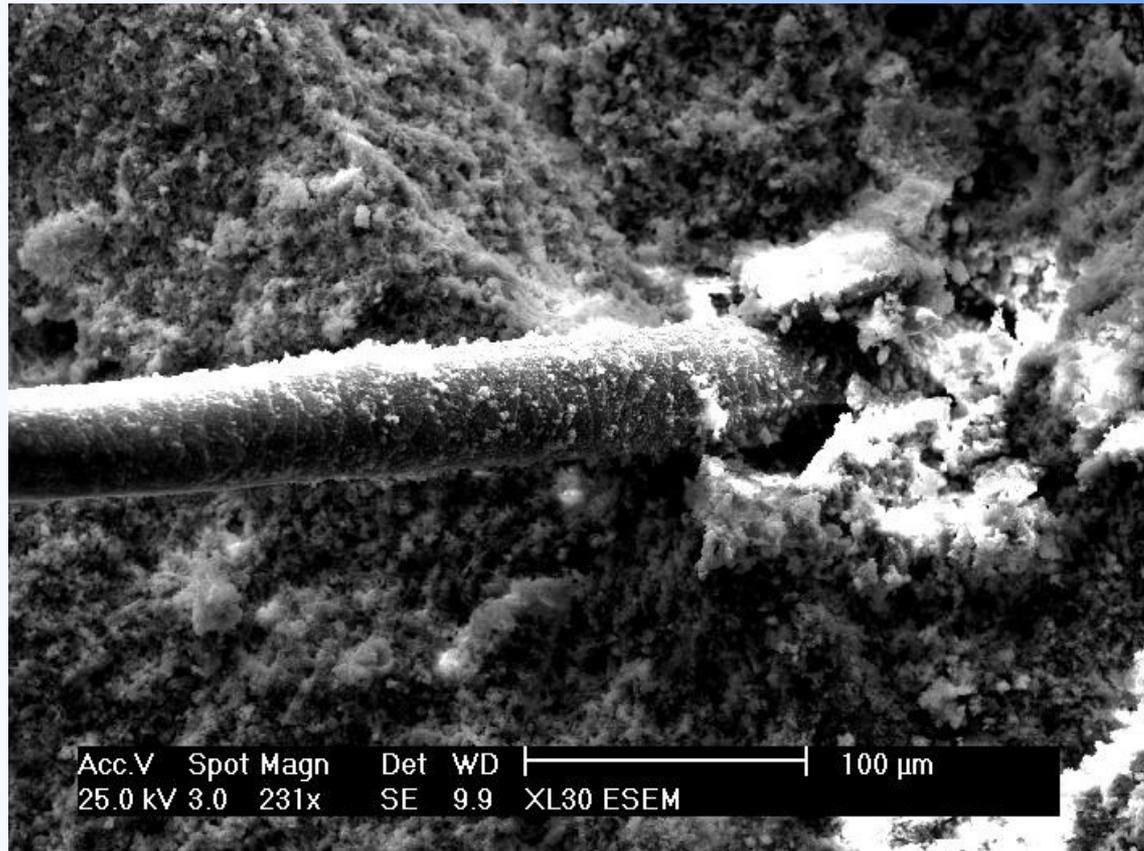
Intact Hair Reinforcement in Plaster  
Hair in good condition with well defined  
imbricate scales forming the cuticle structure  
clearly observed in the hair fibre

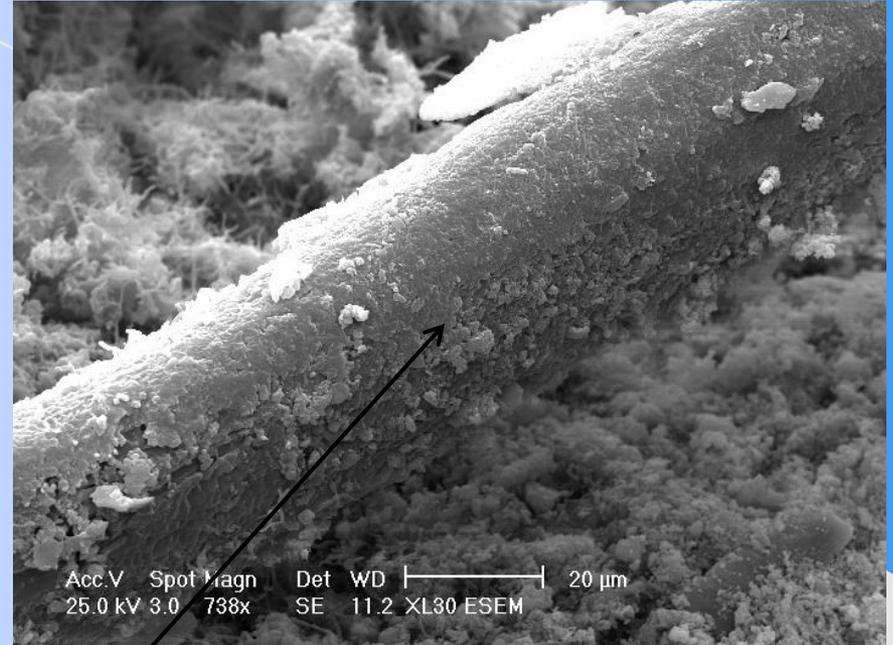
Hair in plaster that had been subjected to long term saturation

Hair partially petrified, and replaced by calcite, now splitting.

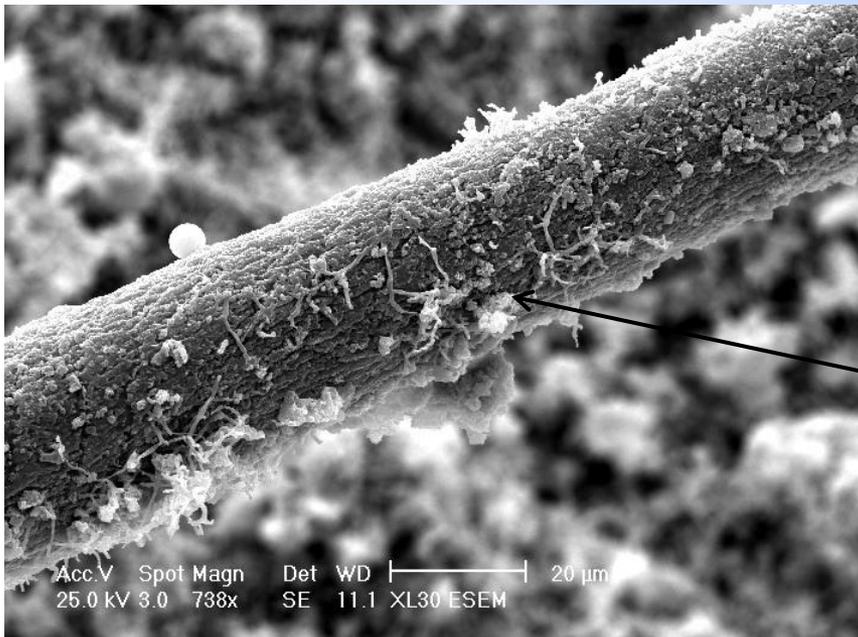
Hair still apparently unaffected, with no structural degradation observed

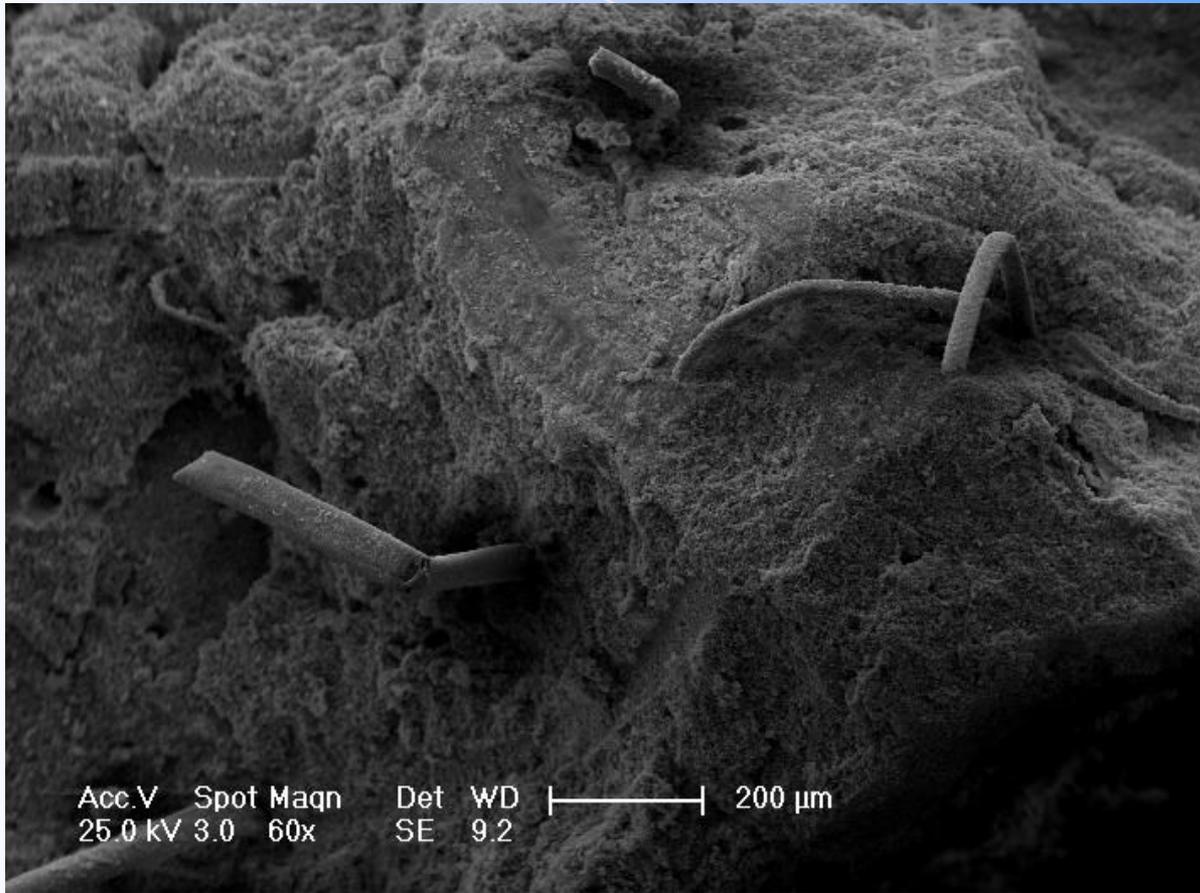
High power magnification of broken and denatured hair fibre in a failed plaster. Residual cuticle scales and absence of a clear medulla suggesting Goat hair.

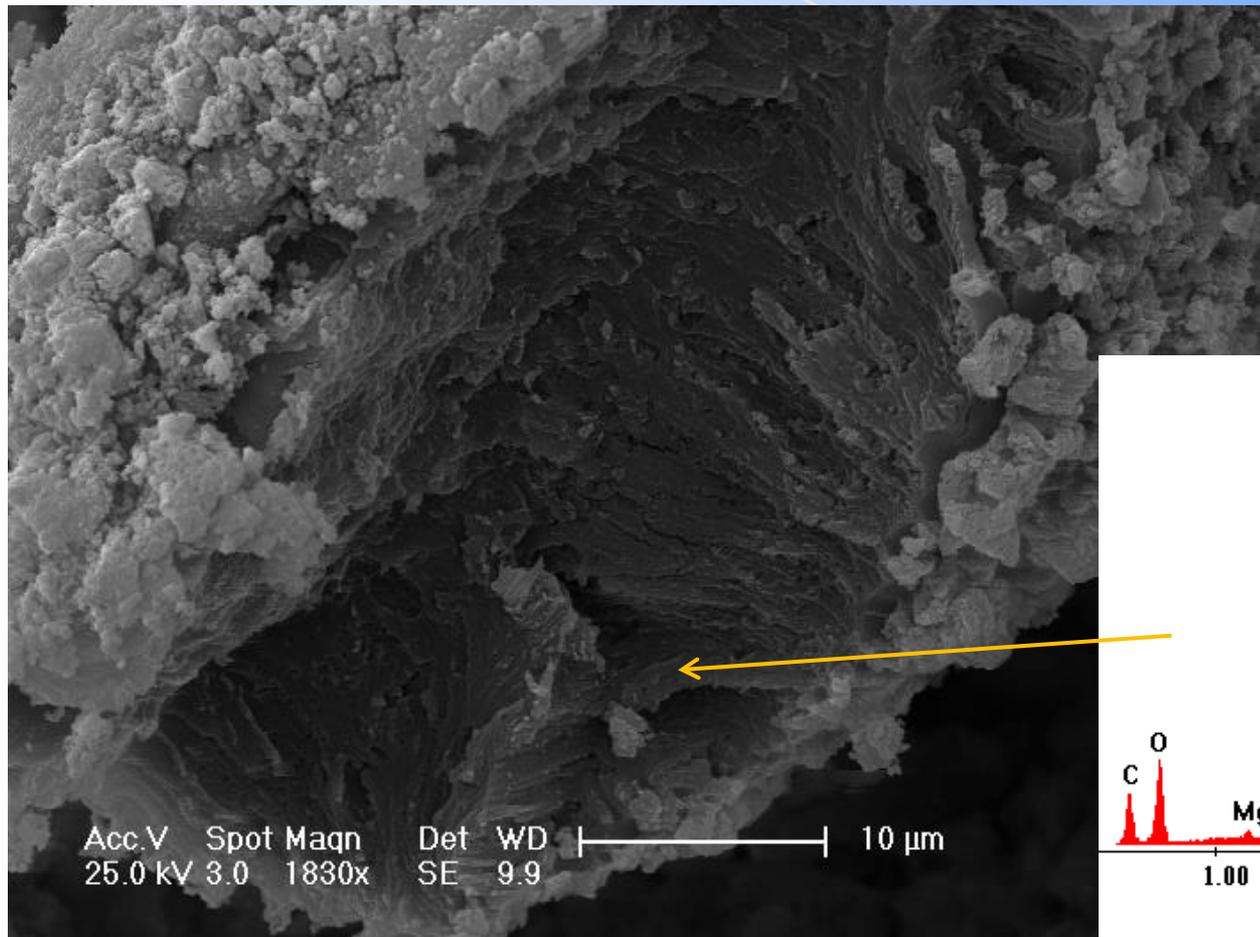
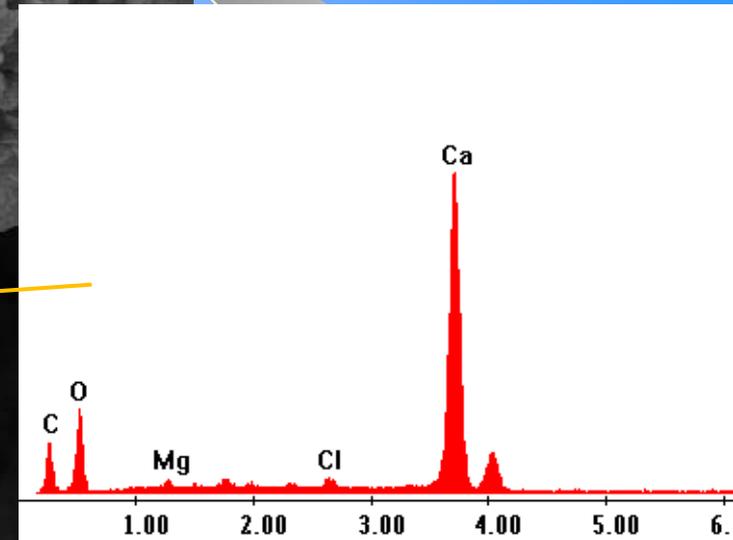
Void left on the dissolution of a hair fibre, with the lining of the void mirroring the pattern of the cuticle scales of a horse hair. The scales on analysis were found to be pure calcium carbonate.
