# OLD TRENT BRIDGE, NOTTINGHAM

## CONDITION SURVEY AND RECOMMENDED REPAIR AND CONSERVATION.

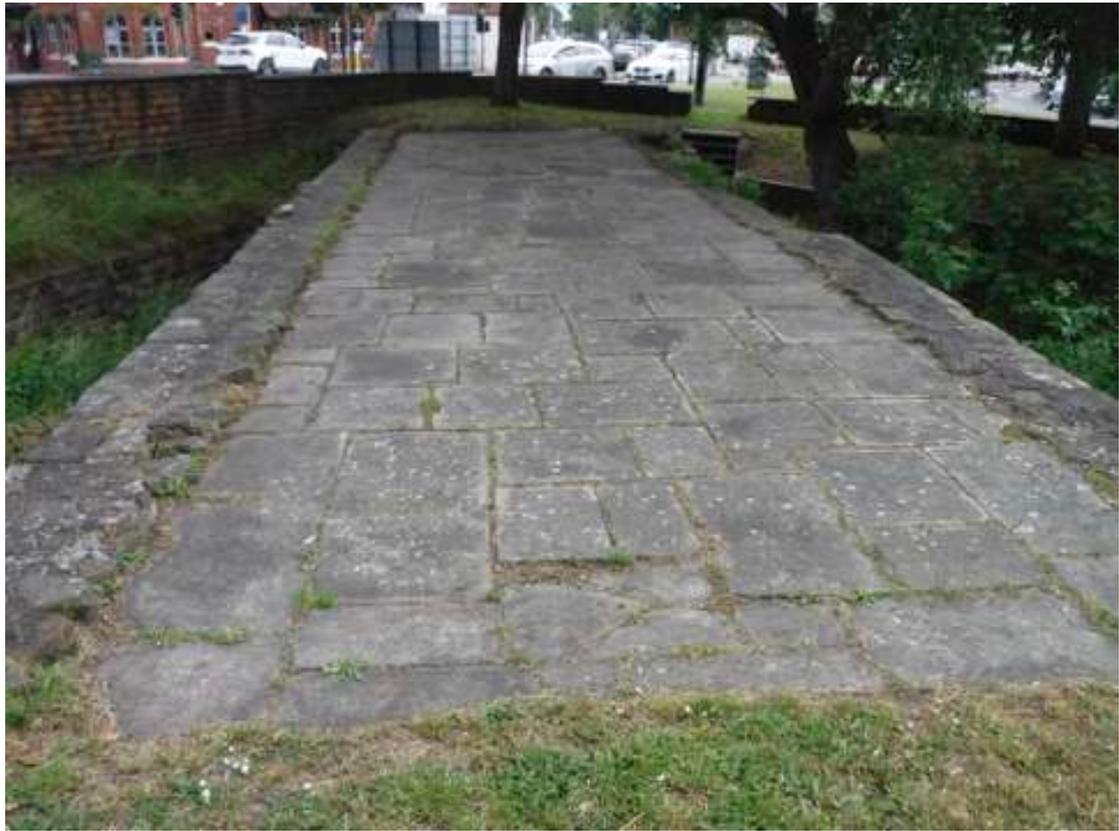
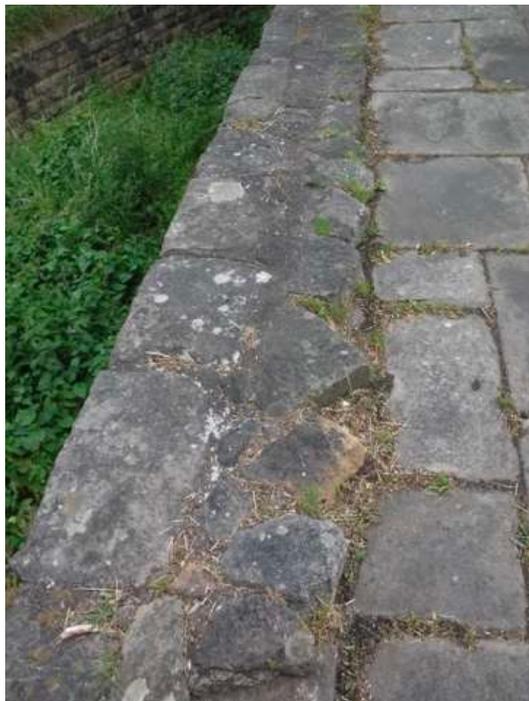
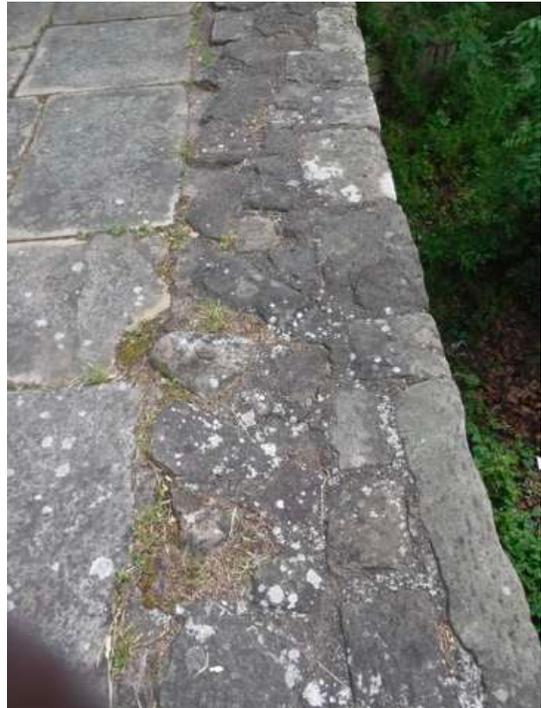
## West elevation

*A) & B) the upper two courses wholly rebuilt using probable 1:1:6 mortar. Water run-off has led to somewhat accelerated weathering of the ashlar beneath.*

The bridge roadway is paved with York stone flags between remodelled wall-tops. The latter would seem to be a Ministry of Works-era rebuild at upper levels, using cementitious mortars with coarse, sharp sand aggregates. These are probably 1:1:6, Portland cement: hydrated lime: sand. This has been durable and has not caused decay to the uppermost stones of the remnant parapet. However, to the east elevation, lower courses of the same have suffered significant frost damage contributed to by such mortar and the associated run-off from the upper parapet. Much of the pointing to the stone flags has been lost, or is fractured, adding to the potential burden of water within the lower former parapet wall, as well as within the arch vaults, which latter exhibit extensive salt crystallisation, as well as salt-induced decay to brick and stone surfaces, as well as to original construction mortars. The cementitious mortars remain substantially intact and well-attached and should be left. In the absence of their promoting decay, they are fit for purpose (in the absence of weathering detail) and were well-executed. The paving should be repointed with similarly robust and frost-resistant mortar to reduce the water (and salt) burden within the arch vaults beneath. (1).

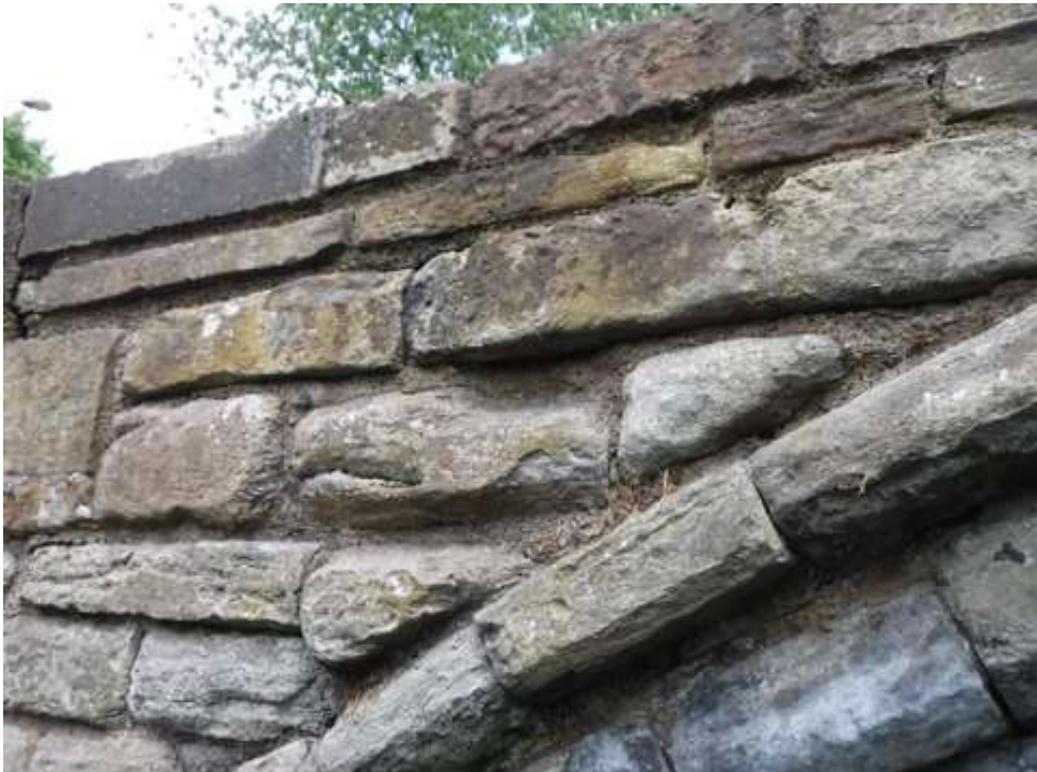
## East elevation

*C) Water run-off has exposed the weaker ashlar stones to significant frost damage at higher levels; rising moisture being trapped by cementitious repointing at lower level has contributed to similar damage at this level, D). This would ideally be rectified by the introduction of projecting stone copings. Providing a proper drip function (1).*

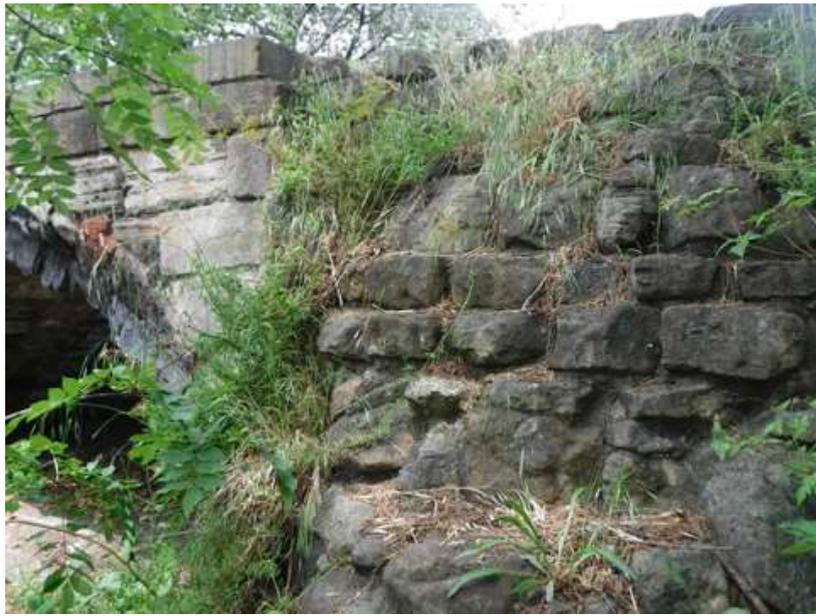
E)

The cutwater to the west side remains substantially intact; only a stub of the same survives to the east side. All remnant cutwaters have been 'rough-racked' to greater or lesser extents, using the same cementitious mortar as above and being part of the same 'Ministry of Works' scheme. This has been less successful, inviting significant growth of vegetation, but remains substantially intact. Rough-racking extends above the more southerly arch to the west side, all but its lower order of voussoirs having been lost. The rough-racking in this location has been lost or is deficient and this should be re-consolidated (1) and only a single skin of brickwork survives at parapet level.

*Rough-racking to west side, to cutwaters and above disrupted arch*

- Remove all weed growth from rough-racked cutwaters and over disrupted arch; assess stability of rough-racking and reconsolidate as necessary using a hot mixed mortar as above but with 25% meta-kaolin addition as a proportion of the quicklime by volume. Provide weatherings throughout to shed, rather than to trap, received water. (2) £600
- Provide mortar weatherings to exposed arch voussoir tops. (1) £200
- Repoint approximately 40%, leaving all intact original or earlier hot mixed lime mortars.(1) £800

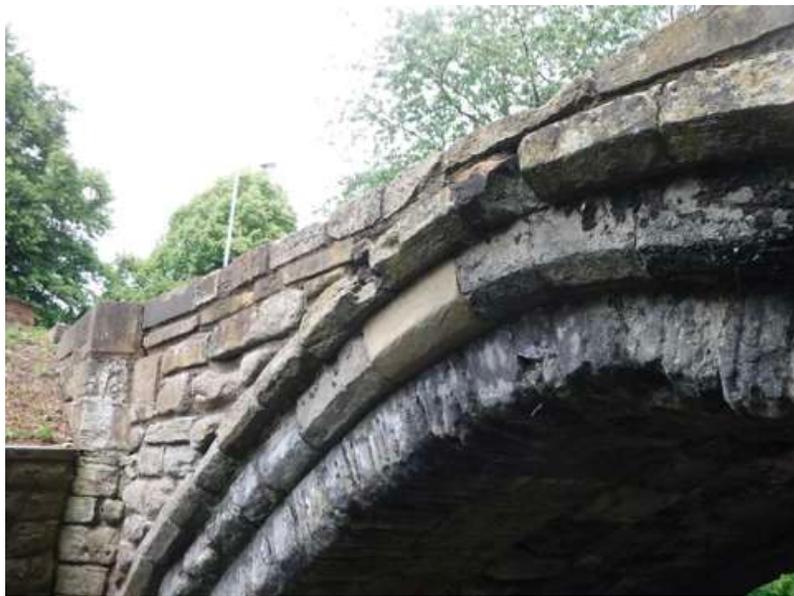
J)

The more sheltered faces of arch-stones to the west side have developed gypsum sulphate skins in response to air pollution. The monument is close to a busy road and is in a sunken area, where particularly diesel exhaust particles will accumulate and attach to the stonework, the more so the wetter the fabric of the bridge is. Where this stonework is not routinely rain-washed, these particles will react with lime in the stone, as well as with free lime that might be leached from lime or cement-lime mortars to the adjacent stonework, creating such skins. These will cause powdering of the stone face beneath. Their presence may suggest some calcareous content in the local sandstone used in the bridge.

- Remove all gypsum soiling to arch stones using fine stainless steel brushes and water. (1) £600
- Repoint 90% using a mildly pozzolanic hot mixed lime mortar. This might be 1 part powdered quicklime: 2 parts coarser sharp sand: 1 part fine sharp sand plus 5% pozzolanic brick dust as a proportion of the slaked lime (10% of the quicklime), or wood ash (fines and charcoal) added at similar proportion. More exposed areas might receive 20% wood ash as a proportion of the quicklime. (1) £1500

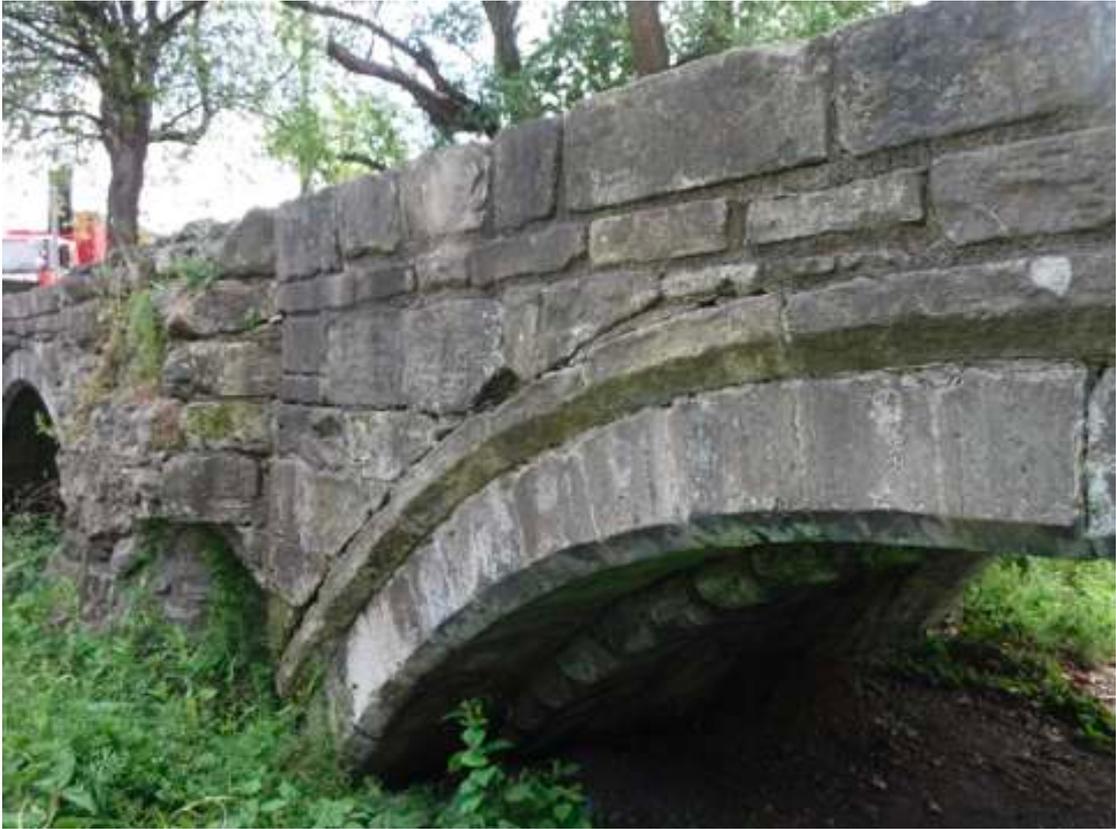
M)

The overall condition of the monument is reasonable, but it is in need of some localised repair and of repointing more generally, as well as some improvements to its immediate setting, which currently offers an ambience of neglect with excessive tree growth and extensive colonisation by weeds and grass. The setting would benefit from more regular maintenance, once essential repairs have been effected.

- Replace 2 # outer arch voussoirs with matching sandstone and dressing, southerly arch. (1) £900
- Replace 4 # ashlar stones like-for-like, new stones to be at least 6" deep. If the same stone cannot be sourced, these repairs may be effected using low-fired, handmade clay plain tiles, consistent with the historic significance of the original fabric. (1) £800

- Remove all weed growth and cut vegetation and remove immediately around the monument. (2) £400
- Remove all self-seeded tree saplings (1) £250
