Method Statement. Consolidation and Repair of Iron-Stone Worker's cottages and associated workshop building, Rosedale East.

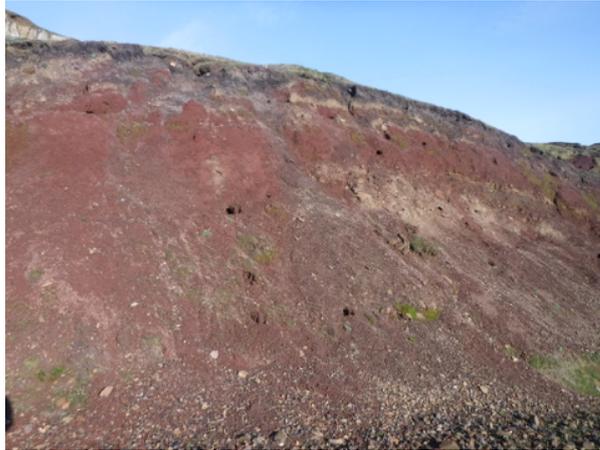
*Calcined ironstone waste.*

This will be harvested from across the spoil-heap in order to preserve the topography of the heap itself and will be passed in small buckets to the former road-way to the incline that served the cottages and workshops above and then carried in power-barrows to the work-site. All necessary materials will be similarly transported.

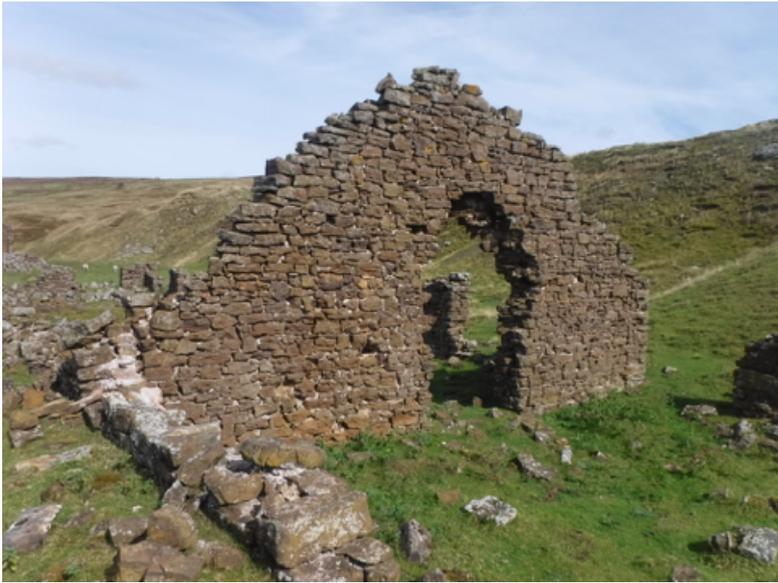
*workshop gable, north side – low, surviving walls of the workshop to the south.*

The primary focus of the works will be to the low, standing walls of the workshop building, as well as to the surviving gable wall. The latter will be scaffolded and all loose or precarious stones will be removed by the trainers before access to the wall by others; the opening will be supported with accrow props to facilitate the re-introduction of lintels and the reinstatement of missing stonework above these lintels. No scaffolding will be required for most of the proposed works, which will entail re-pointing and top-of-the-wall flaunchings. The wall-top flaunchings will be of an eminently hydraulic pozzolanic mortar; pointing will be of similar hydraulicity to the original mortars.

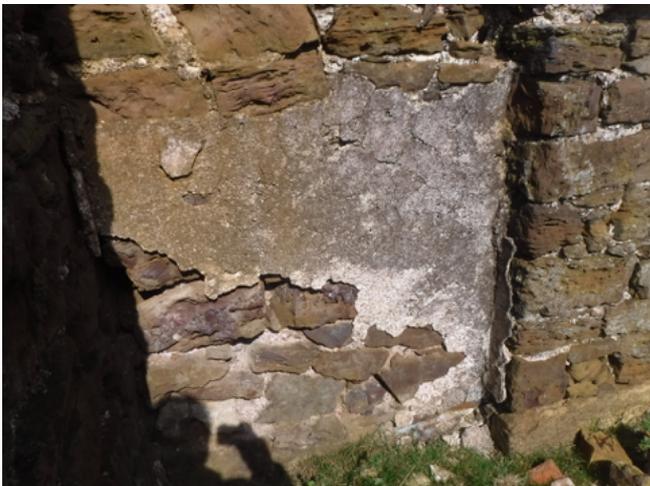
*surviving plaster within north-most cottage*

Plastering will be carried out in the north-most cottage, which has been consolidated in the past using cementitious mortars. No access will be allowed to other cottage-remnants, as these are precarious. All potential hazards will be removed by the trainers prior to access to all proposed work areas.

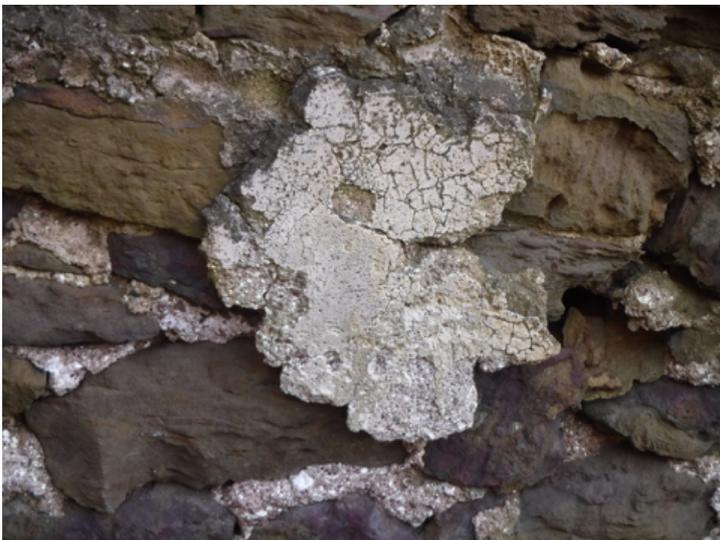
*close-up of similar.*
